AIRPROX REPORT No 2024166

Date: 18 Jul 2024 Time: 1423Z Position: 5213N 00029W Location: ivo Bedford Airfield

PART A: SUMMARY OF INFORMATION REPORTED TO UKAB

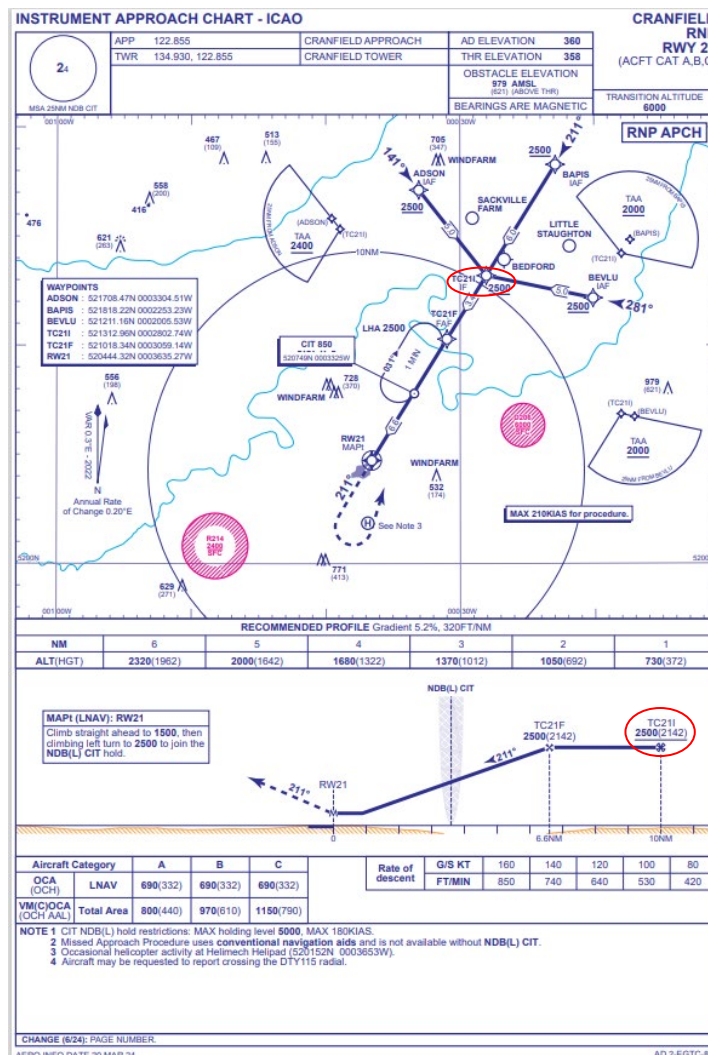
Figure 1 – the Intermediate Fix TC211 is depicted by the red ovals.

This Airprox again highlights the issues of RNP fixes being outside the warning areas of instrument approaches in Class G airspace and not being highlighted on VFR charts.

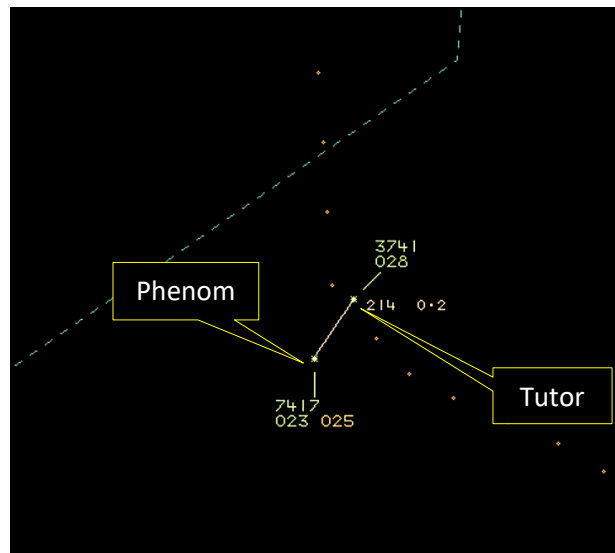
An analysis of the NATS radar replay was undertaken and both the Phenom and Tutor were identified using Mode S data. The Phenom was seen taking a procedural right turn towards the Cranfield Intermediate Fix TC211 for RW21 while maintaining a steady altitude of 2300ft. The Tutor was heading approximately northwest at about 2500ft and was seen to make a slight right turn with a 300ft height gain to 2800ft, taking them behind the Phenom. CPA was at 1422:34 with a separation of 0.2NM horizontally and 500ft vertically (Figure 2).

Figure 2 - CPA at 1422:34 Separation 0.2NM and 500ft

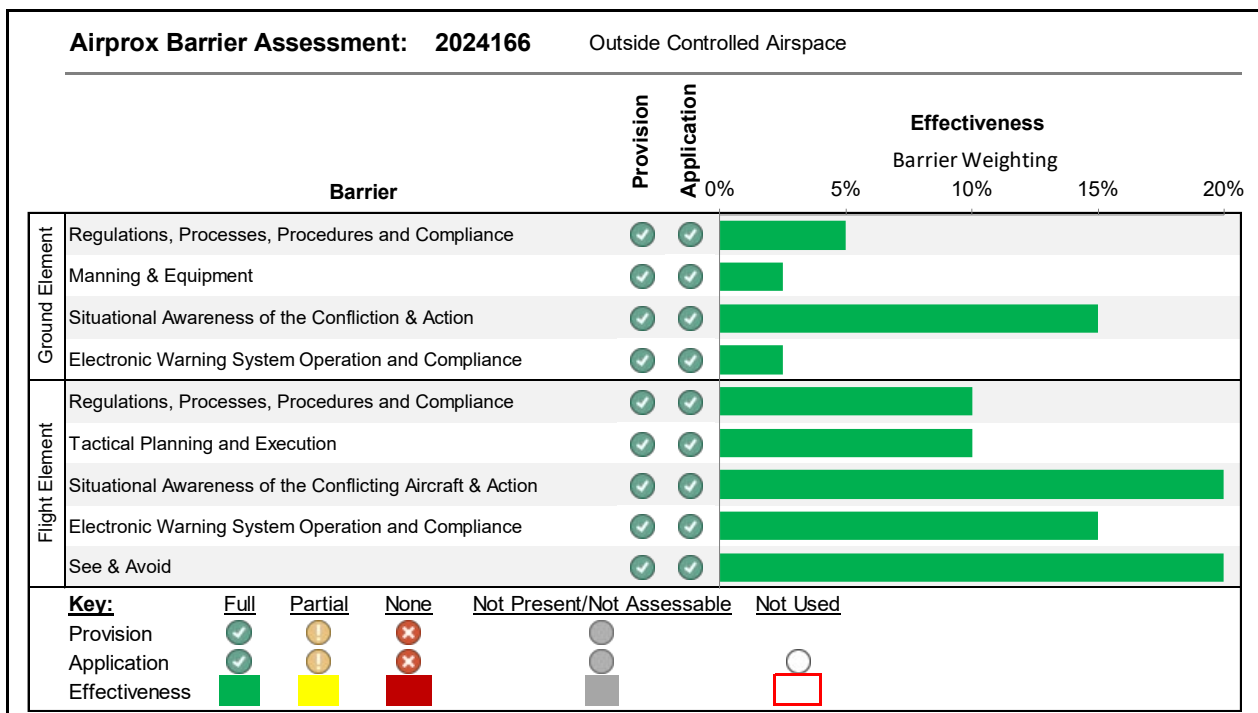
Safety Barrier Assessment⁵

In assessing the effectiveness of the safety barriers associated with this incident, the Board concluded that all ground and flight elements' barriers had been effective.
