AIRPROX REPORT No 2024170

Date: 24 Jul 2024 Time: 1113Z Position: 5157N 00126W Location: Enstone

PART A: SUMMARY OF INFORMATION REPORTED TO UKAB

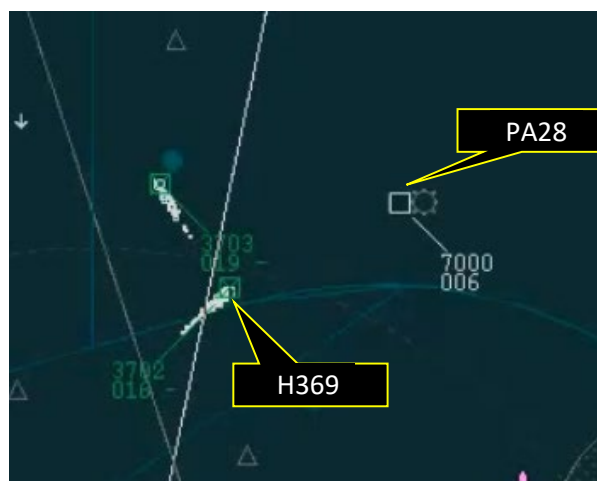
Sequence of Events: At 1111:06, on completion of their transit through the Brize Norton CTR, the pilot of the H369 informed the Brize Norton Zone controller of their intention to change en-route. During this transmission, the PA28 appeared on radar as it climbed out from an approach at Enstone. The Brize Norton Zone controller acknowledged the intentions of the H369 pilot to change en-route and passed Traffic Information regarding the PA28; "*Just be aware Enstone traffic 12 o'clock 5 miles opposite direction climbing, keep a good lookout, squawk conspicuity change en route*". The pilot of the H369 did not acknowledge the Enstone Traffic Information but did respond with "*squawk conspicuity*" to acknowledge the instruction.

Figure 1 - 1111:06. The H369 pilot requested to change en-route.

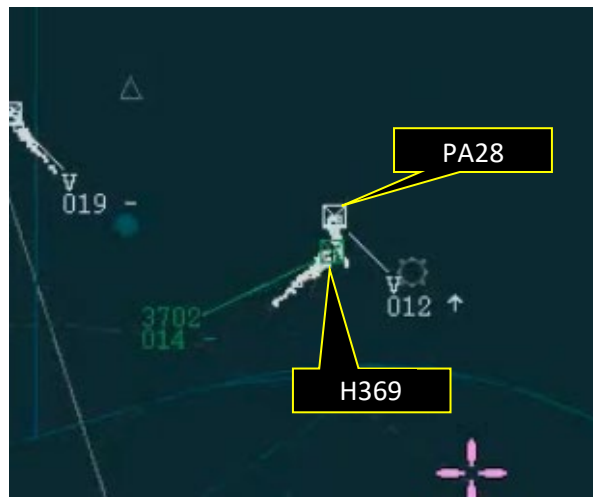
At 1112:20, aware of the decreasing vertical separation between the H369 and PA28, the Brize Norton Zone controller repeated the Traffic Information to the H369 pilot; *“previously called traffic now north, half a mile, manoeuvring, indicating 200ft below, climbing”*. The H369 pilot responded with *“err”*, to which the Brize Norton Zone controller repeated the Traffic Information; *“previously called traffic now north half a mile, manoeuvring, indicating 200ft below, climbing”*. The H369 pilot acknowledged the Traffic Information; *“Affirm”* but did not indicate if they were visual or not.

Figure 2 - 1112:20. The H369 pilot was provided additional Traffic Information on the PA28. (Separation was 0.8NM and 200ft)

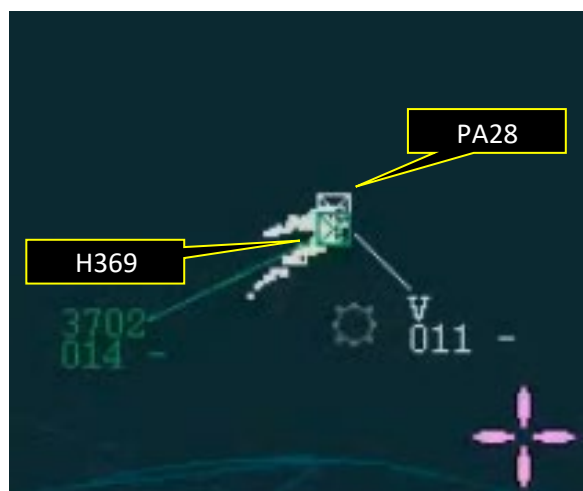
CPA occurred at 1113:04 and the separation was recorded as 0.1NM and 300ft.

Figure 3 - CPA was assessed to have occurred at 1113:04

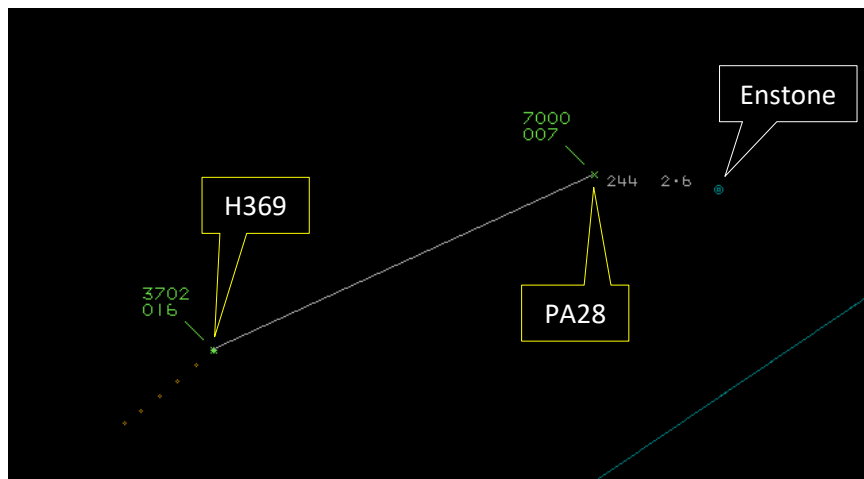
An analysis of the NATS radar replay was undertaken and the H369 could be positively identified from Mode S data (Figure 4). In addition, the pilot of the H369 kindly supplied GPS data for their flight. The PA28 first appeared on the radar replay at 1111:22 and was identified by reference to the PA28 pilot's narrative report.

Figure 4 - The PA28 first appeared on the radar replay at 1111:22

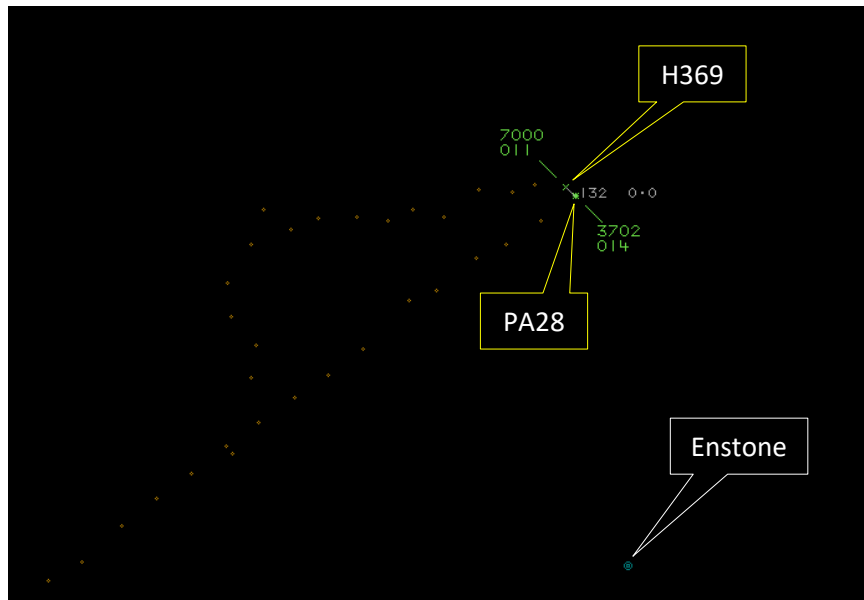
The diagram was constructed and the separation at CPA determined by combining the various data sources.

Figure 5 - CPA at 1113:02
