AIRPROX REPORT No 2024176

Date: 27 Jul 2024 Time: 1409Z Position: 5154N 00107E Location: 1NM N Tendring

PART A: SUMMARY OF INFORMATION REPORTED TO UKAB

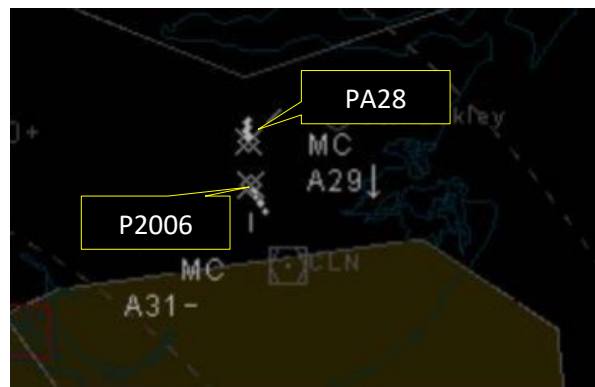
Figure 1 Time 1409:00 Southend Radar

1409:00, according to the recorded surveillance data, the PA28 was on a southerly track, to the north of the Clacton VOR, and their Mode C was indicating altitude 2900ft descending. At this time, the P2006 was in their 12 o'clock position, opposite direction, indicating level at 3100 ft (Figure 1).

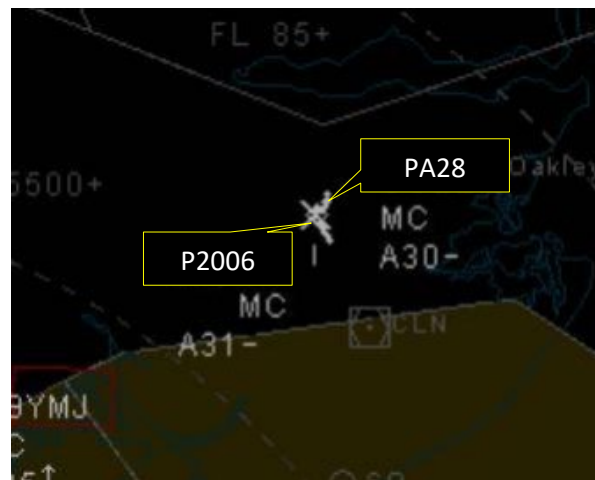
Figure 2 – Time 1409:22 0NM and 100ft

1409:22 (CPA), after the PA28 had commenced a right-hand turn, CPA occurred, with a minimum indicated lateral distance of 0NM and 100ft vertical (Figure 2).

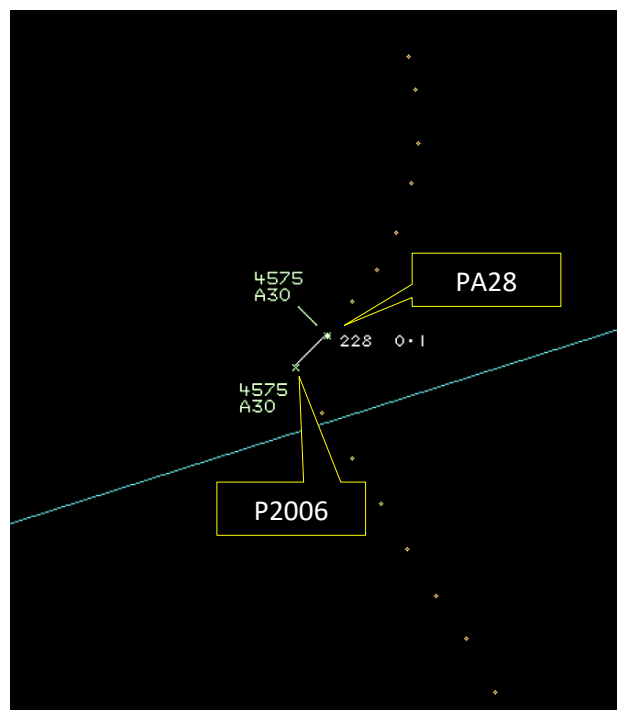
Figure 3 Time 1409:22 0.1NM and 0ft

An analysis of the NATS radar replay, ADS-B data and the P2006 pilot's navigation file were undertaken. The closest point of approach that could be detected from the radar data was at 1409:22 (Figure 3) and again, on the next radar sweep at 1409:26 (Figure 4) with the aircraft separated by 0.1NM and co-altitude on both occasions. The radar depiction provided by Southend ATC could not be replicated.

Analysis of ADS-B data sources matched the radar picture and an interpolation of the aircraft positions between the radar sweeps, with the P2006 position backed up by its navigation file. CPA was assessed to have been at 1409:24 with a separation of less than 0.1NM horizontally and 0ft vertically.
