AIRPROX REPORT No 2024198

Date: 04 Aug 2024 Time: ~1055Z Position: 5107N 00134W Location: Middle Wallop ATZ

PART A: SUMMARY OF INFORMATION REPORTED TO UKAB

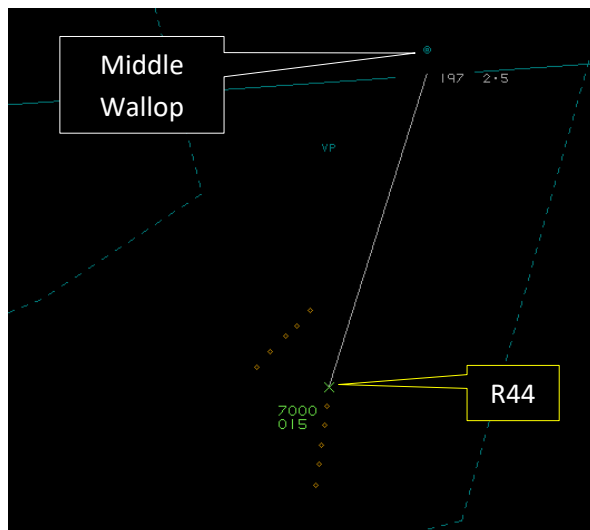
Figure 1 - 1053:38

An analysis of the NATS radar replay was undertaken and the R44 could be positively identified from Mode S data. However, the R44 faded from the radar replay at 1053:38 when it had been 2.5NM SSW of Middle Wallop (Figure 1) and reappeared to the north of the Middle Wallop runway centreline at 1055:29 (Figure 2).

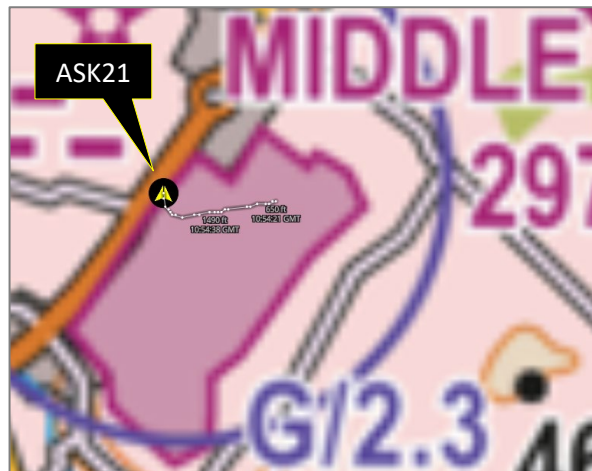
Figure 3 – The position of the ASK21 at 1055 (approximately 30sec after CPA) from GPS data.

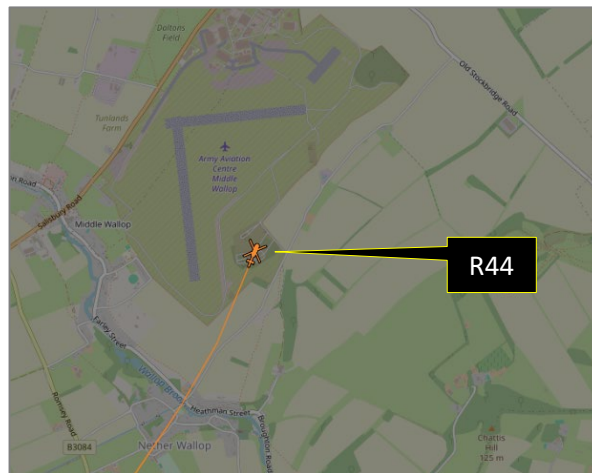
Figure 4 - The position of the R44 at 1054:30 (the approximate time of CPA) from MLAT data.
