AIRPROX REPORT No 2024162

Date: 17 Jul 2024 Time: 1530Z Position: 5214N 00043E Location: Bury St. Edmunds

PART A: SUMMARY OF INFORMATION REPORTED TO UKAB

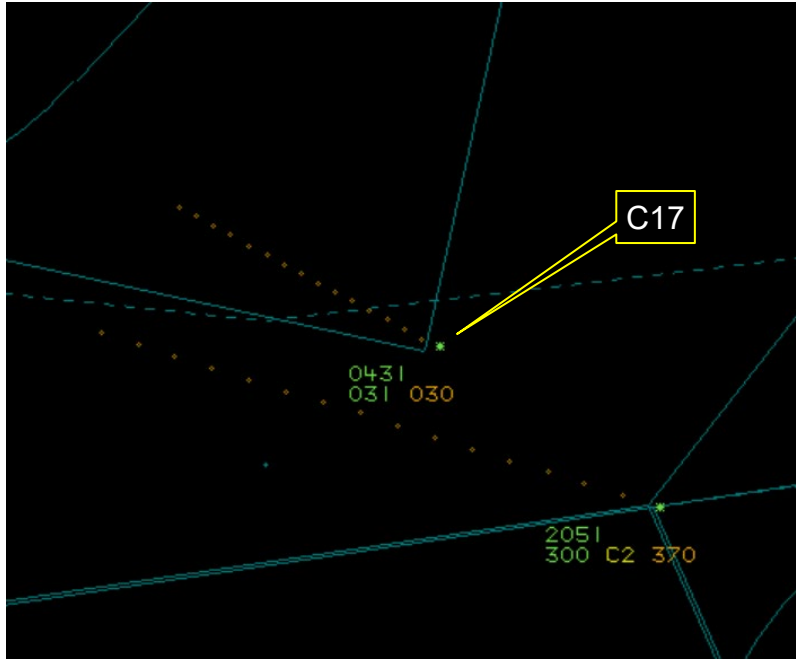
Figure 1: At CPA 1529:45 altitude 3270ft SPS

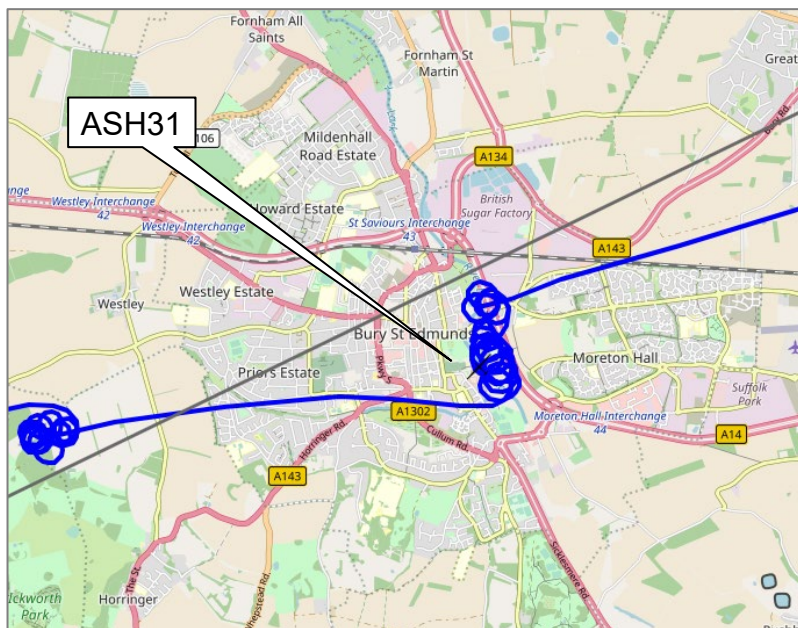
Figure 2: Image taken from ASH31 pilot-provided file at 1529:45, altitude 3340ft

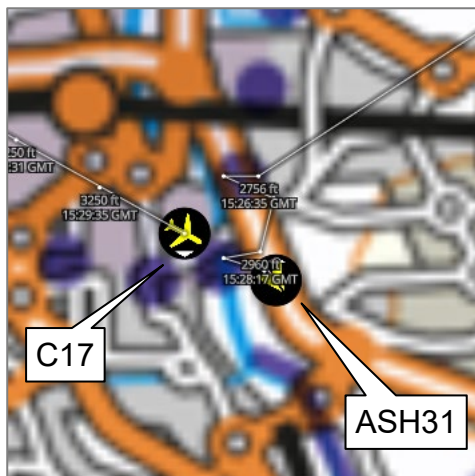
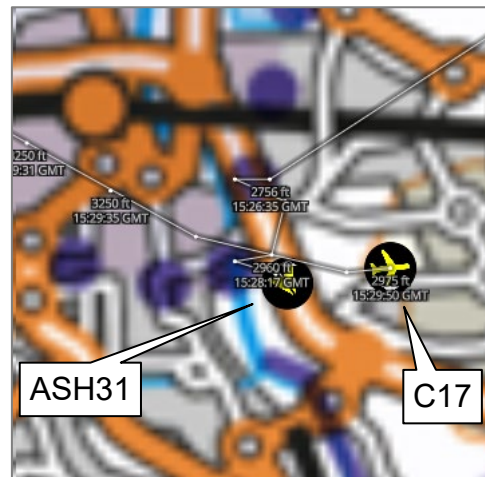
Figure 3: 15:29:40 C17 3125ft ASH31 3268ft Figure 4: 15:29:50 C17 2975ft ASH31 3268ft
 Figures 3 and 4 at 10sec interval between screenshots – the ASH31 data did not refresh.
