**AIRPROX REPORT No 2024202**

Date: 27 Jun 2024 Time: ~1647Z Position: 5147N 00255W Location: IVO The Bryn, Monmouthshire

**PART A: SUMMARY OF INFORMATION REPORTED TO UKAB**

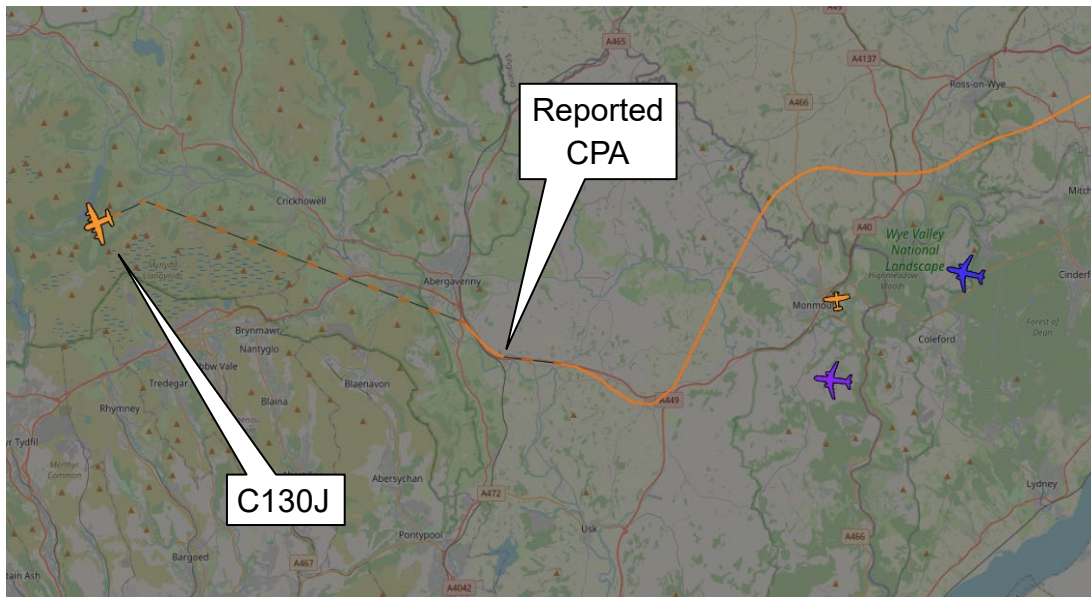
Figure 1: The path of the C130 via an ADS-B tracking tool. The Chinook did not show.

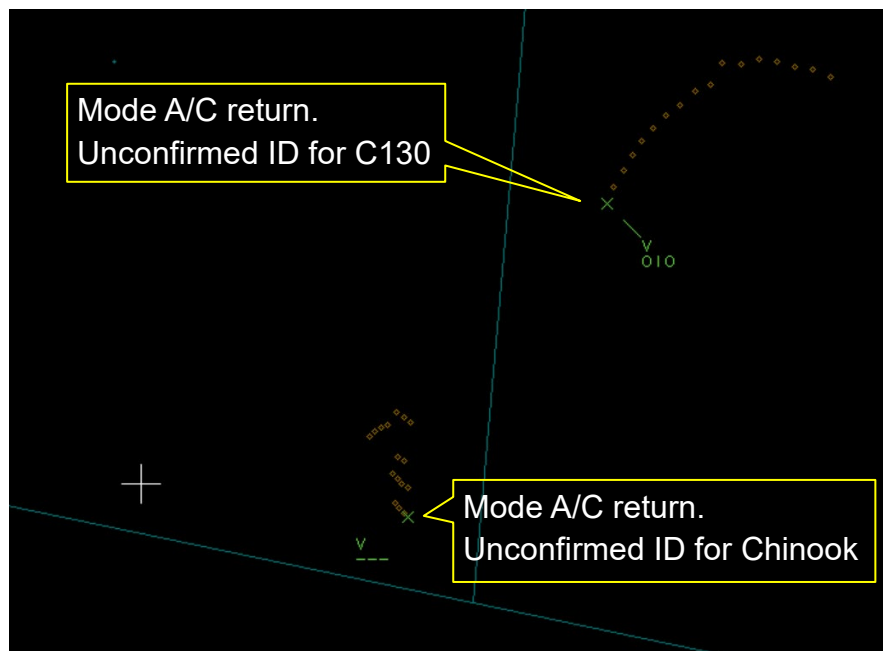
Figure 2: at 1644:51 – the southernmost return disappeared at the next sweep and did not return. The white cross indicates the position of the reported CPA.

Reviewing the radar replay, two aircraft can be seen although they offer no aircraft data. They were operating in line with the report narratives for the C130 and the Chinook with timings, headings, and

speed. Radar coverage in the area of the reported Airprox was not very good with the track believed to be the Chinook disappearing from radar several minutes before the reported incident time. The Airprox position provided by the Chinook pilot does match the position of the C130 on the radar replay and corresponds with the 1647 reported incident time.
