AIRPROX REPORT No 2024203

Date: 12 Aug 2024 Time: 1439Z Position: 5151N 00216W Location: 4.5NM SW Gloucestershire

PART A: SUMMARY OF INFORMATION REPORTED TO UKAB

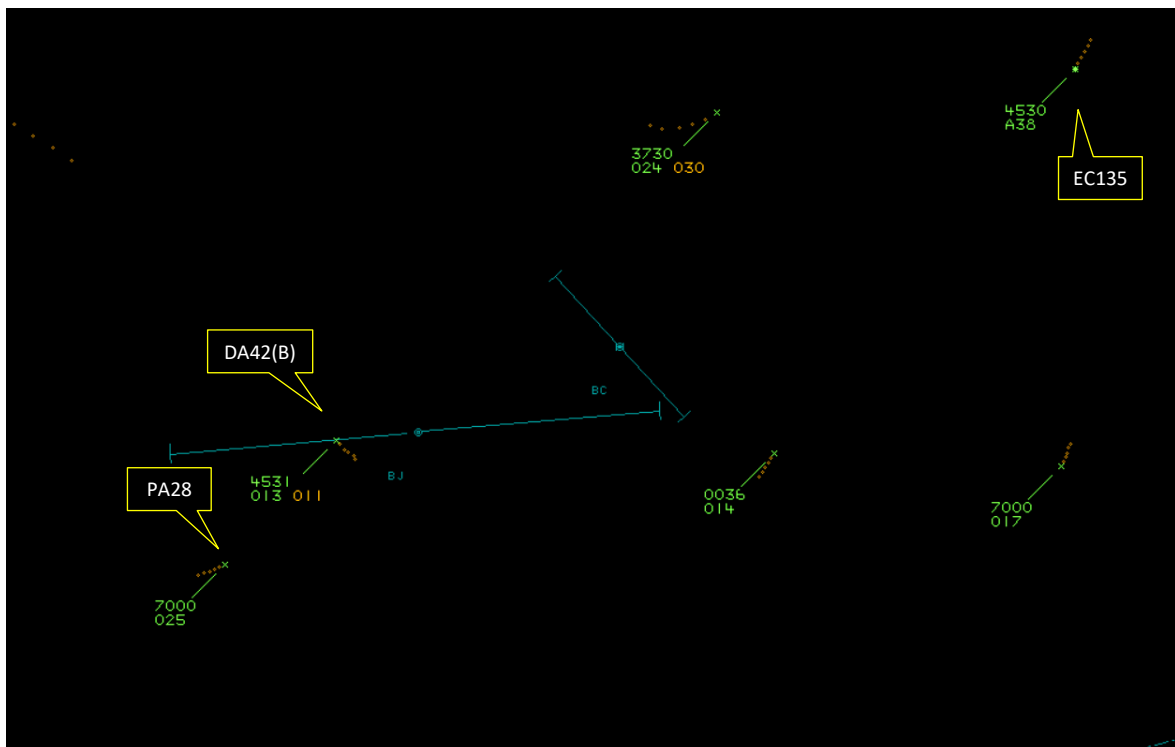
Figure 1 – 1434:27 – levels displayed as FL – add 162ft for altitude.

The DA42(A) pilot acknowledged the Traffic Information and read-back the take-off clearance. No Traffic Information was passed to the pilot on the DA42(B) crossing the upwind end of RW27 in the circuit for RW22 (Figure 1).

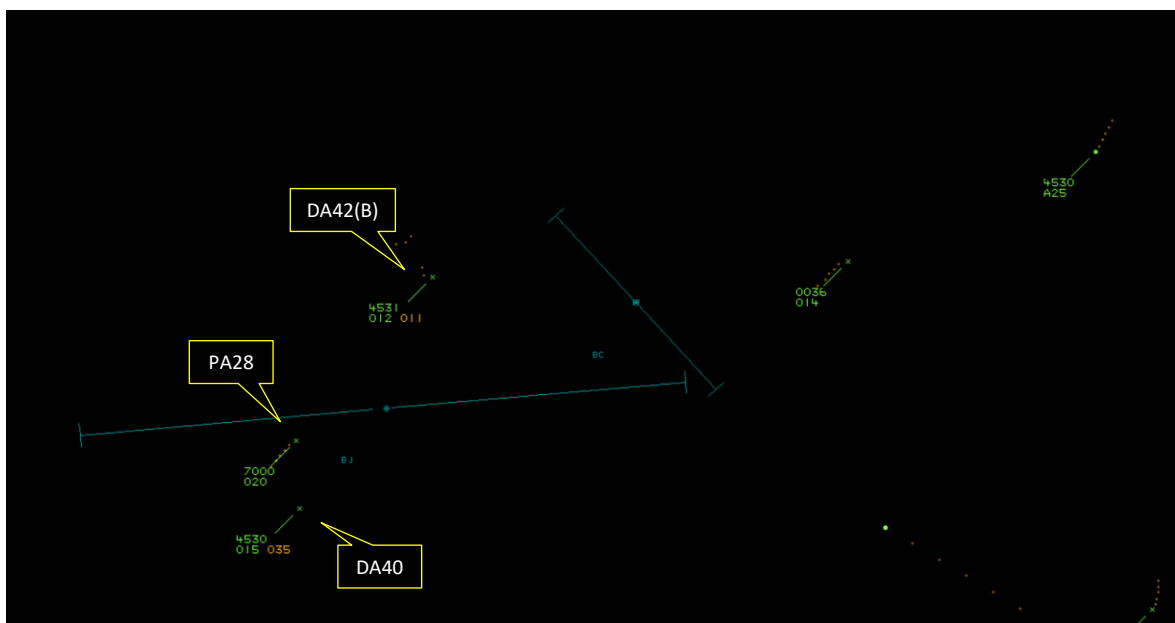
Figure 2 – 1436:24

At 1436:18 the pilot of the PA28 asked for their height restriction to be cancelled which was approved by the trainee controller (Figure 2 – 1436:24).

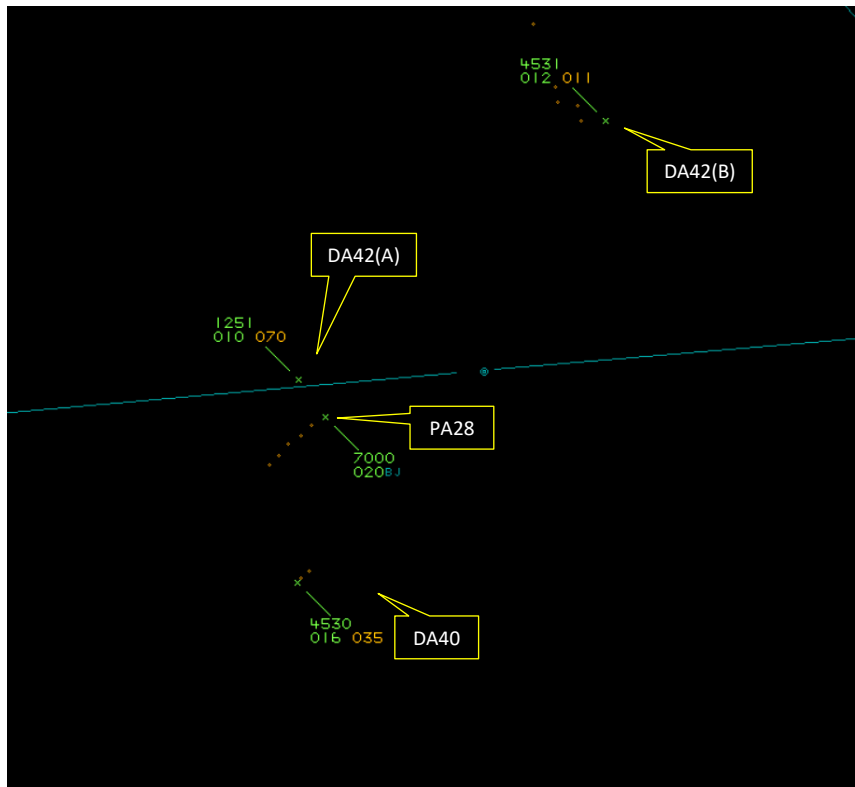
Figure 3 – 1436:32

All aircraft were visible on the area radar replay at 1436:32 (Figure 3)

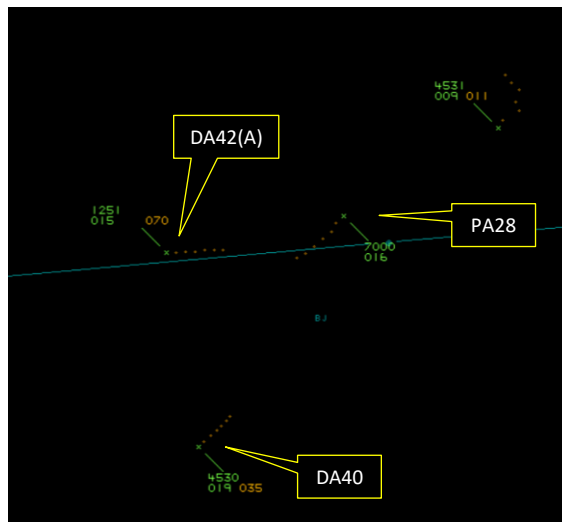
Figure 4 – 1437:07

At 1437:07 the Tower controller requested a level check from the DA42(A) pilot which was reported as 1500ft (Figure 4).

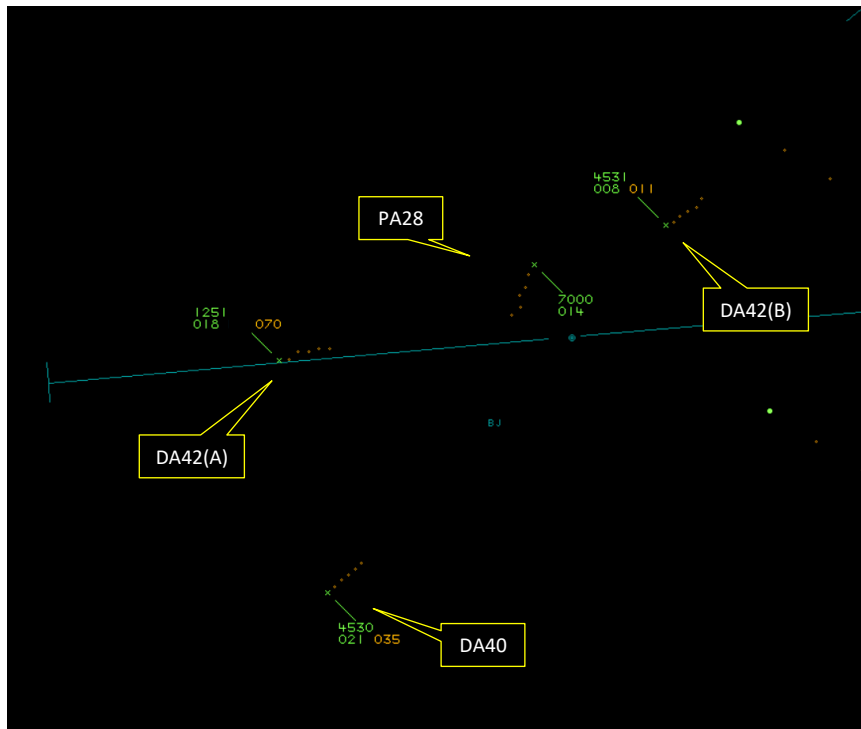
Figure 5 – 1437:26

“Previously mentioned Twin Star has now turned left tracking southwest passing one thousand five hundred feet, you can turn north er right er when er when ready” which was acknowledged by the pilot. The controller then, at 1437:26, advised the DA42(A) pilot:

“Traffic southwest of the field er 4 miles turning right to the north is a DA40”, the pilot reported that the traffic was not in sight (Figure 5).

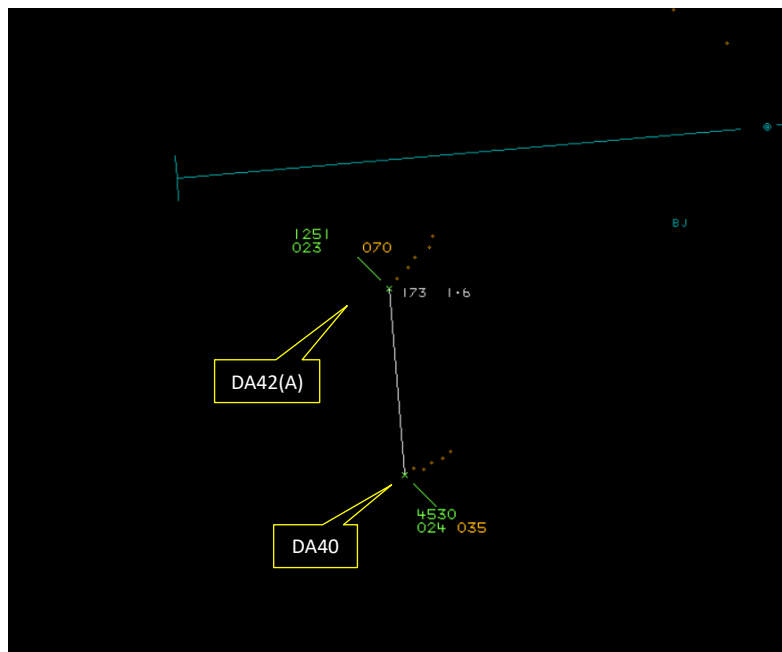
Figure 6 – 1438:06

“Are you visual with previously mentioned Twin Star?” (Figure 6)

The DA40 pilot replied: “The one that departed southwest after we departed southwest? Affirm (callsign), so we’re going to route behind him”.

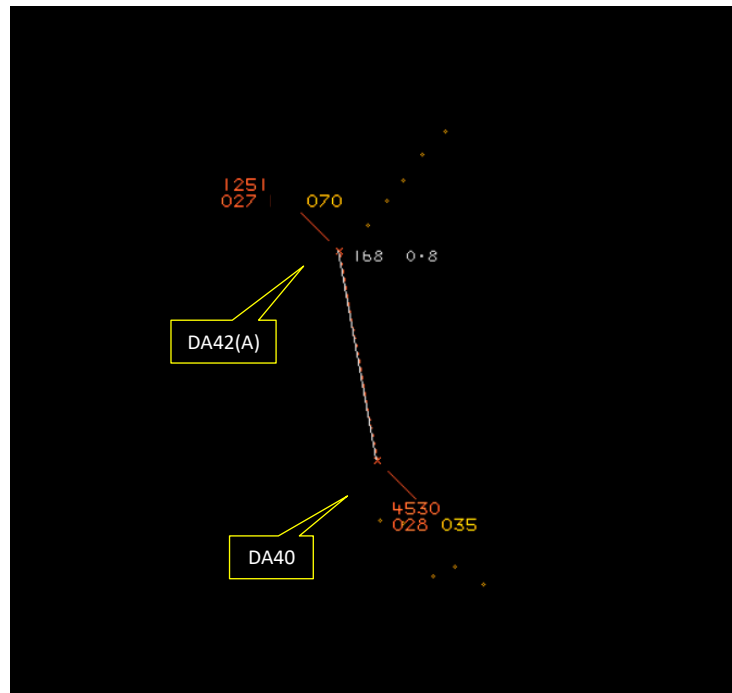
Figure 7 – 1438:25

“Previously mentioned DA40 is visual with you now” and transferred them to the Approach frequency (Figure 7).

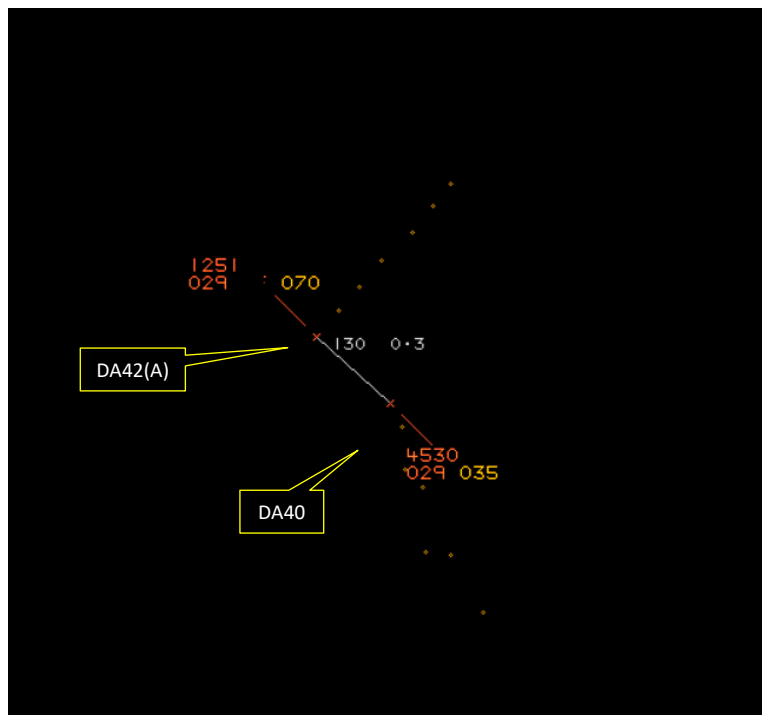
Figure 8 – 1438:35 – CPA

The DA42(A) pilot acknowledged this and confirmed that they had the traffic in sight before reading back the frequency change. CPA occurred at 1438:35 (Figure 8).

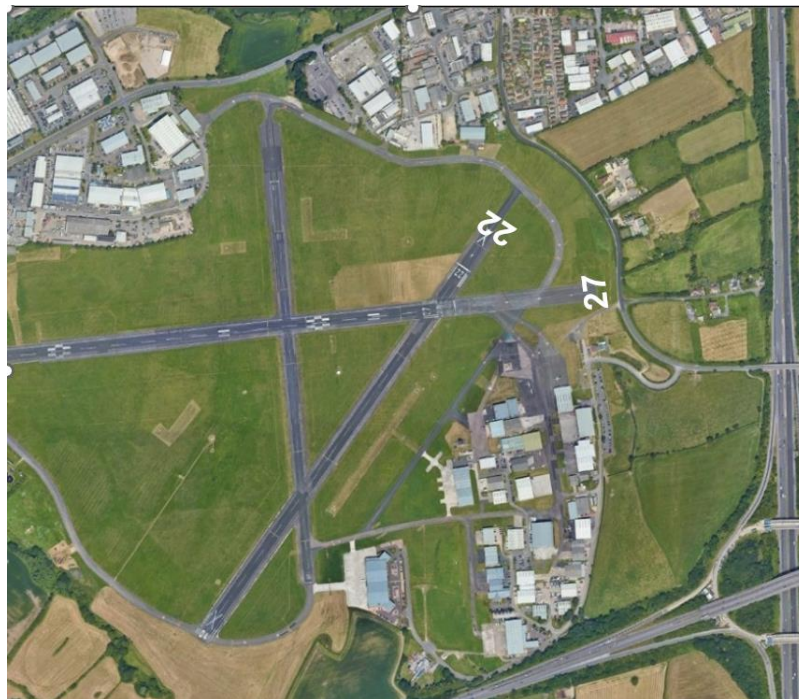
Figure 8 – Gloucestershire runway configuration

In examining how the situation might have been handled differently, the local noise abatement procedures at Gloucestershire have to be taken into account, which specify that the standard circuit for RW22 is right-hand. There is an option to go left-hand after having passed Chosen Hill (1.2NM) if needed, and this might have been an option to expedite the turn to the north for the DA40 after their touch-and-go on RW22. The next arrival on RW27, the EC135, was still over 12NM away and could not be considered to be a factor. However, the potential confliction between the DA40 and RW22 final approach may have dissuaded the Tower controller from taking the DA40 left-hand. The unit investigation stated that both the controller and the OJTI believed that to utilise the left turn for the DA40 would have increased the complexity of the situation (Figure 8).

Gloucestershire Airport reviews its procedures with regard to integration of IFR and VFR traffic during multiple runway operations.
