AIRPROX REPORT No 2024207

Date: 14 Aug 2024 Time: 1734Z Position: 5202N 00212W Location: 3NM northwest of Tewkesbury

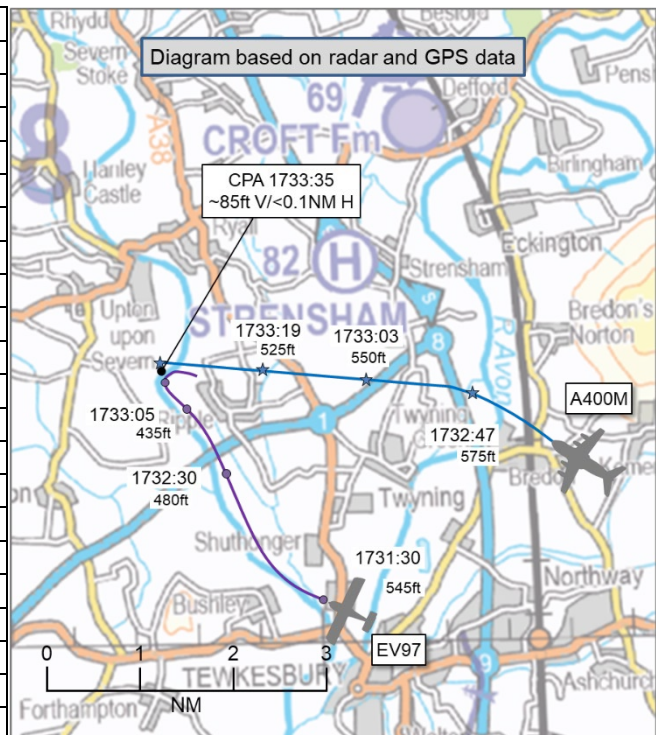
As the EV97 had not been equipped with a transponder and did not show on radar, even as a primary track, it was tracked utilising the CAA's Airspace Analyser Tool. Figures 1 and 2 above show the respective flightpaths of both aircraft. Altitudes have been derived from both radar and GPS with the minimum separation therefore being noted as ~85ft. The diagram at page 1 was constructed by combining radar and GPS sources.

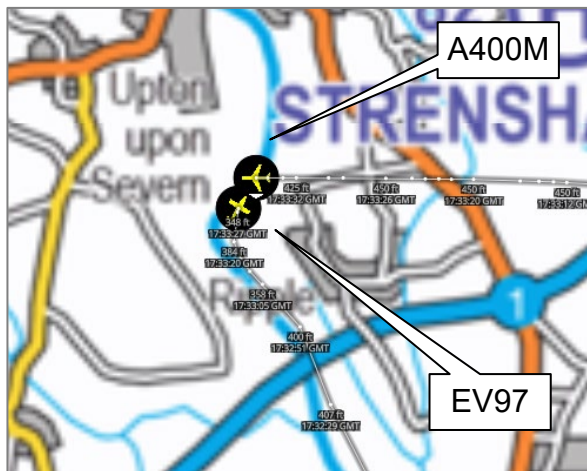
Fig 1: Airspace Analyser Tool derived – A400M timed at 1733:35. EV97 timed at 1733:29.

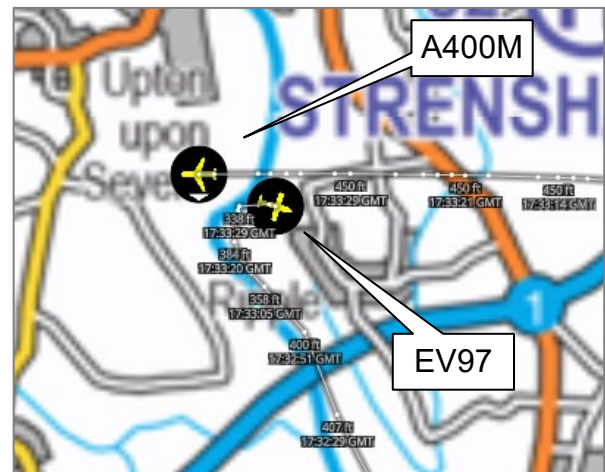
Fig 2: Airspace Analyser Tool picture – A400M timed at 1733:39. EV97 timed at 1733:40.

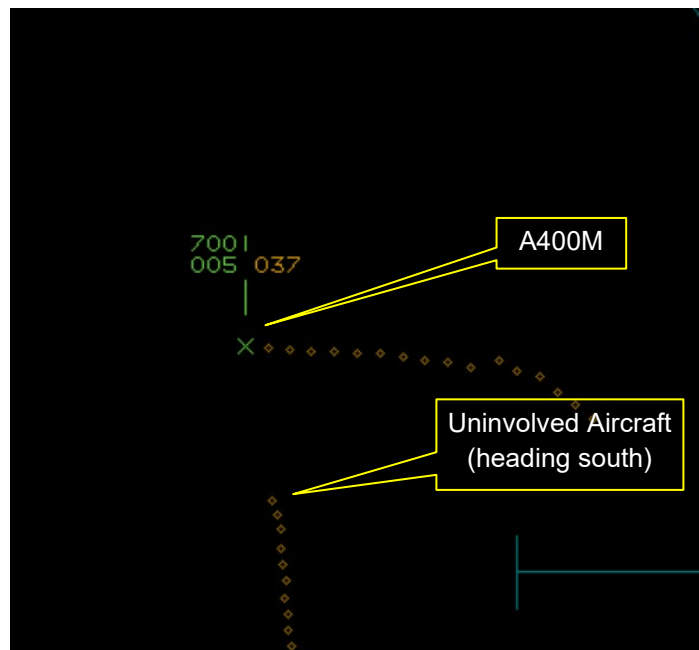
Figure 3: At CPA – 1733:35 A400M only.

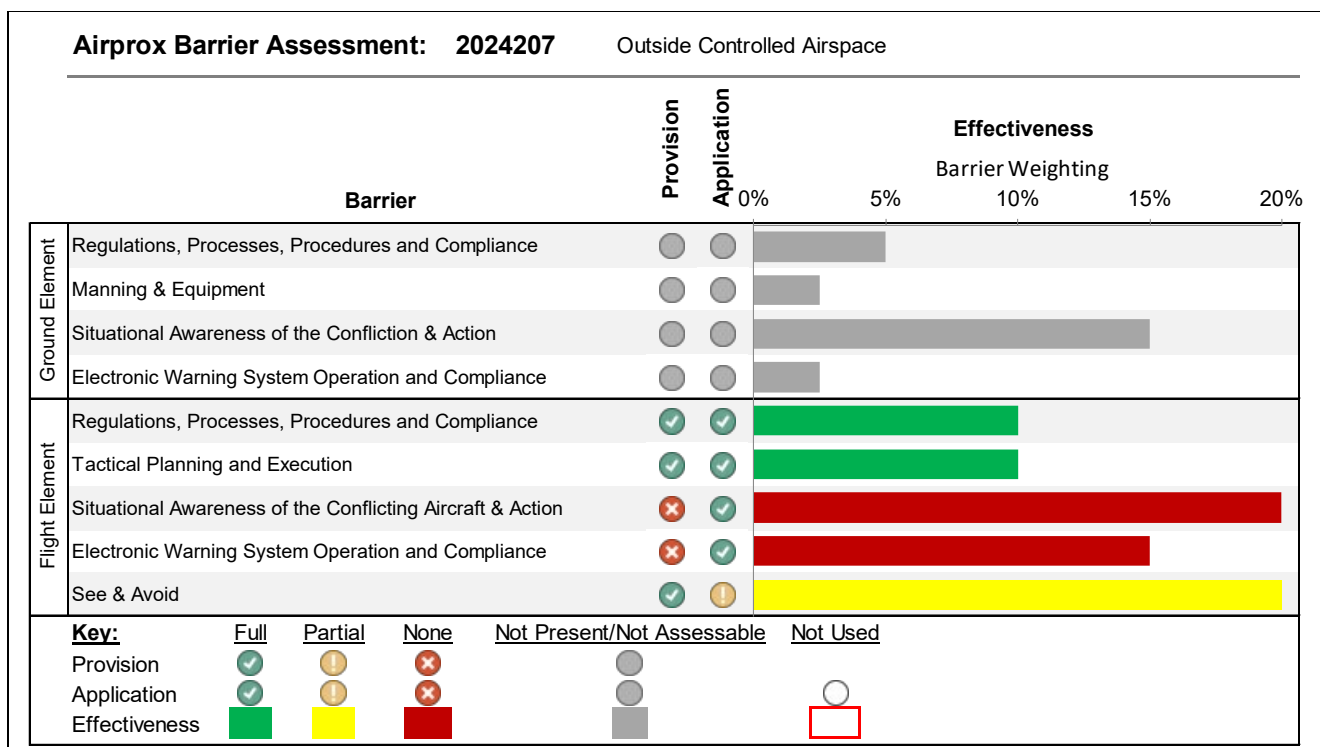
Safety Barrier Assessment³

Situational Awareness of the Conflicting Aircraft and Action were assessed as **ineffective** because neither pilot had any situational awareness of the presence of the other aircraft until sighted.

Electronic Warning System Operation and Compliance were assessed as **ineffective** because neither aircraft had been able to detect electronic emissions from the other.

See and Avoid were assessed as **partially effective** because the A400M pilot had not seen the EV97 before CPA and the EV97 pilot had achieved only a late sighting of the A400M.
