AIRPROX REPORT No 2024220

Date: 29 Jul 2024 Time: 1550Z Position: 5335N 00120W Location: South Kirkby

PART A: SUMMARY OF INFORMATION REPORTED TO UKAB

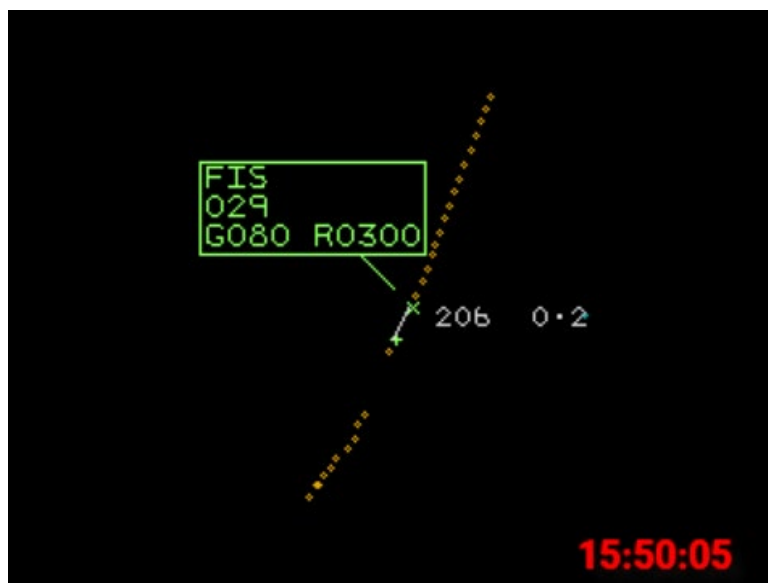
Node Radar displayed [the PA38] continue on their established track at 2600ft before climbing to 2800ft as the aircraft approached a primary contact on an opposite direction track 1NM ahead. Although the primary contact was intermittent and did not consistently display the unknown return at the projected closest point of approach, it was judged that the two aircraft potentially crossed with zero lateral distance (Figure 1) at 1550:09.

Figure 1 – Time 1550:05 last radar contact with another aircraft prior to CPA.

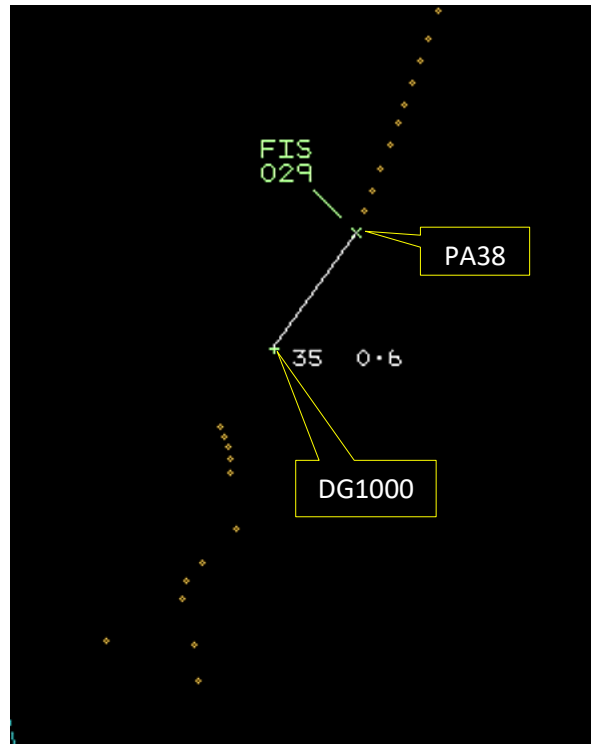
An analysis was made of the NATS radar replay and the PA38 was tracking approximately south, with the DG1000 heading approximately north. The primary track was, at times, intermittent. The last positive radar sweep was at 1549:57 (Figure 2), and the reappearance of the primary returns after CPA.

Figure 2 – Time 1549:57 last primary return prior to CPA

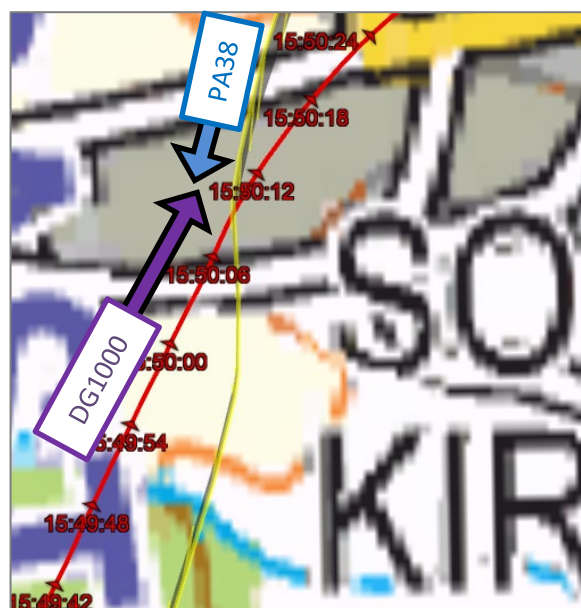
Both aircraft were traced without use of Mode S data and both pilots provided GPS data which was analysed and confirmed as coincident with the radar data (Figure 3).

Figure 3 – Aircraft flight logs

CPA was at 1550:09 with separation less than 0.1NM horizontally, and less than 200ft vertically.
