AIRPROX REPORT No 2024230

Date: 31 Aug 2024 Time: 0949Z Position: 5153N 00212W Location: Gloucester Airport

PART A: SUMMARY OF INFORMATION REPORTED TO UKAB

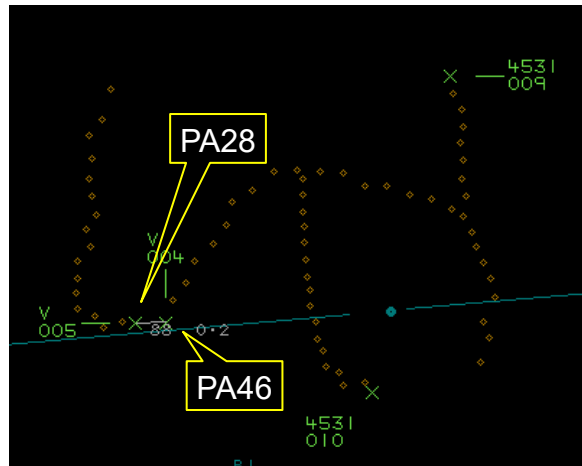
Figure 1: At CPA 0948:58 – 100ft V/0.2NM H

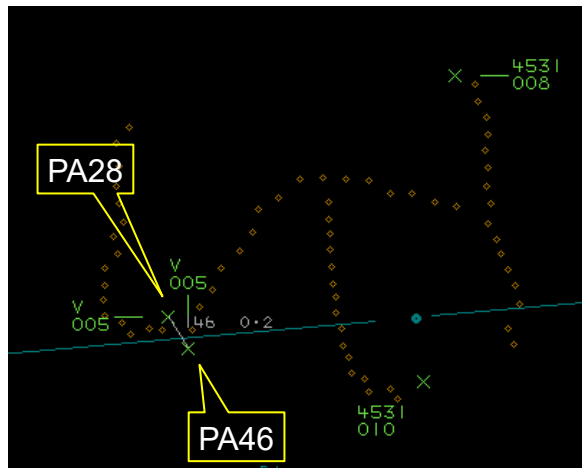
Figure 2: CPA +4sec
