**AIRPROX REPORT No 2024232**

Date: 12 Sep 2024 Time: 1256Z Position: 5301N 00029W Location: RAF Cranwell

**PART A: SUMMARY OF INFORMATION REPORTED TO UKAB**

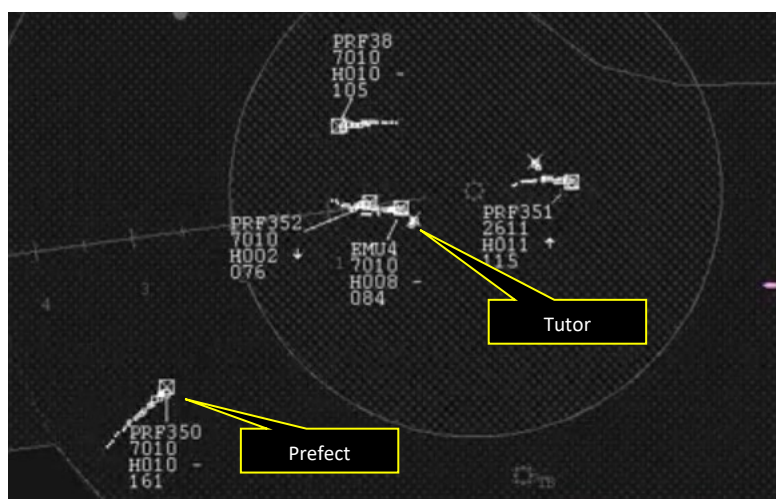
Figure 1 (1253:56). Prefect requested join.

At 1253:56, the Prefect [pilot] requested to join the visual circuit, positioning as standard via initial at 1000ft Cranwell QFE 1009hPa. The Cranwell Tower controller approved the join and provided initial circuit Traffic Information *"join runway 26 QFE 1009, 3 in, and 1 Prefect upwind departing"*.

At 1254:36, the Prefect [pilot] reported at initial. The Cranwell Tower controller acknowledged this and provided standard circuit Traffic Information *"1 Prefect final, 1 Tutor deadside, wind 320 09"*. Of the three originally reported as in, one had previously landed.

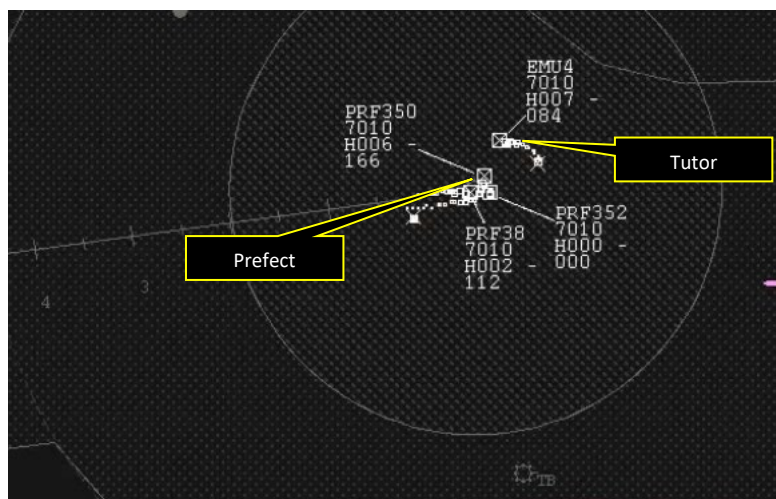
Figure 2 (1255:37). Prefect commenced their break.

At 1255:37, the Prefect [pilot] commenced their break from deadside to downwind. At 1255:43, the Tutor [pilot] reported “*downwind subject to a Prefect break in front of me, downwind to rejoin through initials*”.

CPA occurred at 1255:46 and was recorded as 0.1NM horizontal and 100ft vertical separation.
