AIRPROX REPORT No 2024233

Date: 13 Sep 2024 Time:1351Z Position: 5626N 00321W Location: Perth Airport

PART A: SUMMARY OF INFORMATION REPORTED TO UKAB

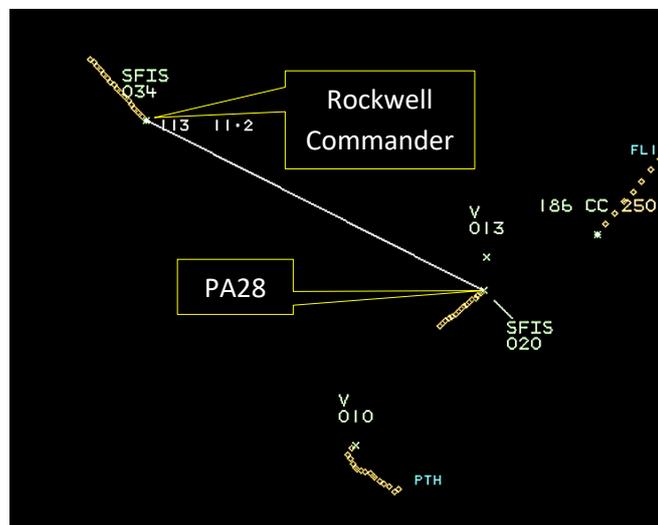
An analysis of the NATS radar replay was undertaken and both aircraft were positively identified using Mode S data, although the returns for the PA28 were intermittent (Figures 1 and 2).

1344:23 PA28 last seen on radar.

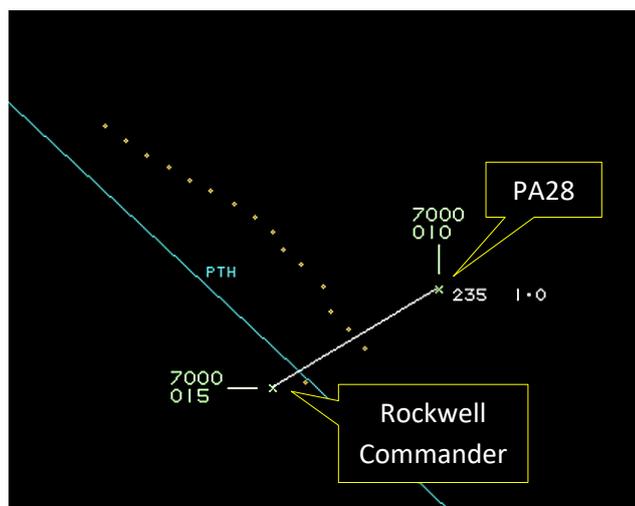
1351:07 after CPA the PA28 reappeared diverging from the Rockwell's track

The pilot of the Rockwell Commander provided GPS data which matched ADS-B and radar tracks and the PA28 was also recorded on ADS-B data. At 1351:07, when the PA28 re-appeared on radar (Figure 2), the tracks between the two aircraft were diverging with the PA28 heading approximately

northeast and the Rockwell Commander heading approximately 250°. CPA was assessed to have occurred at 1350:42 with a vertical separation of 900ft and lateral separation of 0.2NM, based on radar and ADS-B data.
