AIRPROX REPORT No 2024240

Date: 21 Sep 2024 Time: 1149Z Position: 5320N 00256W Location: 2NM W Liverpool airport

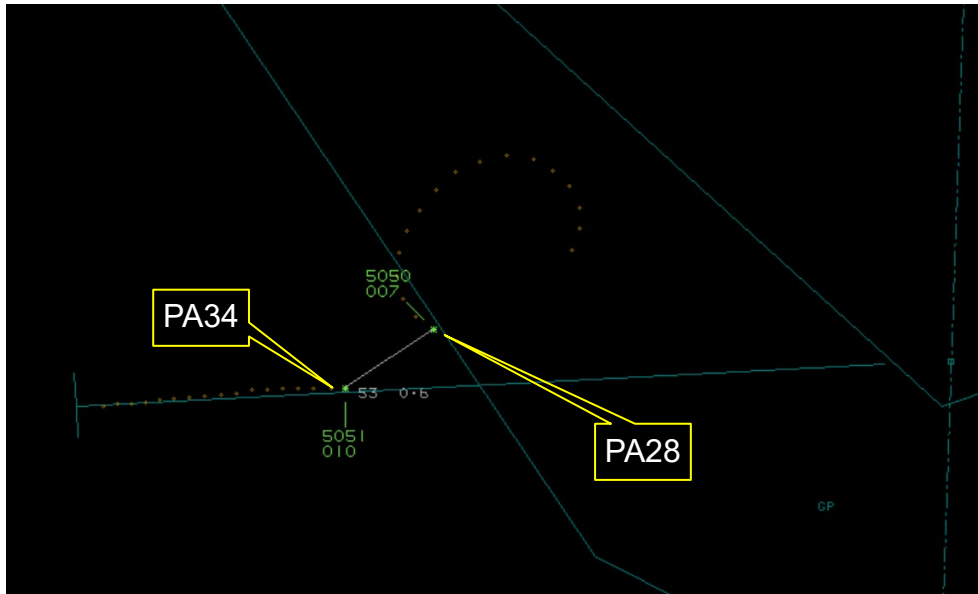
The PA28 pilot had been instructed to orbit over Garston Docks, however they had continued too far south to accommodate their turn to be clear of the final approach track.

Figure 1: At CPA – 1148:35 300ft V/0.6NM H

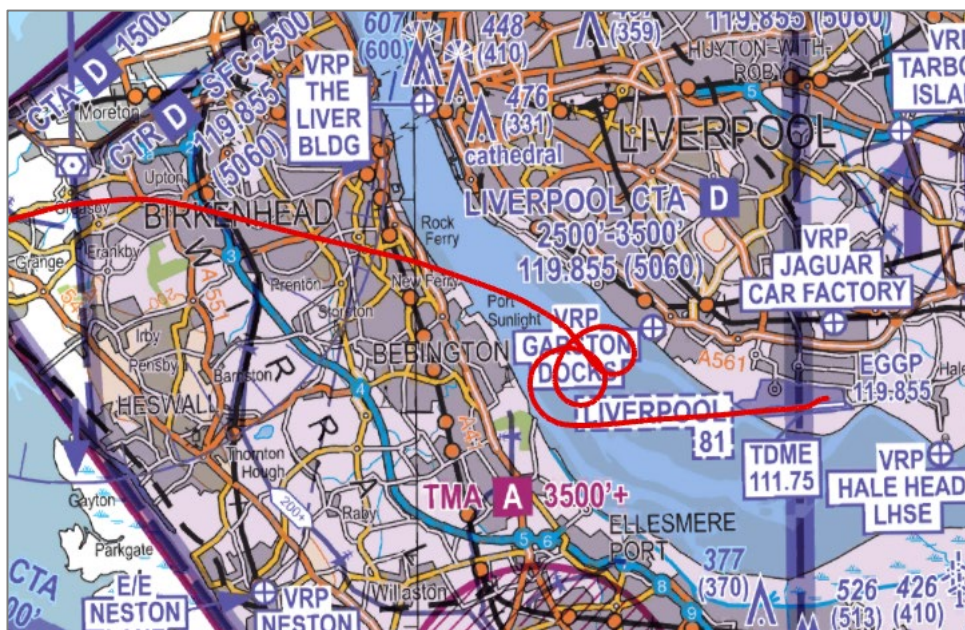
Figure 2: PA28 pilot provided image of their approach path to Liverpool Airport

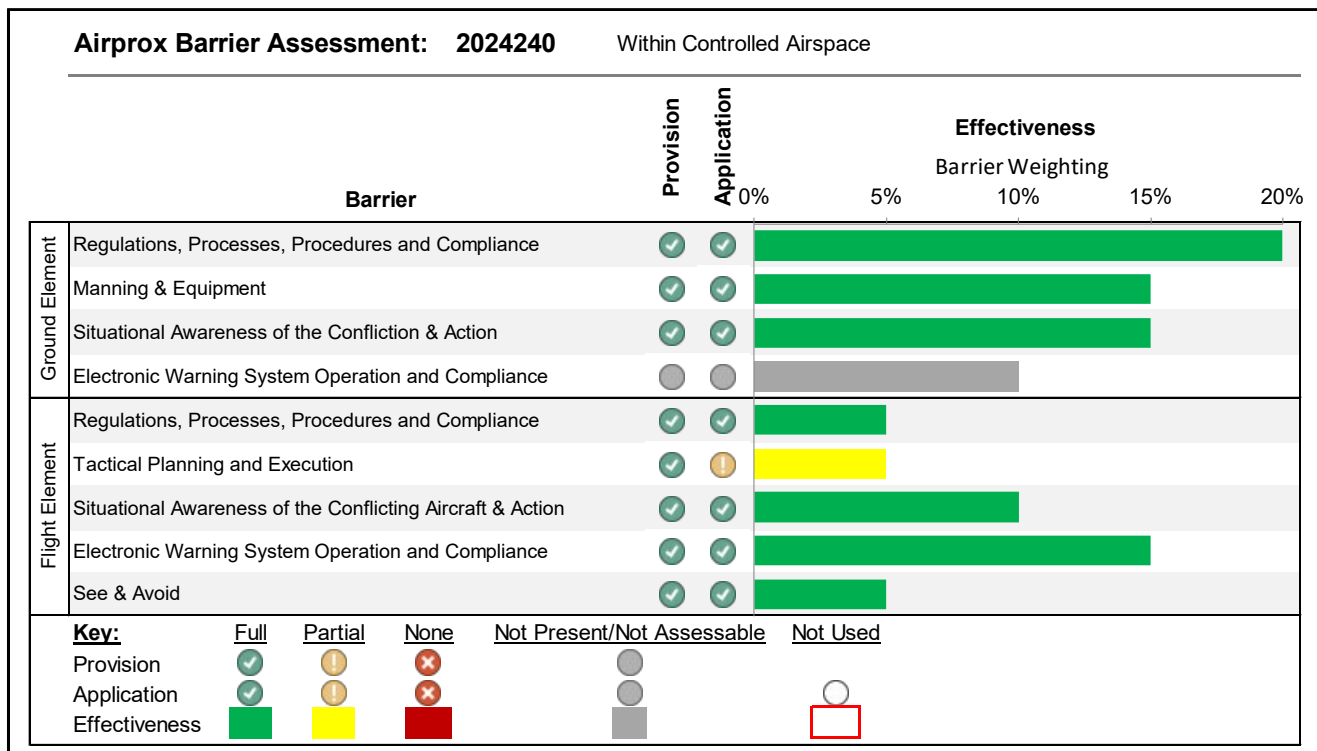
Tactical Planning and Execution was assessed as **partially effective** because the PA28 pilot had allowed their orbit to close toward the approach path of the PA34.
