AIRPROX REPORT No 2024248

Date: 29 Sep 2024 Time: 1234Z Position: 5627N 00314W Location: 7NM W Dundee

PART A: SUMMARY OF INFORMATION REPORTED TO UKAB

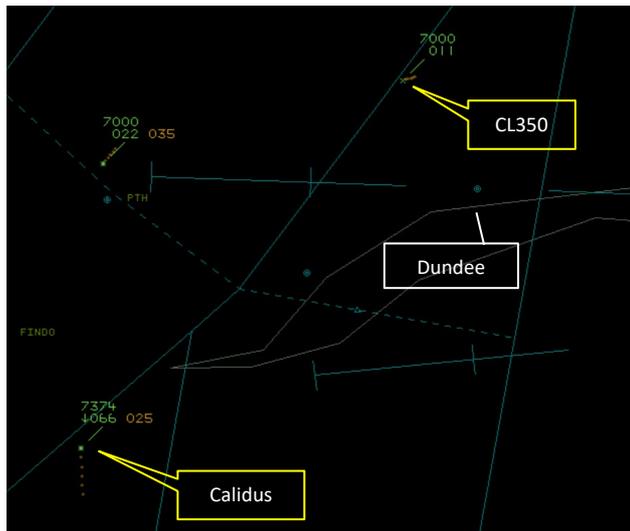
Figure 1 – 1230:35

An analysis of the NATS radar was undertaken. At 1230:35 the CL350 could be seen 15NM southwest of Dundee, indicating FL066, in the descent. The Calidus could be seen 4NM northwest of Dundee indicating FL011 (Figure 1).

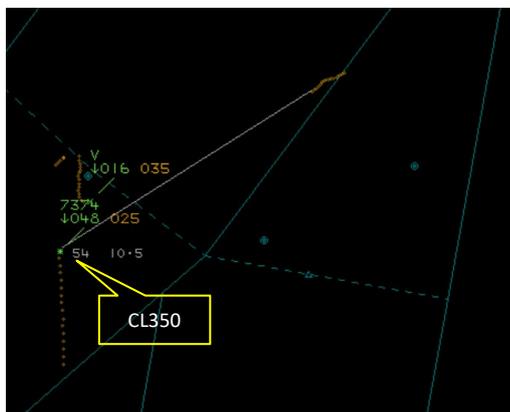
Figure 2 – 1231:54

At 1231:54 the Calidus faded from radar contact on the NATS radars (Figure 2) and did not re-appear until after the Airprox.
