AIRPROX REPORT No 2023190

Date: 22 Aug 2023 Time: 1242Z Position: 5108N 00216W Location: 4NM Southwest Warminster

PART A: SUMMARY OF INFORMATION REPORTED TO UKAB

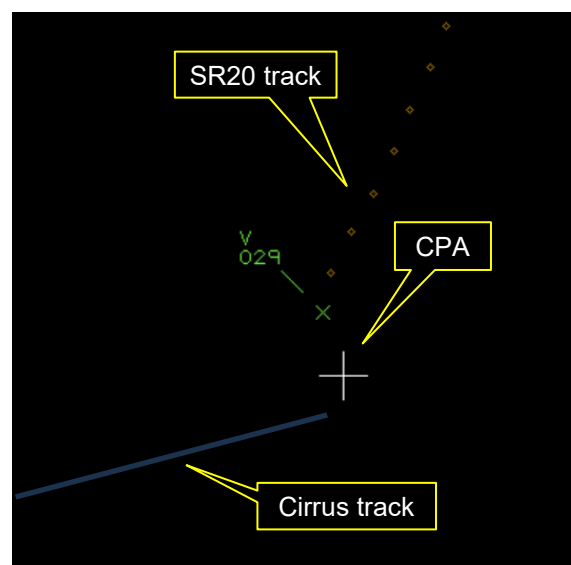
CPA 1241:42 ~50ftV/<0.1NM H

Both aircraft were plotted via an ADS-B source. The SR20 had an active transponder and was tracked by radar but the Cirrus did not show on radar, even as a primary contact. The Cirrus pilot reported to have been listening out on the nearest glider site frequency (The Park). The SR20 pilot reported that they had been listening out on the Bournemouth Radar frequency. Bournemouth ATS investigation showed first contact from the SR20 pilot to have been at 1250, i.e. more than 8min after CPA.
