**AIRPROX REPORT No 2023193**

Date: 23 Aug 2023 Time: 1016Z Position: 5154N 00213W Location: Gloucestershire Airport ATZ

**PART A: SUMMARY OF INFORMATION REPORTED TO UKAB**

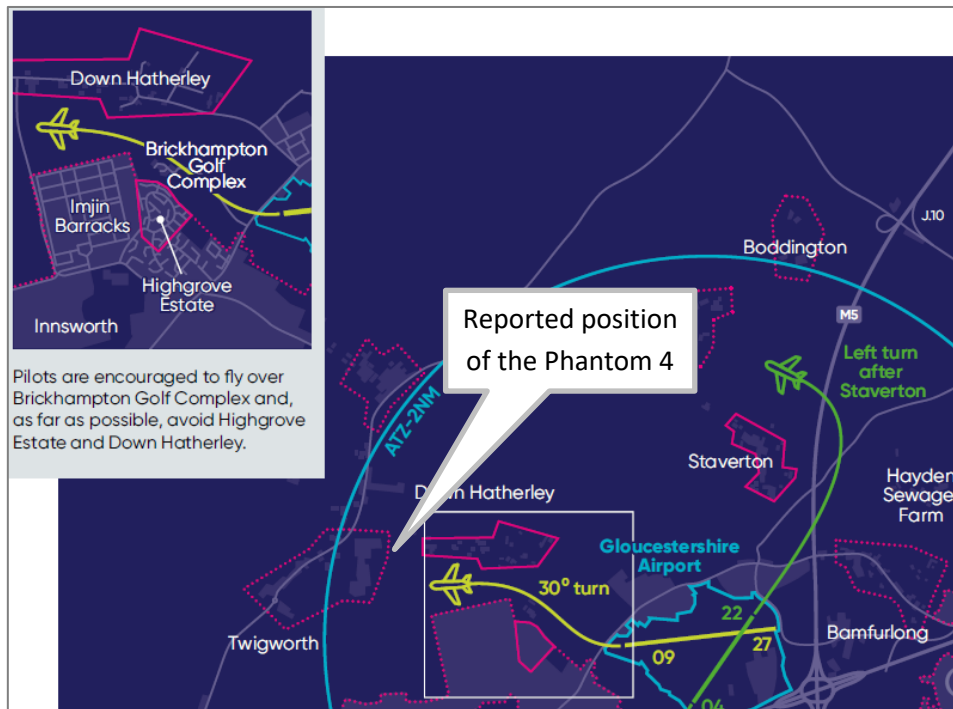
[In retrospect, the pilot of the TB20 opined that] the reported position and time indicated that the other aircraft was on the edge of the ATZ and on the noise abatement climb-out track.

Figure 2 – The noise abatement procedure at Gloucestershire Airport and the reported position of the Phantom 4

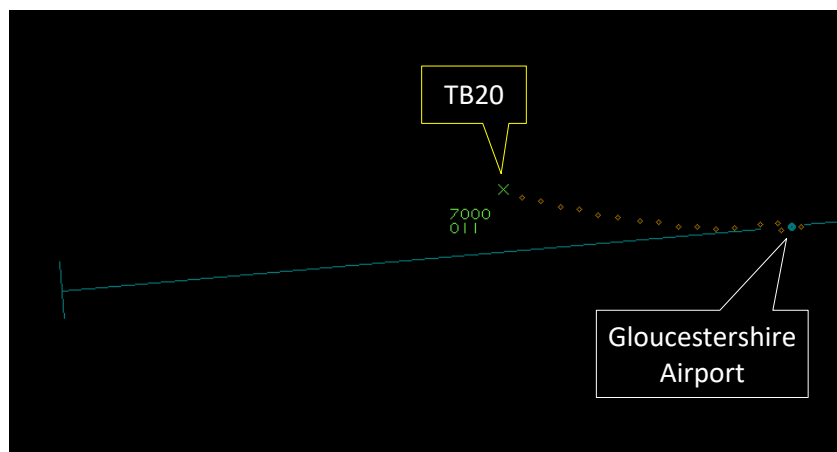
Figure 3 – CPA at 1015:34

An analysis of the NATS radar replay was undertaken. The TB20 could be positively identified from Mode S data (see Figure 3). The Phantom 4 was not observed on radar.

The pilot of the TB20 kindly supplied GPS track data for their flight, and the pilot of the Phantom 4 provided coordinates for the position of their UAS at the moment of CPA. It was by combining the data sources that the diagram was constructed.

The pilot of the Phantom 4 reported the height of their UAS had been 280ft AGL. The elevation of the terrain at the reported position of the Phantom 4 was approximately 46ft. Consequently, the vertical separation between the aircraft may have been approximately 862ft but this could not be verified. From the reported position of the Phantom 4, the horizontal separation between the aircraft had been 0.1NM but this could not be verified.

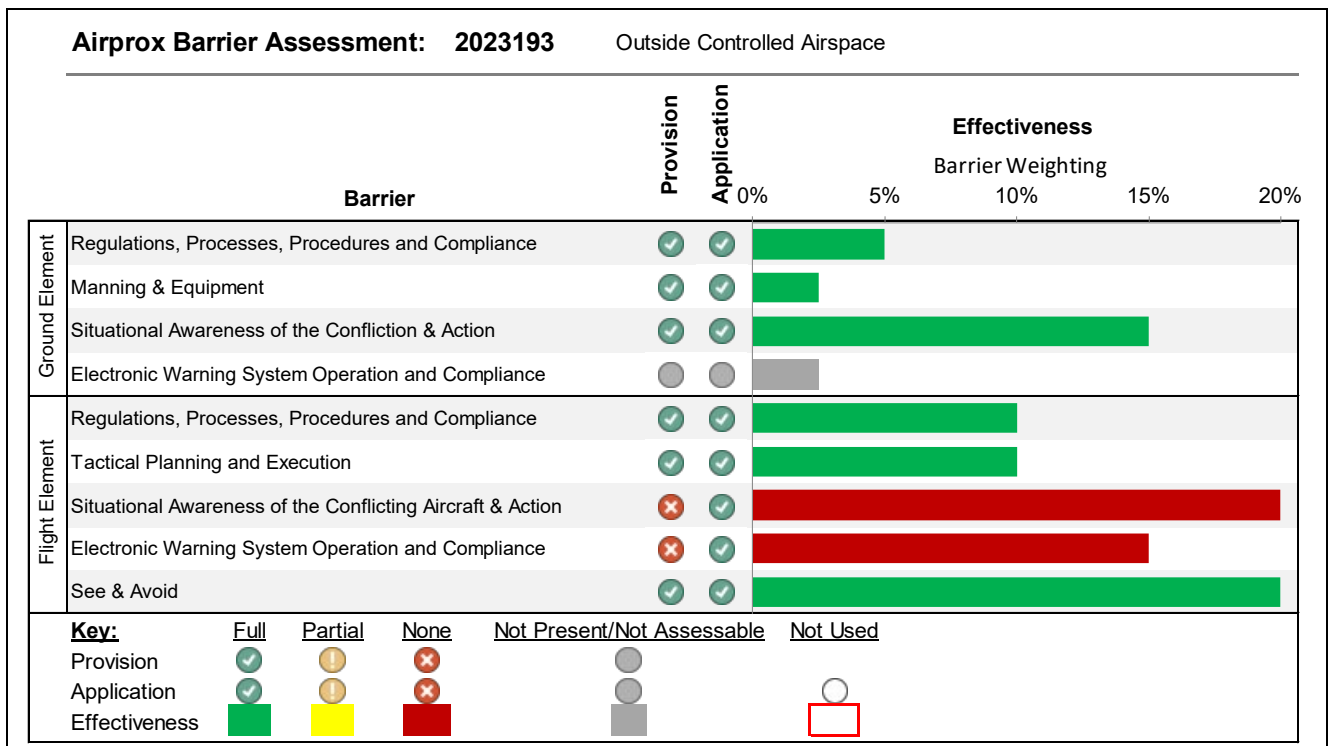
**Situational Awareness of the Conflicting Aircraft and Action** were assessed as **ineffective** because the pilot of the TB20 had not had situational awareness of the presence of the Phantom 4.

**Electronic Warning System Operation and Compliance** were assessed as **ineffective** because the EC equipment fitted to the TB20 would not have been expected to have detected the presence of the Phantom 4.
