## **AIRPROX REPORT No 2023208**

Date: 06 Sep 2023 Time: 1420Z Position: 5249N 00334W Location: 6NM S Bala

## PART A: SUMMARY OF INFORMATION REPORTED TO UKAB

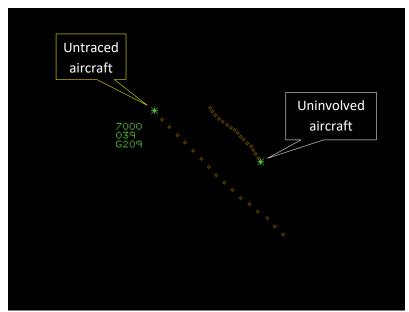
Figure 1 – CPA at 1420:18

An analysis of the NATS radar replay was undertaken. The ASH26 was not observed on radar. Two aircraft were observed on radar to have been in the vicinity at the time of the Airprox, one of which was quickly discounted from having been involved (see Figure 1). The other aircraft could not be positively identified but is believed to have been involved. Despite best efforts, and having ascertained a probable identity, the pilot of that aircraft could not be definitively established.

The pilot of the ASH26 kindly supplied GPS track data for their flight. It was by combining the separate sources that the diagram was constructed and the separation at CPA determined. The untraced aircraft was observed on radar to have been flown at Flight Levels and an appropriate conversion factor was used to determine its altitude.
