AIRPROX REPORT No 2023211

Date: 15 Aug 2023 Time: 1010Z Position: 5316N 00248W Location: 4NM southeast Liverpool airport

PART A: SUMMARY OF INFORMATION REPORTED TO UKAB

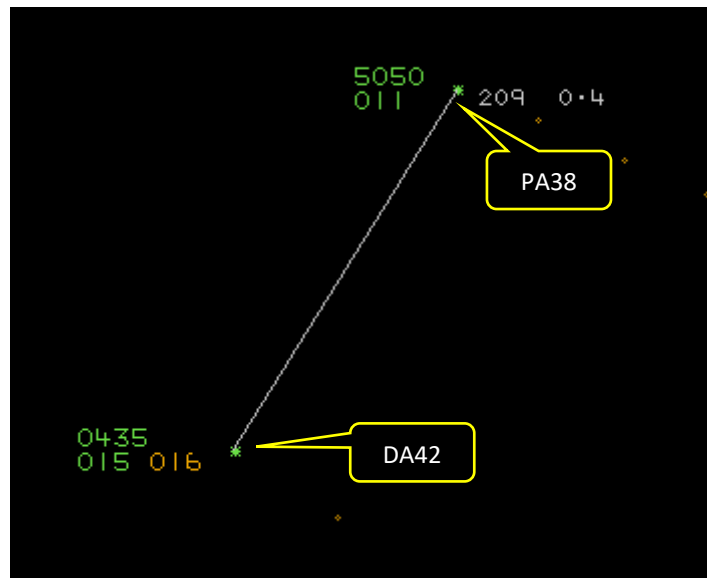
At 1009.43 CPA occurred with the aircraft separated laterally by 0.4NM and vertically by 400ft.

1009.43 CPA 400ft V / 0.4NM H
