AIRPROX REPORT No 2023213

Date: 09 Sep 2023 Time: 1519Z Position: 5158N 00038W Location: 3NM N Leighton Buzzard

PART A: SUMMARY OF INFORMATION REPORTED TO UKAB

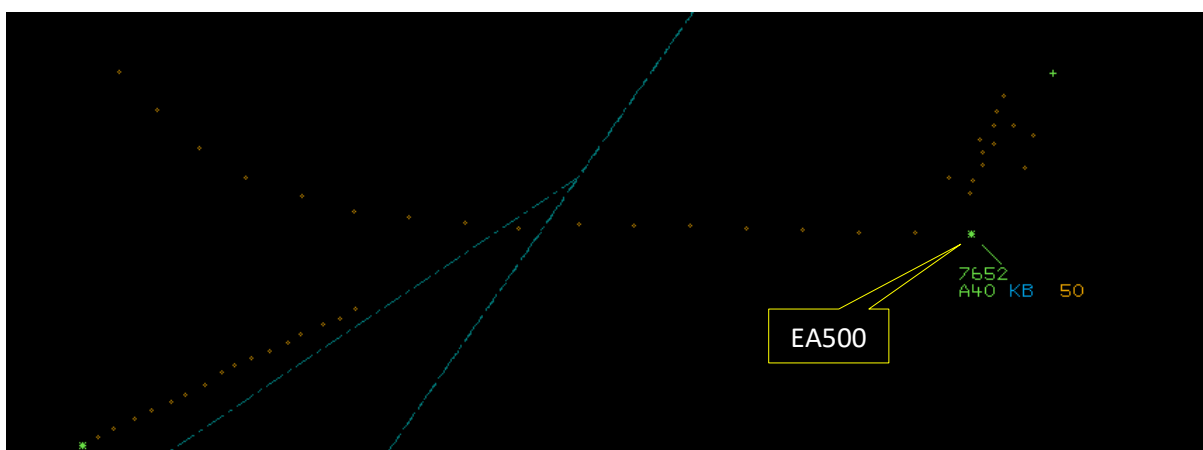
Figure 1 – CPA at 1518:50

It is believed that the pilot's request to "say again" was the approximate time of CPA (Figure 1), as [the EA500] passed the position where the intermittent primary contact had previously disappeared.

An analysis of the NATS radar replay was undertaken and the EA500 could be positively identified from Mode S data (see Figure 1). The pilot of the Pegasus kindly supplied GPS track data for their flight. Several sporadic primary-only returns were observed in the vicinity of the EA500 at the time of the Airprox. These primary-only radar returns broadly aligned with the GPS track of the Pegasus, but the identity of the aircraft could not be verified.

The diagram was constructed and the separation at CPA determined by combining the different data sources.
