AIRPROX REPORT No 2023234

Date: 03 Oct 2023 Time: 1439Z Position: 5057N 00051W Location: 7NM northwest Goodwood

PART A: SUMMARY OF INFORMATION REPORTED TO UKAB

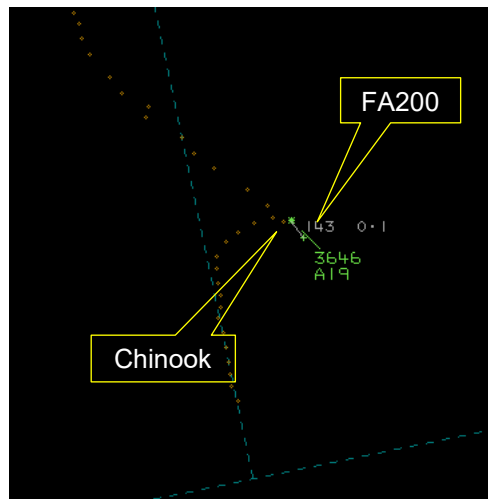
Utilising occurrence reports and information from the local investigation, outlined below are the key events that preceded the Airprox. Whilst the NATS radar recordings have been able to identify the FA200 through use of alternate radar heads, the Airprox occurred at a range of approximately 17NM from the Odiham radar head and therefore when considering the altitude of both aircraft they were at the extremes of the theoretical base of radar coverage. This makes the display of the Chinook but non-display of the FA200 to the Odiham Approach controller an expected scenario given the FA200's lower altitude.

At 1439:29, the Chinook pilot had contacted the Odiham Approach controller and had requested Traffic Information regarding the FA200, "*Established now, two thousand feet, one zero two one, squawking three six four six. Request information on traffic, light aircraft, now southbound at eighteen hundred feet*". The Odiham Approach controller acknowledged the Chinook pilot and reported that nothing had been observable on radar. The Chinook pilot reported the Airprox and elected to continue with the training sortie.

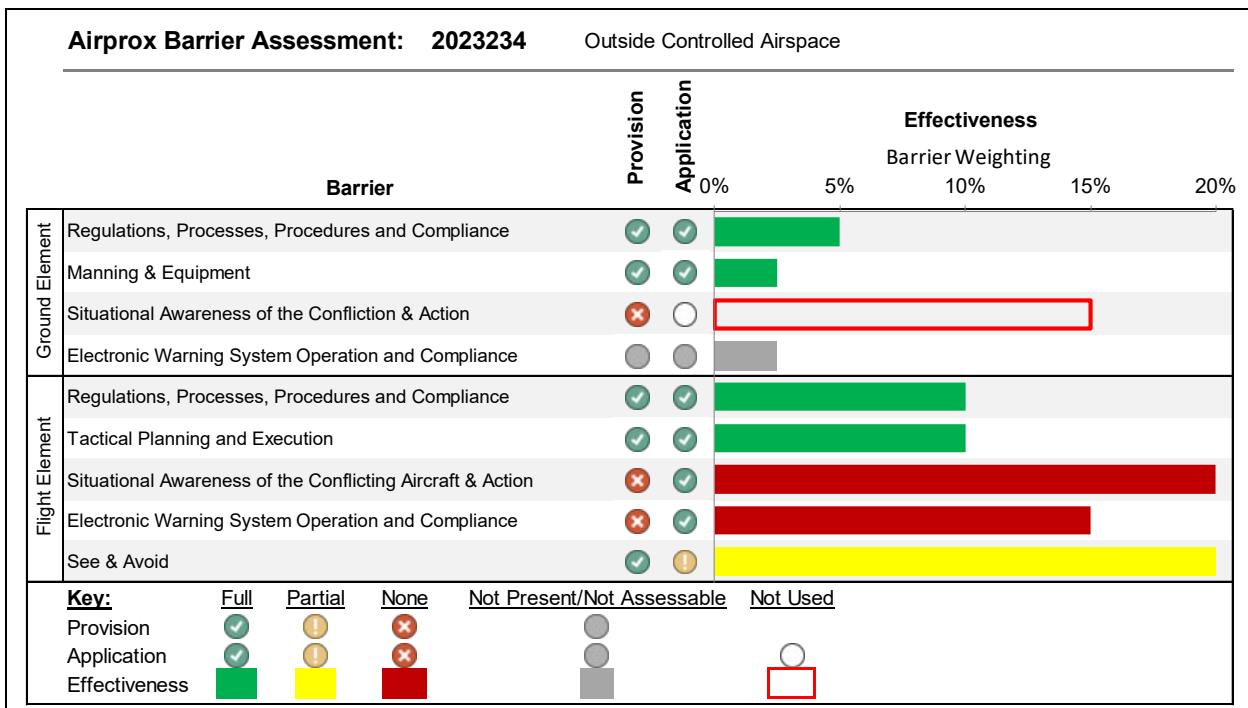
Safety Barrier Assessment²

Situational Awareness of the Confliction and Action were assessed as **not used** because there is no requirement for the Odiham controller to monitor the flight under a Basic Service.

Situational Awareness of the Conflicting Aircraft and Action were assessed as **ineffective** because neither pilot had any situational awareness of the presence of the other aircraft

Electronic Warning System Operation and Compliance were assessed as **ineffective** because the conspicuity equipment carried by both aircraft was incompatible with that carried by the other.

See and Avoid were assessed as **partially effective** because the Chinook pilot had achieved only a very late sighting of the FA200, and the FA200 pilot, having visually acquired the Chinook, had flown close enough to cause concern to the Chinook pilot.
