AIRPROX REPORT No 2023238

Date: 17 Oct 2023 Time: 1011Z Position: 5154N 00209W Location: Gloucestershire Airport ATZ

PART A: SUMMARY OF INFORMATION REPORTED TO UKAB

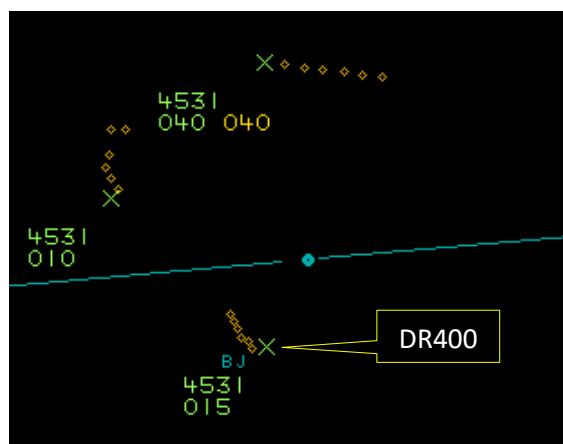
Figure 2 – 1009:30

At 1009:30 the EV97 pilot was instructed, *“left turn west, RW09 cleared for take-off, surface wind zero eight zero, one three.”* The pilot read back, *“cleared take-off.”* (Figure 2)

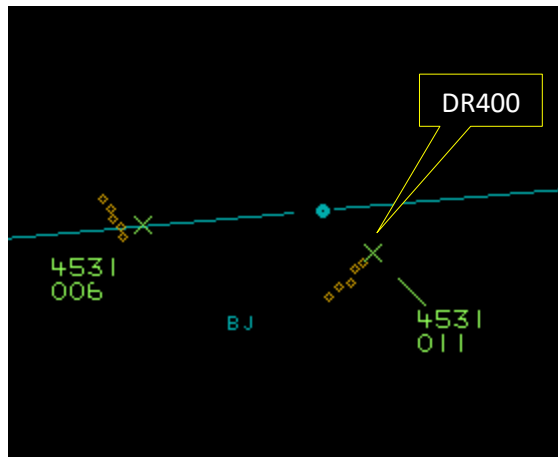
Figure 3 – 1010:10

At 1010:10 the DR400 pilot was advised, *“traffic upwind, just airborne, is a Eurostar.”* The pilot responded, *“roger traffic, descending deadside.”* (Figure 3)

When the Traffic Information was passed to the DR400 pilot, the position of the EV97 was described as “*traffic upwind, just airborne.*” The subsequent report received from the DR400 pilot could be interpreted that they hadn’t quite assimilated the ‘just airborne’ element of the Traffic Information and only assimilated the ‘upwind’ element, and that this resulted in their focus being to the starboard side of their aircraft rather than to the port side. Whilst the DR400 pilot eventually sighted the EV97, and the EV97 *could* be described as being upwind, with the benefit of hindsight perhaps the sighting might have been earlier, had a description that could not be misinterpreted been used e.g., “*just airborne, turning to the west.*”

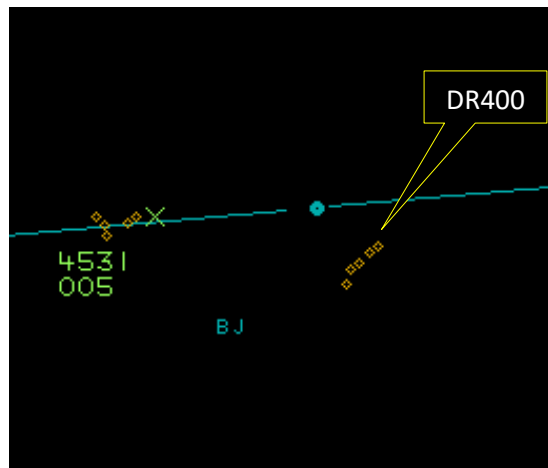
Figure 4 – 1010:20 (the aircraft are not visible due to the radar overhead)

At 1010:20 the EV97 pilot was advised, “traffic is a Robin descending on the deadside, shortly to turn crosswind.” The pilot responded, “Roger copy that.” (Figure 4)

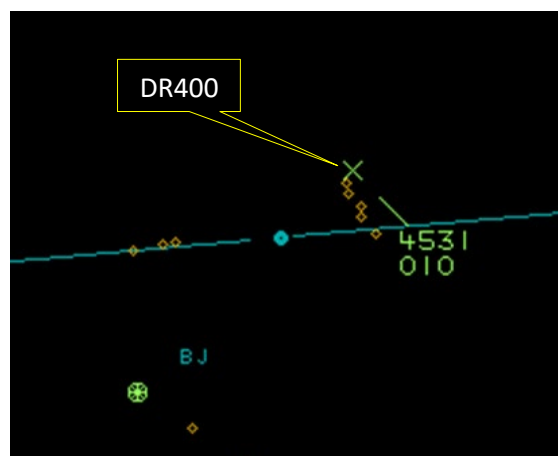
Figure 5 CPA – 1010:51

At 1010:51 CPA (as timed and measured by the RAC) occurred, with the aircraft reported as being separated by 0.0NM laterally and 300ft vertically. The EV97 was still not visible to the radar in Figure 5 below.

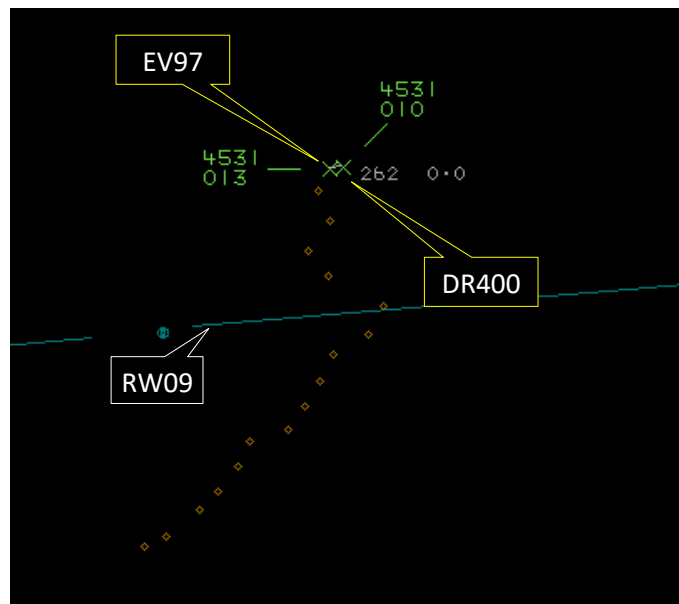
Figure 7 – 1010:51

An analysis of the NATS radar replay was undertaken and both aircraft could be positively identified from Mode S data (see Figure 7). The EV97 first appeared on radar at 1010:51 and this is the moment assessed to have been CPA. The track of the EV97 before CPA has been shown in the diagram as an approximation. The separation of the aircraft at CPA has been determined from the radar data.
