**AIRPROX REPORT No 2023249**

Date: 07 Nov 2023 Time: 1546Z Position: 5308N 00016W Location: 4NM NW Coningsby

**PART A: SUMMARY OF INFORMATION REPORTED TO UKAB**

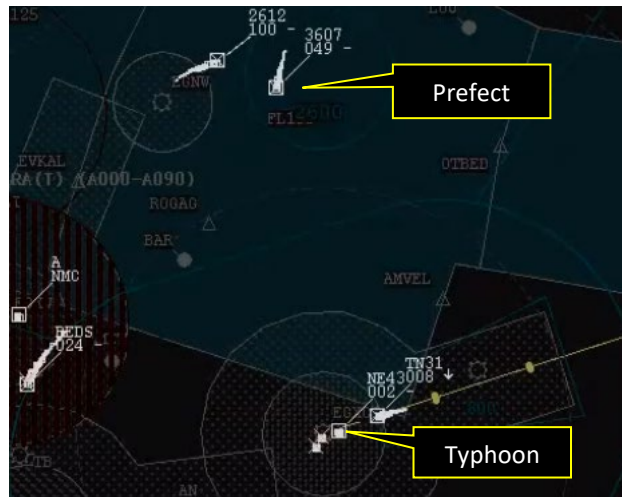
At 1542:16, the Coningsby Deps controller approved the release of the Typhoon formation following a request from the Coningsby Tower controller. The release was approved, subject to radar traffic at 2NM with intentions to join the visual circuit.

Figure 1 (1542:16): Typhoon formation departure approved.

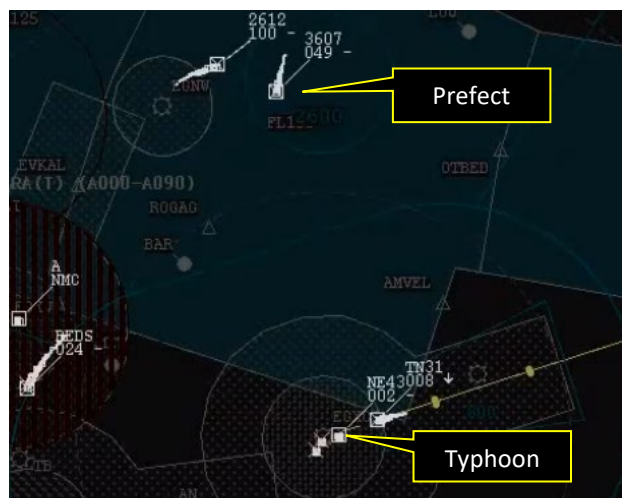
At 1543:30, as the formation was lined up for departure, the Coningsby Departure controller contacted the Waddington Radar Supervisor to request Traffic Information on the Prefect. The Waddington Supervisor provided the following Traffic Information *“Prefect, inbound to Cranwell currently at 4500ft on the Barnsley”*. The Coningsby Departures controller responded with *“4500, can you maintain that for the minute? I’ve just got a 3 ship about to roll, all going north bound?”* The Waddington Supervisor then engaged with the Waddington LARS controller, who confirmed the 4500ft altitude restriction with the Prefect, before confirming the agreement with the Coningsby Departure controller *“Yeah, he can, 4500ft on the Barnsley”*. Prior to ending the call at 1544:15, the Mode 3A and callsigns for the Typhoon formation were passed to the Waddington Supervisor.

Figure 2 (1543:30): Traffic Information on Prefect requested.

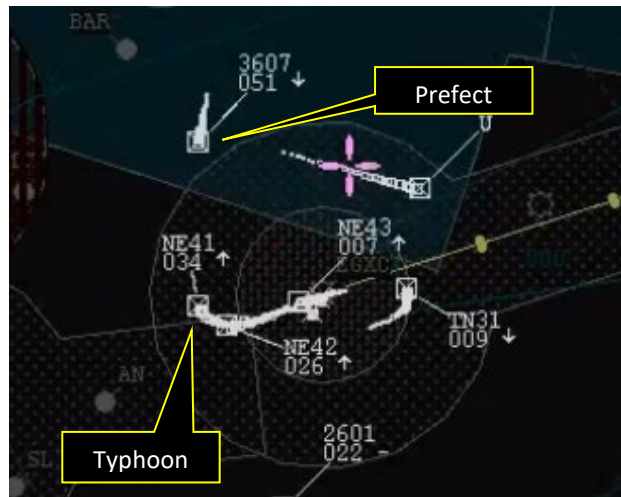
Figure 3 (15:45:20): Typhoon formation contacted Coningsby Departures controller. (Separation: 5.2NM and 2000ft)

At 1545:20, the Typhoon formation lead contacted Coningsby Departures controller passing FL40. The Coningsby Departures controller identified the Typhoon formation, issued a climb to FL150 and applied a Traffic Service. Traffic Information was then immediately passed on the Prefect *“Traffic, north 3 miles, tracking south, indicating 4500 feet.”* The Typhoon formation lead acknowledged the FL150 climb and Traffic Service, but not the Traffic Information.

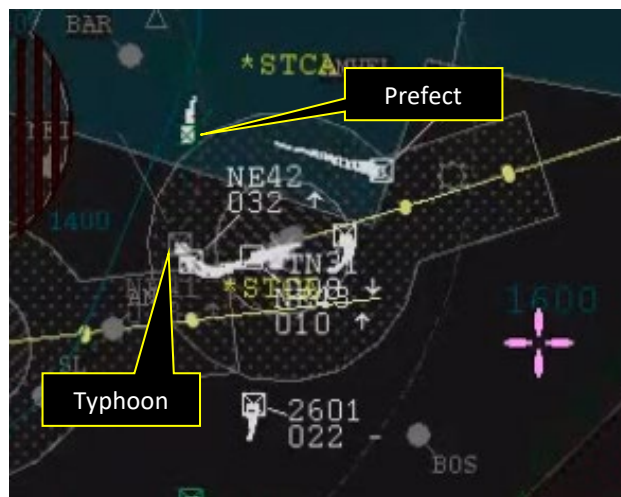
Figure 4 (1545:26): Short-Term Conflict Alert for the Waddington Lower Airspace Radar Service controller. (Separation: 4.3NM and 1400ft)

At 1545:26, the LARS controller received a Short-Term Conflict Alert but, due to responding to a civil LARS transit, did not pass Traffic Information to the Prefect pilot on the Typhoon formation until 1545:48 *“Traffic south, half a mile, tracking north indicating similar level climbing, formation of Typhoons, are you visual?”* The Prefect pilot reported visual and queried that the Typhoon formation were not restricted below.

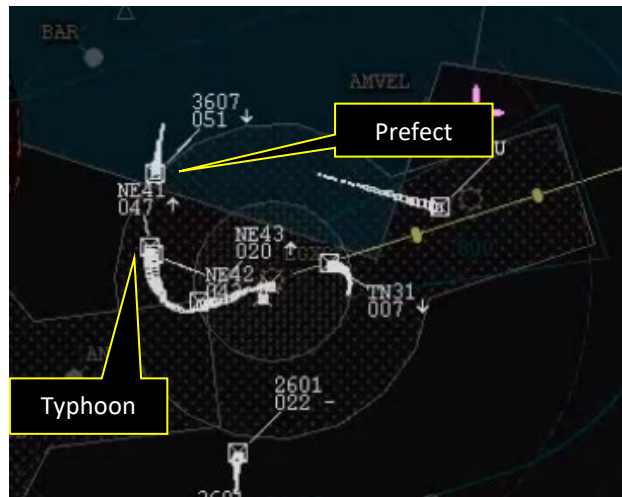
Figure 5 (1545:38): Updated Traffic Information on the Prefect to the Typhoon formation. (Separation: 3.1NM and 800ft)

At 1545:38, the Coningsby Departures controller passed updated Traffic Information to the Typhoon formation lead on the Prefect “Traffic, north 2 miles, tracking south, same level”. Again, the Traffic Information was not acknowledged by the Typhoon formation lead.

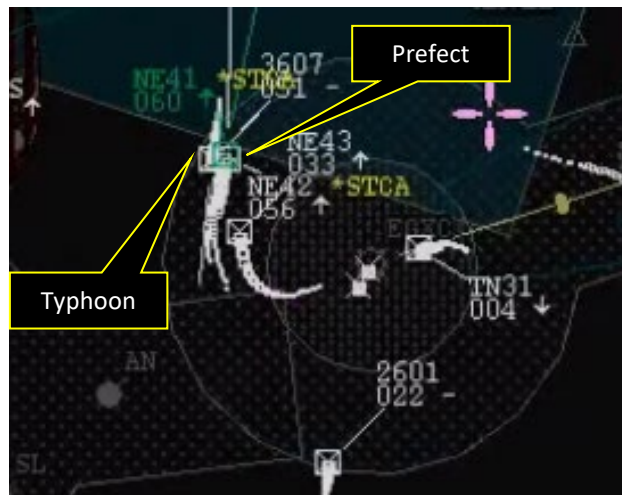
Figure 6 (1545:56): Short-Term Conflict Alert for the Coningsby Departures controller. (Separation: 0.5NM and 600ft)

At 1545:56, the Coningsby Departures controller ‘in-commed’<sup>2</sup> the Typhoon formation iaw BM Policy and the Traffic Service being provided. This action activated the Short-Term Conflict Alert, which immediately alerted due to the proximity of the Prefect and Typhoon formation.

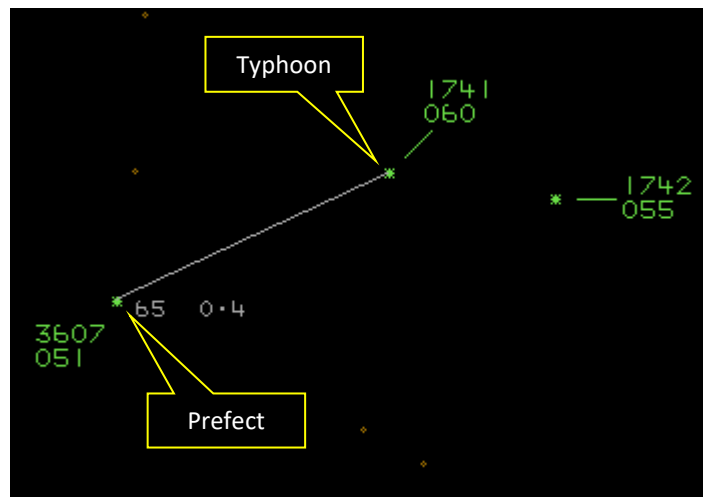
Figure 7 (1545:59). CPA.

CPA occurred at 15:45:59 and recorded as 0.4NM and 900ft separation.
