AIRPROX REPORT No 2024010

Date: 23 Jan 2024 Time: 1230Z Position: 5214N 00029W Location: 1NM S Bedford

PART A: SUMMARY OF INFORMATION REPORTED TO UKAB

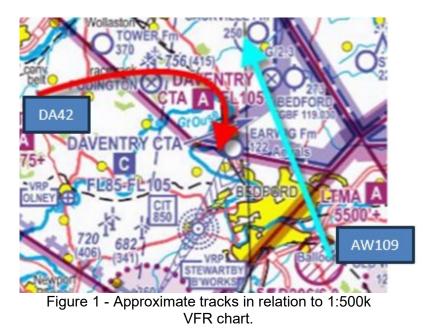
[DA42 C/S] was performing manoeuvres in the vicinity of Bedford and displaying Mode C altitude of 3500ft. [DA42 C/S] was operating under SSR code 7417 (Cranfield Airport - IFR Conspicuity Purposes).

At 1227:44, the GW INT controller provided Traffic Information to the pilot of [the AW109], "traffic just in your left eleven o'clock range of about seven miles indicating three thousand four hundred feet manoeuvring, I'll keep you updated." The pilot of [the AW109] responded that they were maintaining 2500ft.
