**AIRPROX REPORT No 2024017**

Date: 27 Jan 2024 Time: 1324Z Position: 5119N 00033W Location: Fairoaks ATZ

**PART A: SUMMARY OF INFORMATION REPORTED TO UKAB**

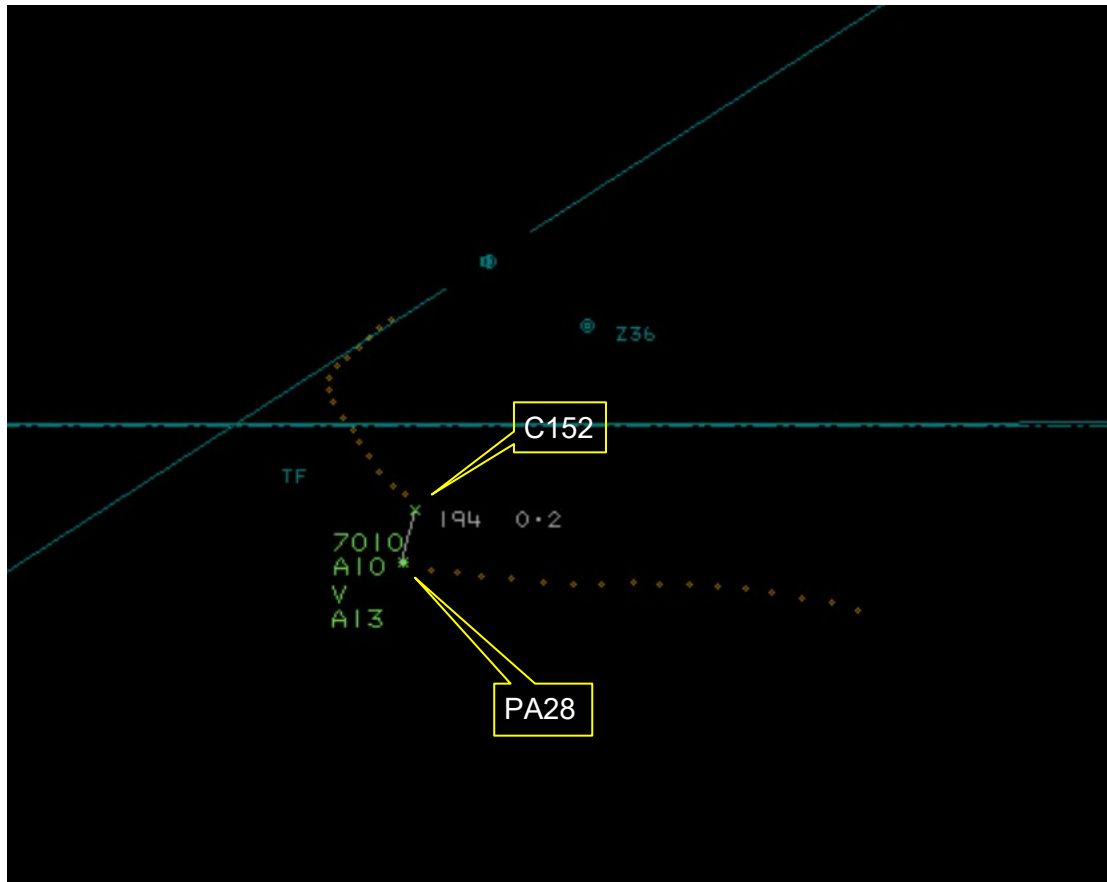
CPA at 1323:59 300ft V/0.2NM H
