AIRPROX REPORT No 2024044

Date: 30 Mar 2024 Time: ~1139Z Position: 5237N 00309W Location: Welshpool

An Airprox was reported when a PA28 and an EV97 flew into proximity at Welshpool at around 1139Z on Saturday 30th March 2024. Both pilots were operating under VFR in VMC, both in receipt of an AGCS from Welshpool Radio.

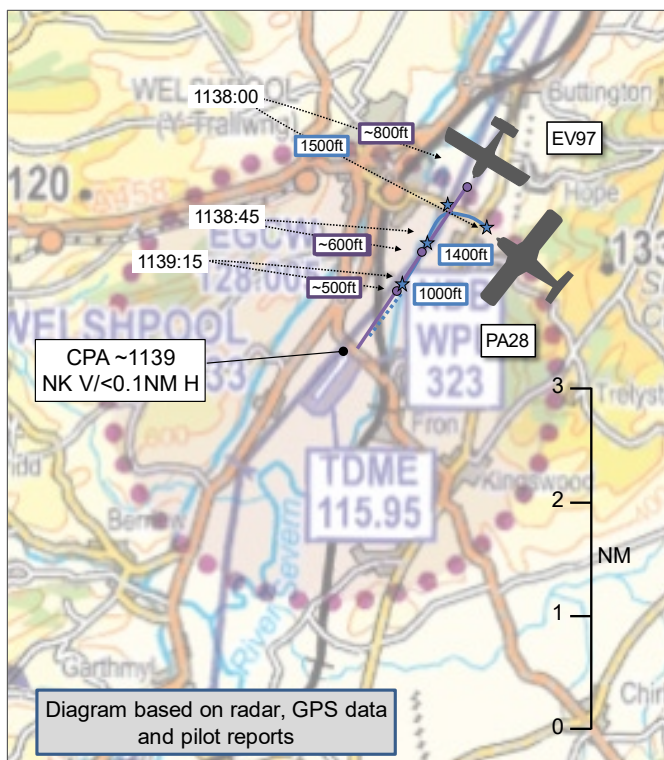
Unfortunately, the EV97 did not show on the radar at all, however they did display on an ADB-S data tool. The diagram at the top of the report was compiled by amalgamating the radar and ADS-B data sources.

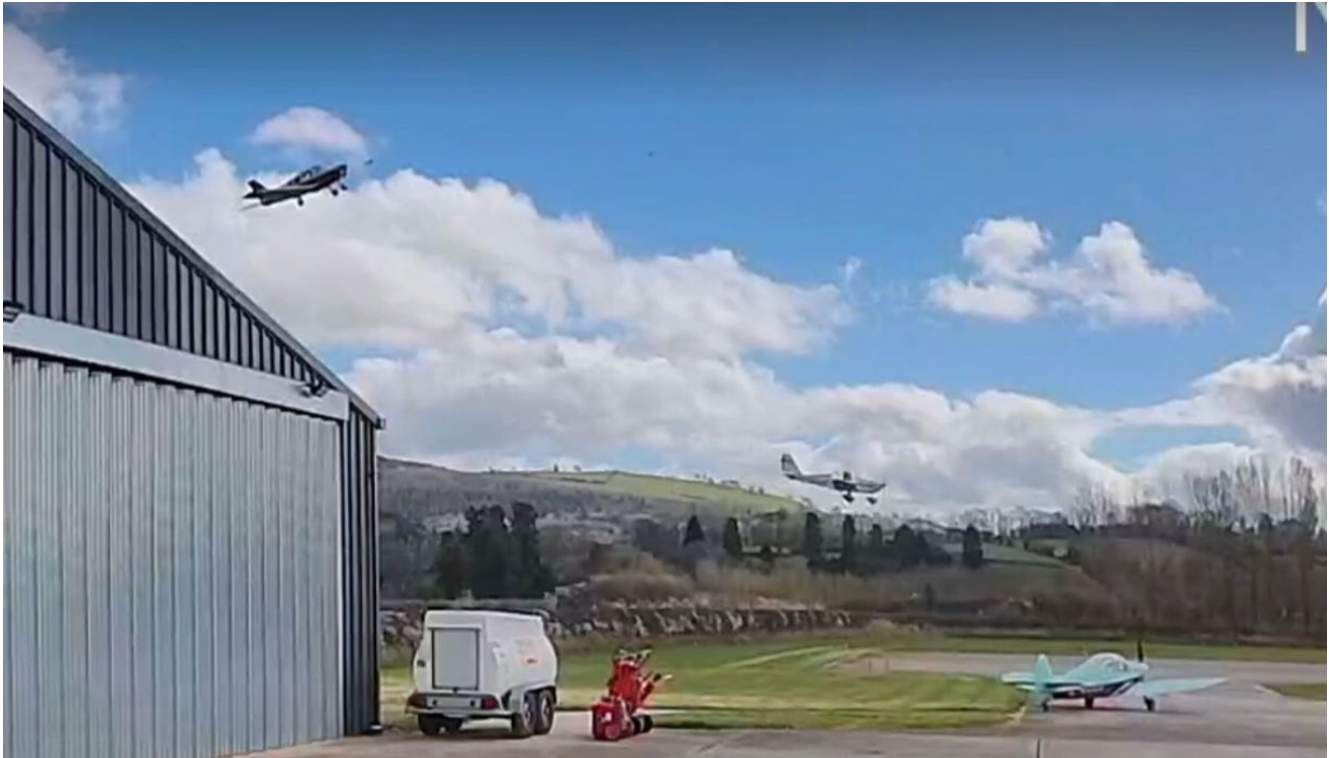
Figure 1 – Photograph taken from the CCTV at Welshpool

THE WELSHPOOL AGO reports that 2 microlights joined the circuit from the north, both making regular calls of their position. The PA28 was joining the circuit from the south. Both microlights joined straight in from the north as at the time the circuit was quiet. The C42 landed first and the EV97 was No2. The

C42 backtracked and vacated the runway and the EV97 pilot called short final as the runway was now clear. Then the PA28 pilot also called short final. The PA28 pilot had earlier called final and traffic information had been passed however they had not sighted the traffic ahead. The C42 was parked on the grass apron and the pilot could see the approach and notified the two aircraft that they were almost on top of each other and insisted the PA28 pilot needed to go around. The PA28 went around and the EV97 landed. Neither pilot saw the other aircraft [they believed]. The PA28 continued to do 3 more attempts to land, by this time the circuit became very busy, and they ended up departing the circuit 20min later.

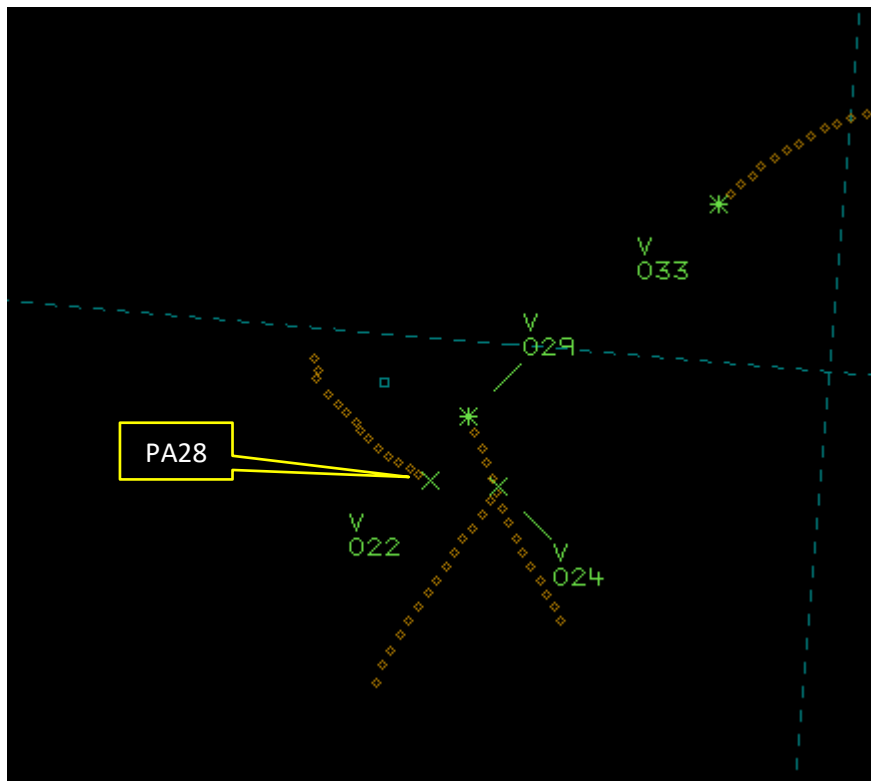
Figure 1 – 1136:20

An analysis of the NATS radar replay was undertaken. The PA28 could be identified using Mode S data and could be seen conducting an overhead join to Welshpool. See Figure 1. Neither the EV97 nor the C42 could be seen on the radar.

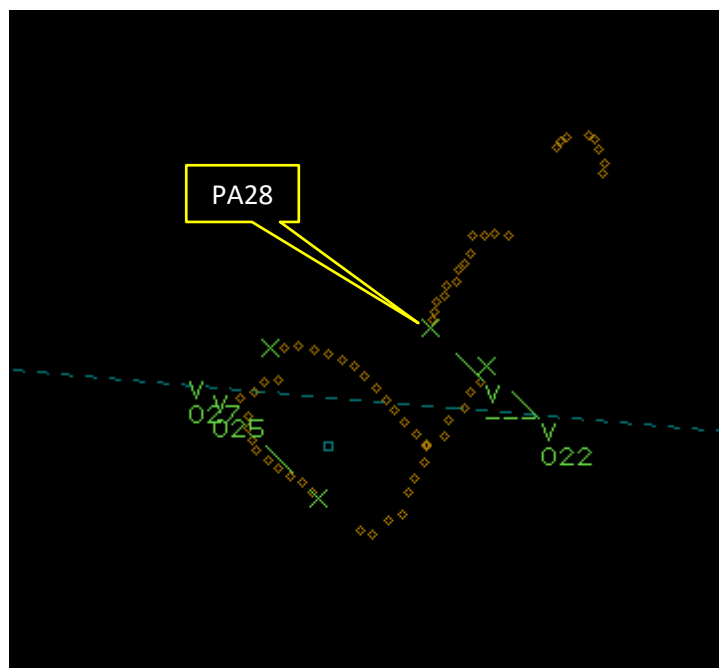
Figure 2 - 1139:16

The PA28 could be seen on the radar conducting a standard visual circuit (Figure 2), before disappearing from the radar at 1139:20.
