AIRPROX REPORT No 2024055

Date: 20 Apr 2024 Time: 0937Z Position: 5056N 00037W Location: 5NM W Parham

PART A: SUMMARY OF INFORMATION REPORTED TO UKAB

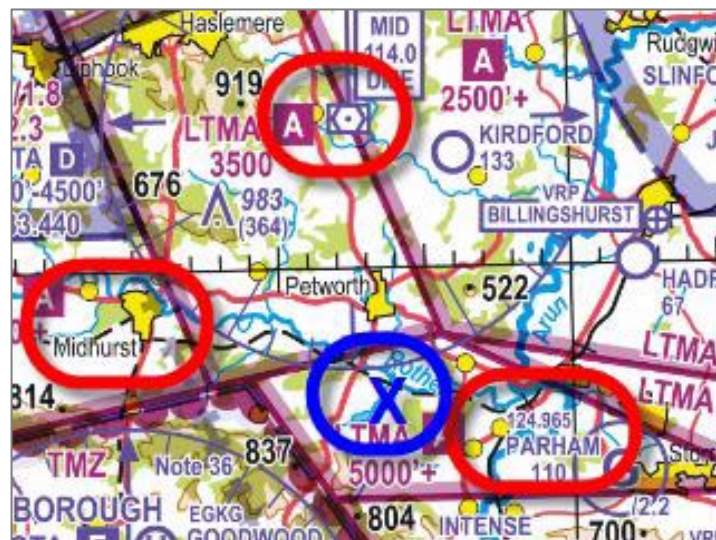
Figure 1. The blue 'X' marks the approximate position of the Airprox

The Farnborough LARS West controller (LF-LARSW) requested details from the pilot of [the R22] at 0934:03 who reported routeing to Midhurst (whether they meant the town or [VOR] was not known), positioned west of Parham at altitude 1700ft (Figure 1). The pilot requested a Basic Service which was provided as well as the QNH 1029hPa. [The R22] did not display Mode C on radar.

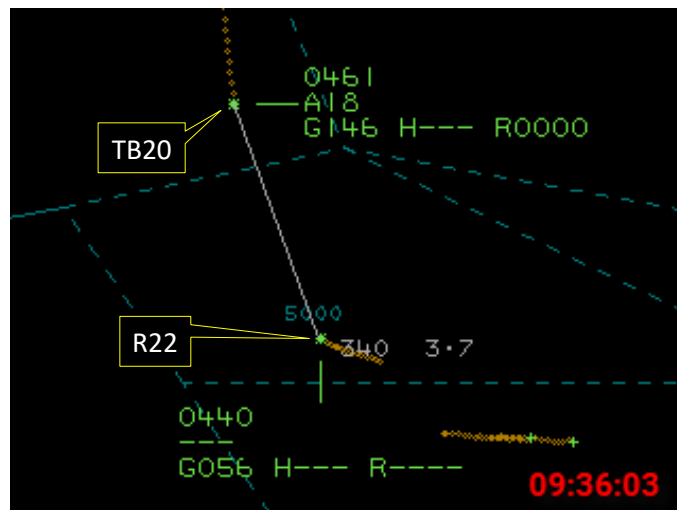
Figure 2. Aircraft tracks

The LF-LARSW [controller] instructed the pilot of [the TB20] to squawk conspicuity and free-call Lee-on-Solent at 0936:03 (Figure 2). The pilot responded transferring to “*Solent*”.

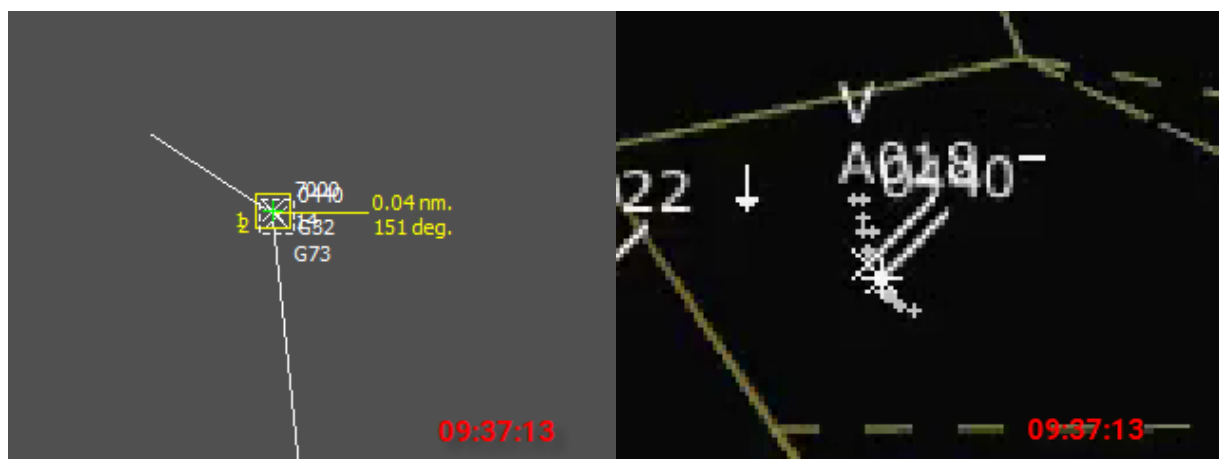
Figure 3. CPA at 0937:13

As the two aircraft approached each other, no lateral avoiding manoeuvres were visible on radar (Figure 3).

The Closest Point of Approach occurred at 0937:13 and was recorded on Heathrow 10 radar as 0.04NM. The vertical distance could not be determined as [the R22] did not display Mode C data (Figure 3), however, [the pilot] had previously reported at altitude 1700ft. [The TB20] Mode C displayed 1800ft.

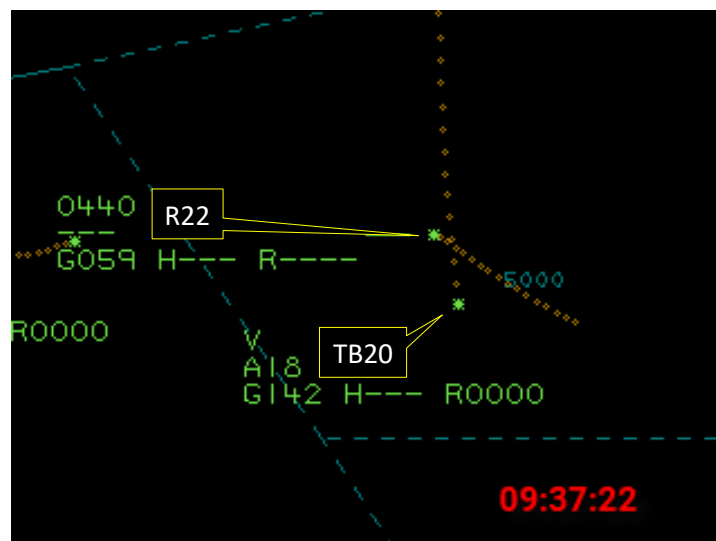
Figure 4. Aircraft positions after CPA

NODE radar indicated that neither pilot performed any visible lateral avoidance manoeuvre prior to, or during, the conflict (Figure 4).

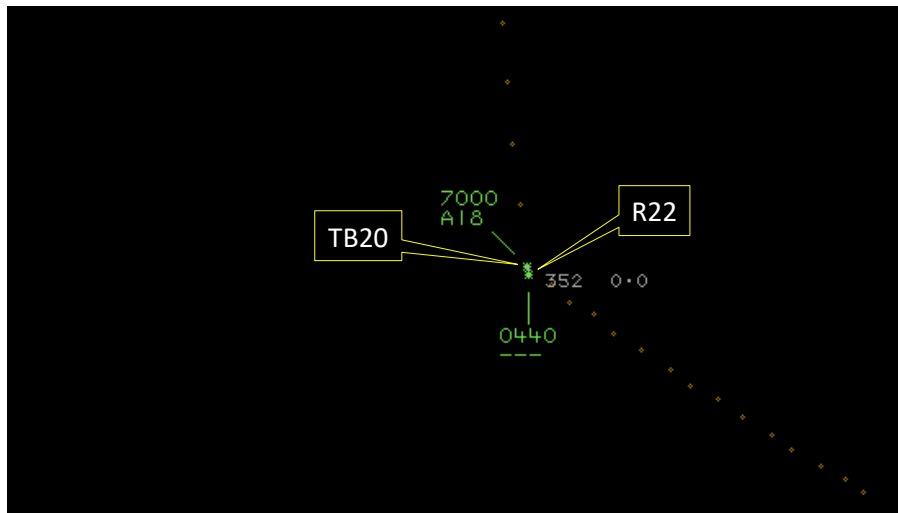
Figure 5 – CPA at 0937:13

An analysis of the NATS radar replay was undertaken and both aircraft were positively identified from Mode S data (Figure 5). The diagram was constructed and the separation at CPA determined from the radar data.
