AIRPROX REPORT No 2024062

Date: 24 Apr 2024 Time: 0939Z Position: 5254N 00042W Location: IVO Grantham

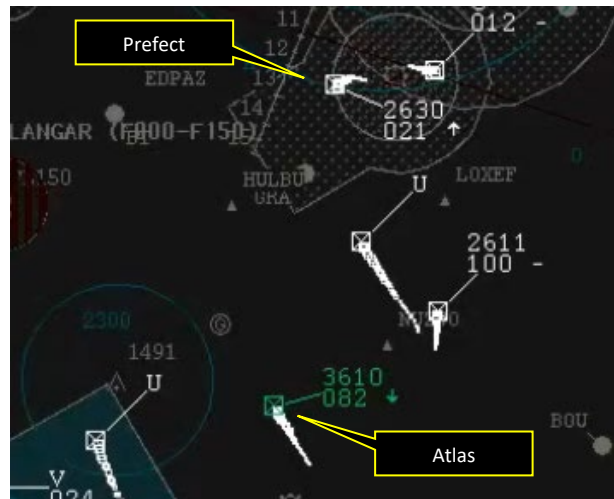
Figure 1 (0936:54): Atlas pilot issued own navigation for HULBU.
(Separation: 10.6NM and 6400ft)

At 0936:54, the Atlas pilot was provided own navigation for the HULBU reporting point and requested to report at the Initial Approach Fix by the Waddington Director controller.

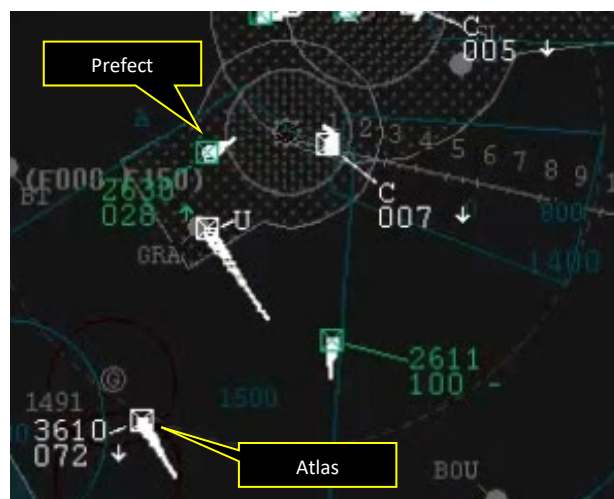
Figure 2 (0937:17): Traffic Information provided to the Prefect pilot on the Atlas.
(Separation: 9NM and 4800ft)

At 0937:17, the Cranwell Departures controller provided Traffic Information to the Prefect pilot on the Atlas. "Traffic south southwest, seven miles, tracking north west, indicating four thousand feet above descending, Atlas into Waddington's radar pattern". The Prefect pilot acknowledged the Traffic Information responding, "not sighted".

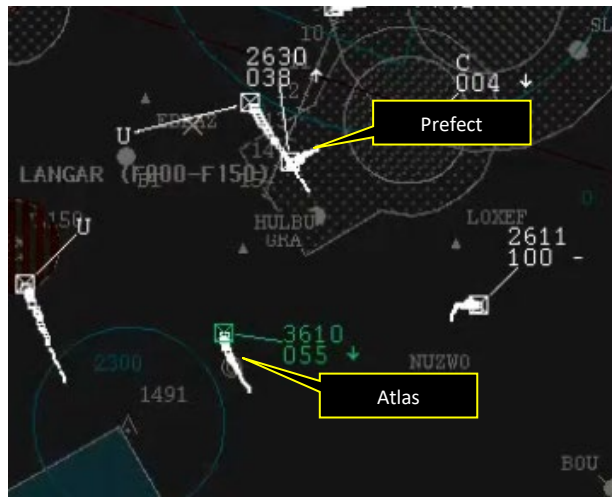
Figure 3 (0937:55): Traffic Information provided to the Atlas pilot on the Prefect. (Separation: 6NM and 1800ft)

Whilst still on the landline to the Cranwell Approach controller, at 0937:55 the Waddington Director controller provided Traffic Information to the Atlas pilot on the Prefect and offered an option to stop the descent. *“Traffic north north-east, five miles, tracking south-west, indicating One Thousand Two Hundred feet below, climbing, would you like to stop your descent?”* The Atlas pilot elected to stop the descent at altitude 4700ft.

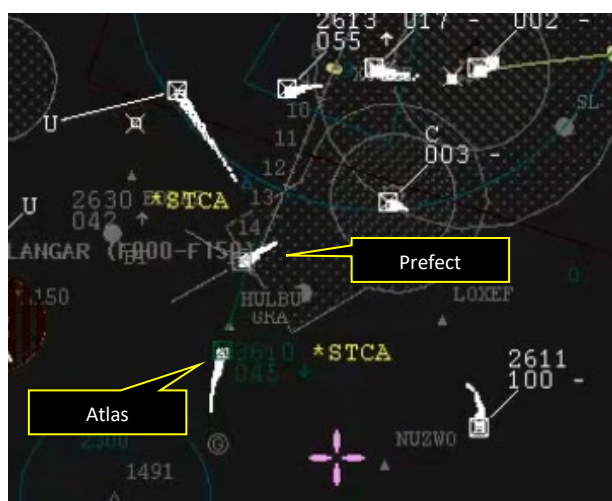
Figure 4 (0938:25): Traffic Avoidance right-hand turn offered to the Atlas pilot. (Separation: 3.3NM and 300ft)

At 0938:25, the Waddington Director controller offered a right-hand turn for traffic avoidance. *“if you take a right turn heading ... Twenty degrees to maintain clear of that traffic”*. The Atlas pilot had already initiated a right-hand turn in response to a TCAS TA on the Prefect.

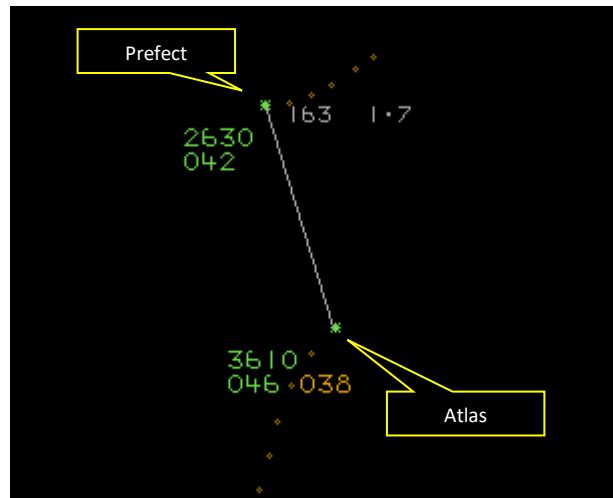
Figure 5 (09:38:43). CPA.

CPA occurred at 0938:43 and was recorded as 1.7NM and 400ft separation.
