**AIRPROX REPORT No 2024076**

Date: 04 May 2024 Time: 1225Z Position: 5044N 00319W Location: ivo Exeter ATZ

**PART A: SUMMARY OF INFORMATION REPORTED TO UKAB**

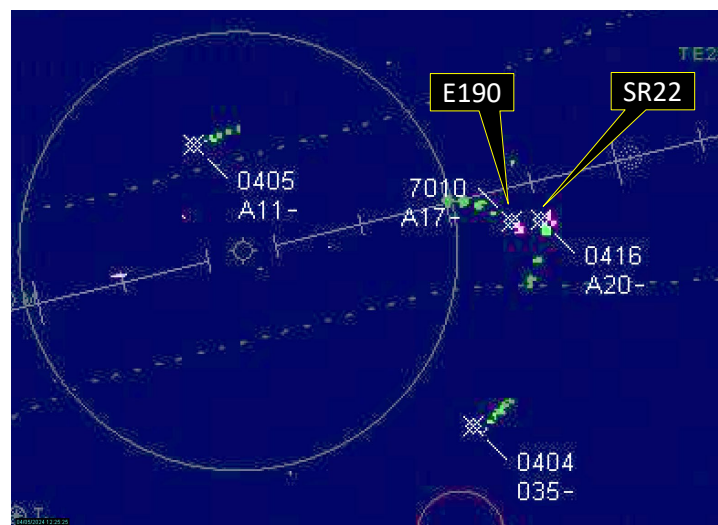
The Closest Point of Approach (CPA) occurred at 1225:25. The E190 was 3.3NM east of the airport, in a right turn maintaining altitude 1700ft. The SR22 was 3.7NM east of the airport, still tracking approximately 017°M maintaining altitude 2000ft. The distance between the two aircraft reduced to 300ft vertically and 0.4NM laterally.

Figure 1: CPA between E190 (7010) and SR22 (0416), as seen on the ATM.

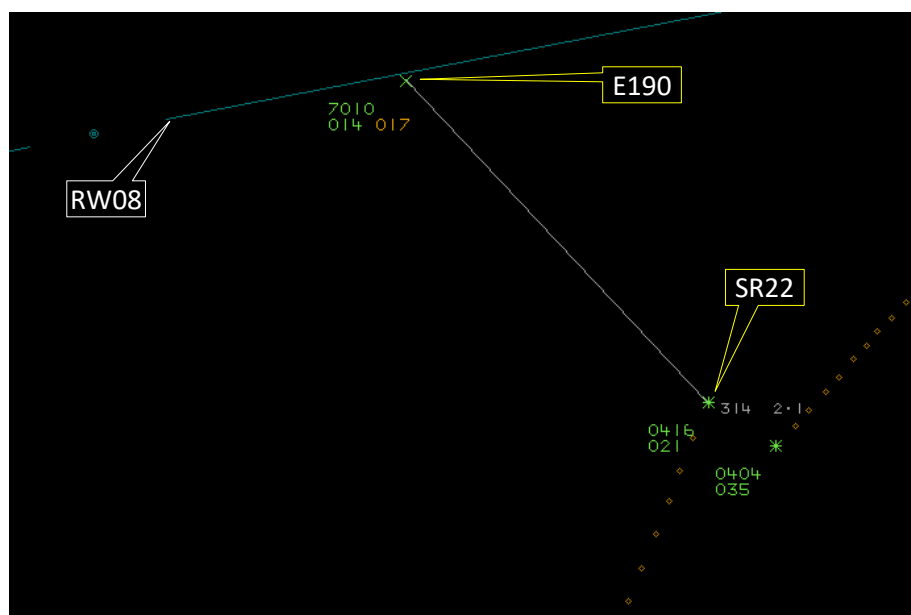
An analysis of the NATS radar replay was undertaken and both aircraft could be positively identified from Mode S data (Figure 2). Due to limitations of the radar system, the returns from the E190 were not precise in the moments leading up to CPA. CPA was assessed to have occurred between the radar sweeps at 1225:22 and 1225:26 (Figures 3 and 4).

Figure 2 - The E190 first appeared on the radar replay at 1224:46
