**AIRPROX REPORT No 2024083**

Date: 07 May 2024 Time: 1535Z Position: 5113N 00113W Location: 1.4NM N of Popham

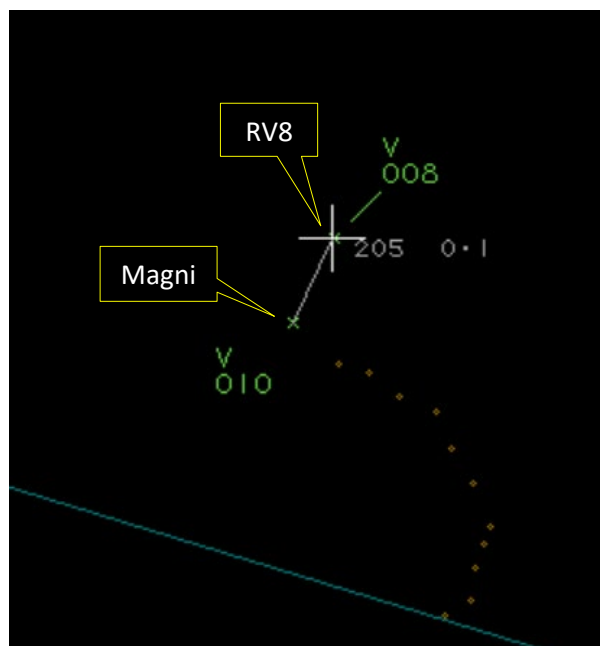
A review of the NATS radar replay was undertaken and both aircraft were identified using Mode S data although, as the Airprox occurred shortly after the RV8's take-off, the RV8 Mode S was detected after the initial sweep, with its initial appearance on radar recorded as a separation of 200ft and 0.1NM from the Magni (Figure1).

Figure 1- Time 1535:22 separation 200ft and 0.1NM

The Magni had first appeared on radar 11sec earlier and their track was also available on GPS and ADS-B. It was assessed that the CPA may have been a few seconds earlier as later radar sweeps displayed the two aircraft diverging. CPA was recorded as at approximately 1535:22 with 200ft vertical separation and <0.1NM.
