AIRPROX REPORT No 2024087

Date: 10 May 2024 Time: 1249Z Position: 5212N 00014W Location: 2NM west of Abbotsley

PART A: SUMMARY OF INFORMATION REPORTED TO UKAB

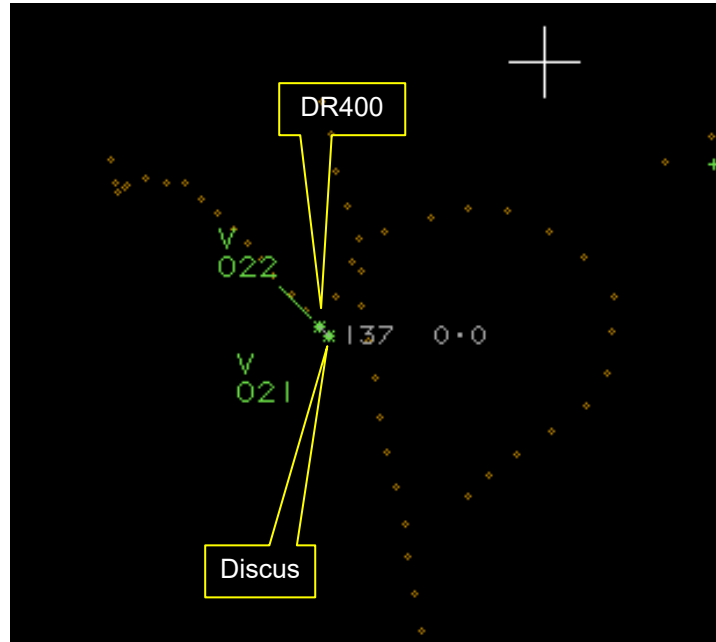
Figure 1: CPA 1248:38 100ft V/<0.1NM H

Both the Discus and the DR400 were tracked on radar and identified using Mode S data. The DR400 track was seen as a constant left-hand turn maintaining 2200ft; the Discus track showed the aircraft on a southeast trajectory in a gentle descent passing through 2100ft at CPA.
