### **AIRPROX REPORT No 2024098**

Date: 24 May 2024 Time: 1059Z Position: 5215N 00045W Location: 3NM SSE of Sywell

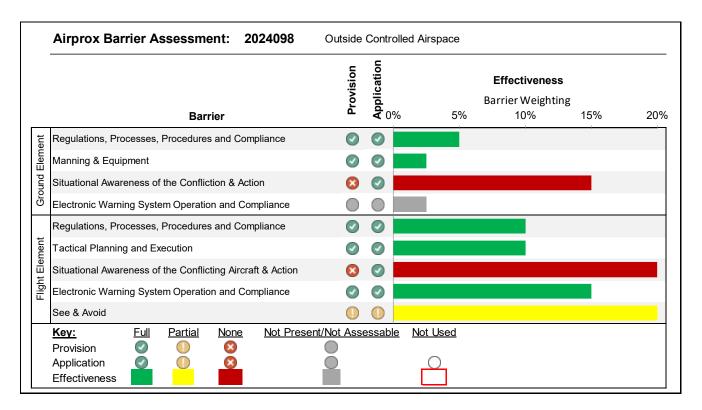
**Situational Awareness of the Confliction and Action** were assessed as **ineffective** because the Cranfield controller had no situational awareness of the presence of the RV6.

## Flight Elements:

**Situational Awareness of the Conflicting Aircraft and Action** were assessed as **ineffective** because the RV6 pilot had no situational awareness of the DA40 and the DA40 pilot achieved only late situational awareness of the RV6.

**See and Avoid** were assessed as **partially effective** because the DA40 pilot achieved only a late sighting of the RV6 and the RV6 pilot did not achieve visual contact with the DA40.
