AIRPROX REPORT No 2024121

Date: 25 Apr 2024 Time: 1051Z Position: 5422N 00136W Location: Catterick

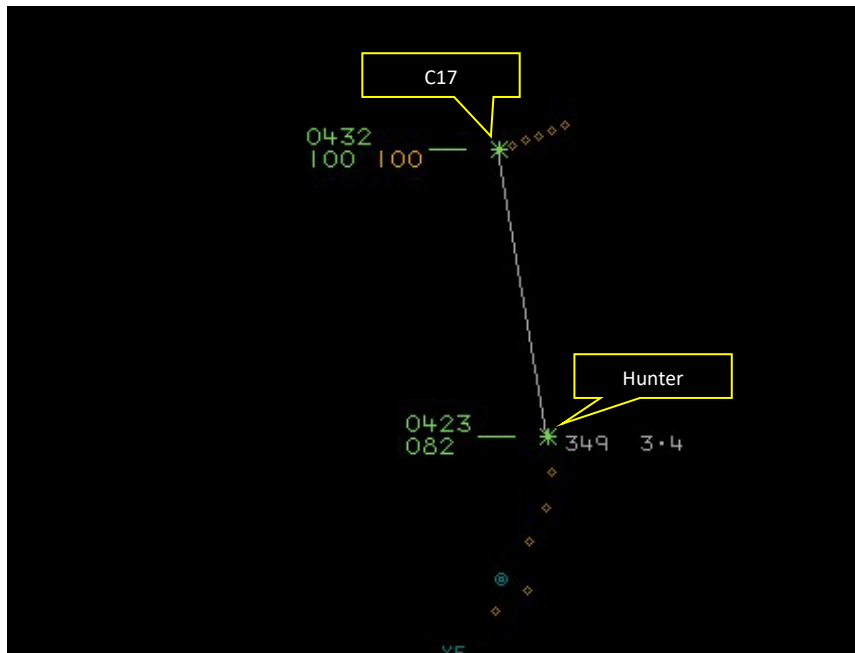
Figure 1. (1049:45) The Hunter turned towards the C17.

At 1049:45, the Hunter pilot turned and climbed towards the C17 whilst requesting, via the Leeming Radar controller, to 'embellish' the C17. The request was passed from the Leeming Radar controller responsible for the Hunter to the Leeming Approach controller responsible for the C17. The C17 pilot subsequently denied the request and the Leeming Approach controller was in the process of passing the denial to the Leeming Radar controller to inform the Hunter pilot. During the period that the request was being actioned by the Leeming controllers the Hunter pilot continued to maintain their interception profile before passing astern of the C17, where it was sighted by the Loadmaster.

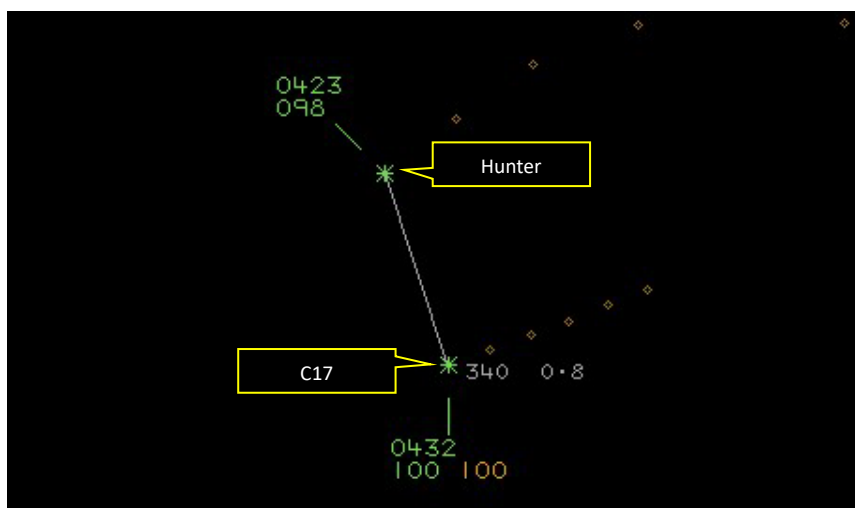
Figure 2. (1050:43) CPA.

CPA occurred at 1050:43 and was recorded as 0.8NM and 200ft separation.
