AIRPROX REPORT No 2024124

Date: 17 Jun 2024 Time: 1301Z Position: 5213N 00005E Location: 4NM W Cambridge

PART A: SUMMARY OF INFORMATION REPORTED TO UKAB

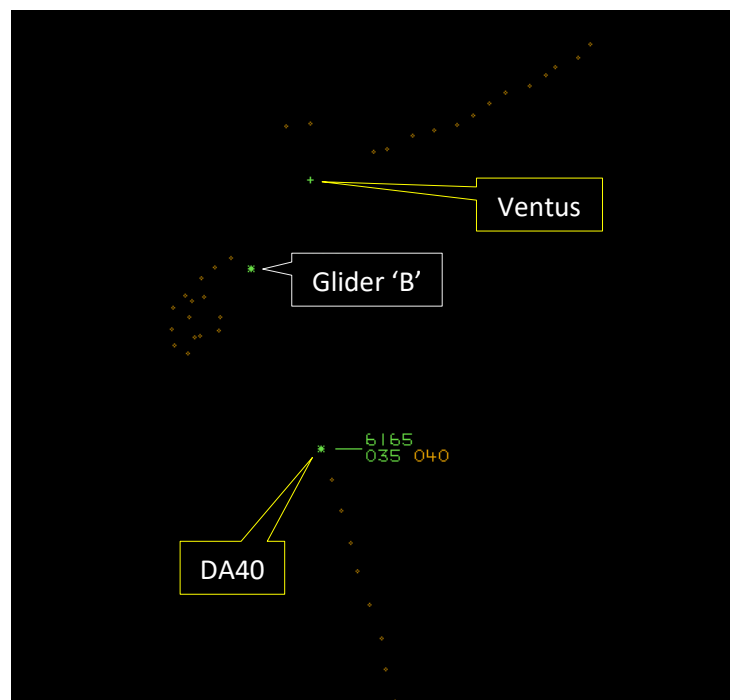
Figure 1 – Aircraft positions at 1301

An analysis of the NATS radar replay was undertaken and the DA40 could be positively identified from Mode S data. The pilot of the Ventus kindly supplied GPS track data for their flight and an intermittent, primary-only return on the radar replay was subsequently determined to have been the Ventus (Figure 1).

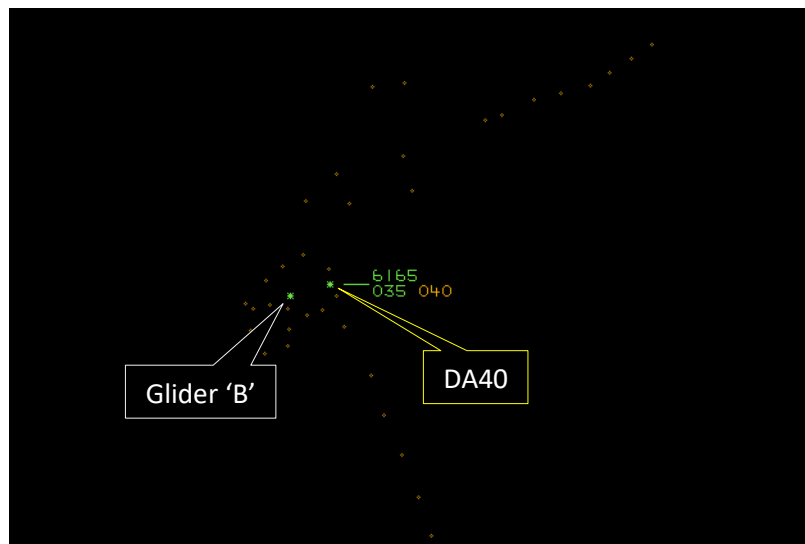
Figure 2 – Aircraft positions at 1301:14 (2sec before CPA)

The Ventus faded from radar replay in the moments before CPA (Figure 2).

The diagram was constructed and the separation at CPA determined by combining the data sources. Analysis of the recorded position and time of the aircraft appeared to indicate that the Ventus had passed in front of (and above) the DA40. In the diagram, the DA40 is depicted at Flight Levels and, for ease of comparison, the Ventus is depicted at altitudes referenced to 1013hPa.
