AIRPROX REPORT No 2024126

Date: 16 Jun 2024 Time: 1252Z Position: 5203N 00107W Location: Turweston

PART A: SUMMARY OF INFORMATION REPORTED TO UKAB

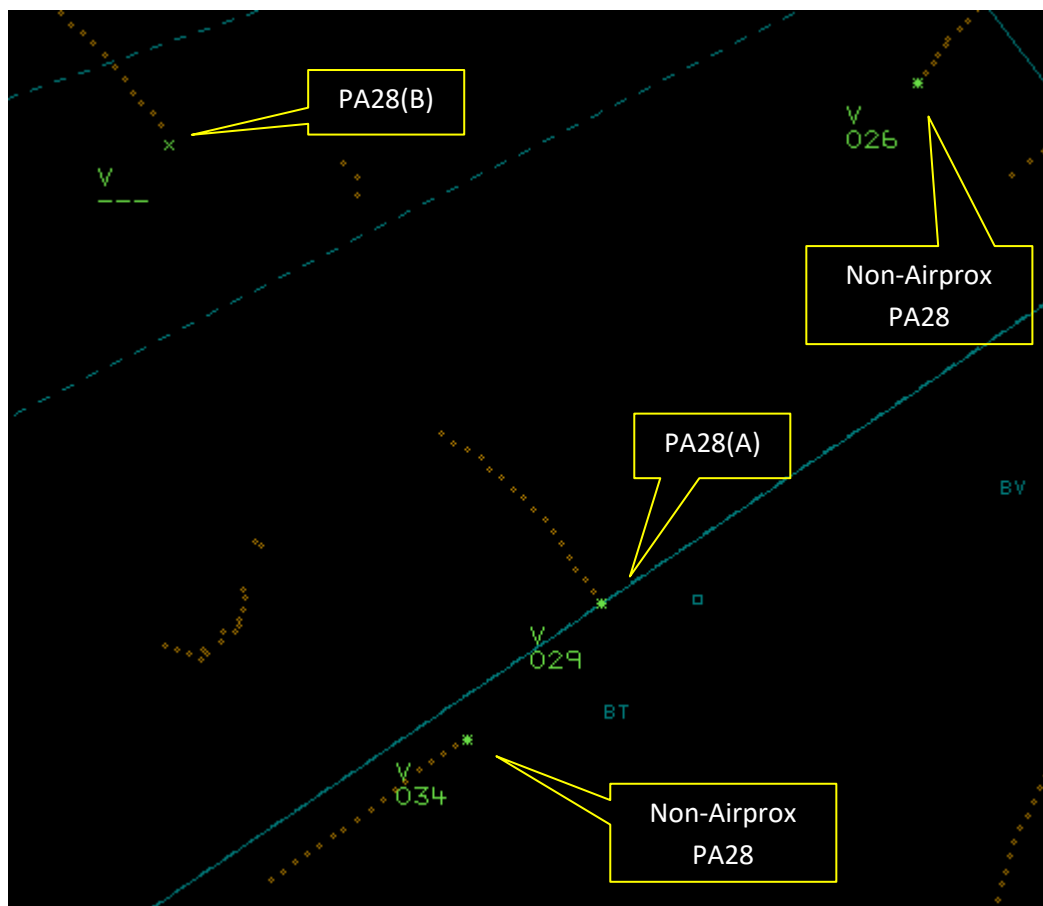
Figure 1 – 1249:07

An analysis of the NATS radar replay was undertaken. Both aircraft could be seen and identified using Mode S data. At Figure 1, PA28(A) could be seen joining via the overhead indicating FL029 (radar QNH 1002hPa, Turweston elevation 438ft), with a non-Airprox PA28 joining from the south-west indicating FL034. PA28(B) was to the northwest of the airfield, with no Mode C and another non-Airprox PA28 was joining from the northeast.

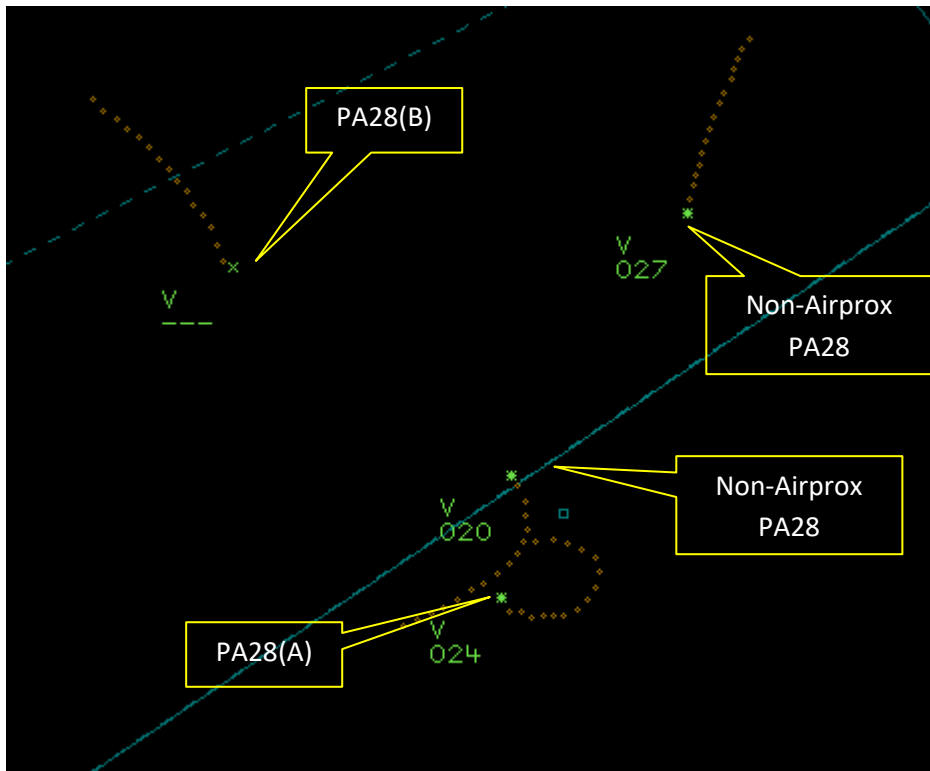
Figure 2 – 1250:29

At Figure 2, PA28(A) had turned to fit in behind the other joining aircraft as described by the PA28(A) pilot in their report.

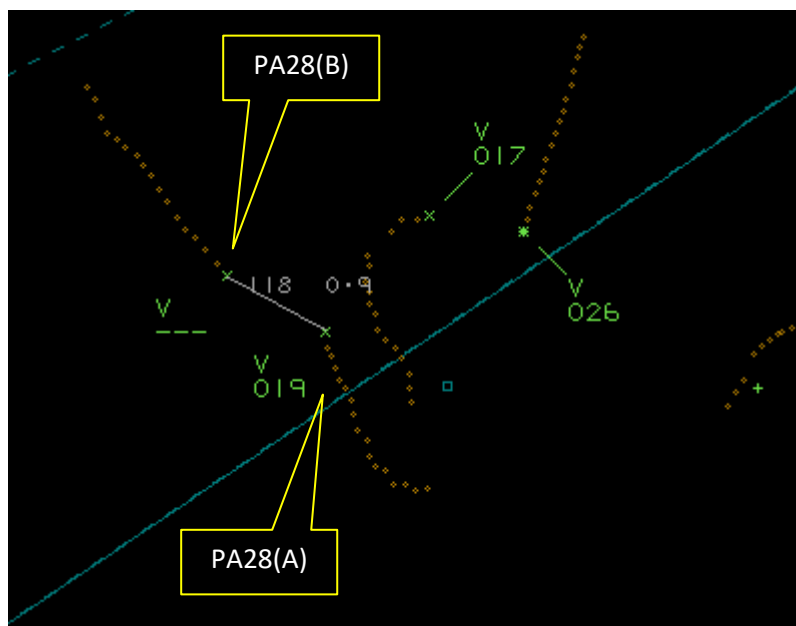
Figure 3 - 1251:14

At Figure 3, PA28(A) was descending on crosswind indicating FL019 with PA28(B) 0.9NM northwest, height unknown.

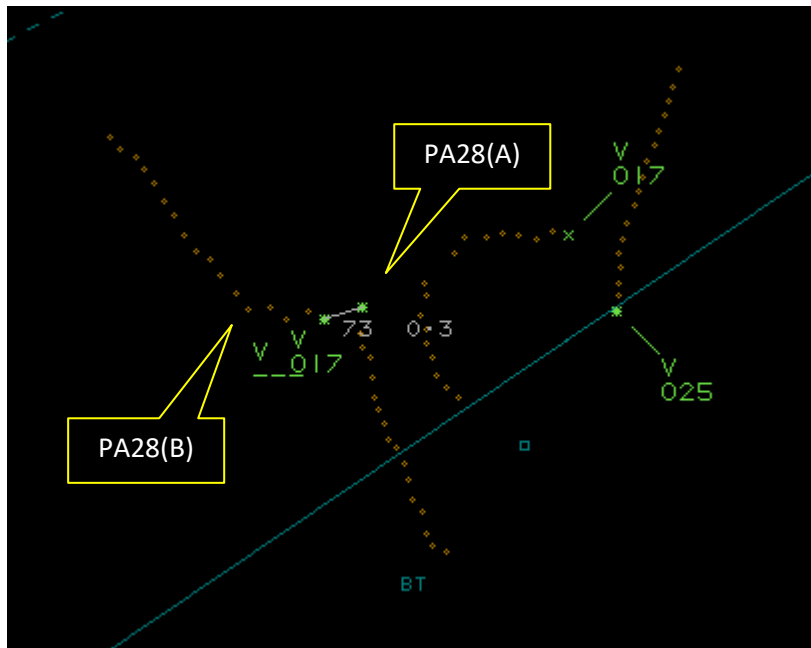
Figure 4 – 1251:30

Figure 4 showed PA28(A) still on crosswind, whilst PA28(B) appeared to have turned onto east.

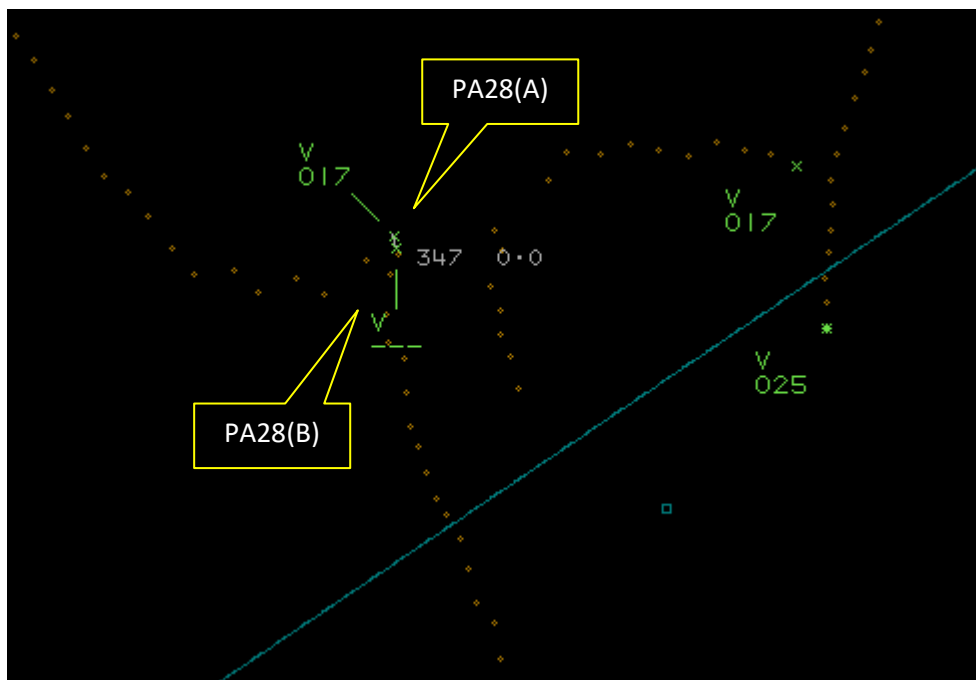
Figure 5 - 1251:38 (radar CPA)

As PA28(A) turned onto a downwind heading, PA28(B) caught up (Figure 5, radar CPA), after which the two aircraft paralleled each other until 1251:59 (Figure 7) when PA28(B) had moved into PA28(A)'s 2 o'clock, probably the point at which the PA28(A) pilot became visual.

When determining the risk of the Airprox, the Board considered the reports from both pilots and that of the AGO, together with the radar screenshots. The radar replay indicated that the two aircraft had been in very close horizontal proximity at the start of the downwind leg, with neither pilot visual with the other aircraft at that point. PA28(B)'s Mode C had not displayed on the radar for some reason and so their actual height could not be known, however, it was noted that the PA28(A) pilot estimated that there had been 100ft of vertical separation. The Board unanimously agreed that there had been a risk of collision, with some members assessing that it had been a serious risk, where providence had played a major part. Others countered that the 100ft of vertical separation meant that safety had been much reduced below the norm. In the end the latter view prevailed; Risk Category B.
