AIRPROX REPORT No 2024139

Date: 21 Jun 2024 Time: 0907Z Position: 5147N 00035E Location: 2NM ENE of Boreham

PART A: SUMMARY OF INFORMATION REPORTED TO UKAB

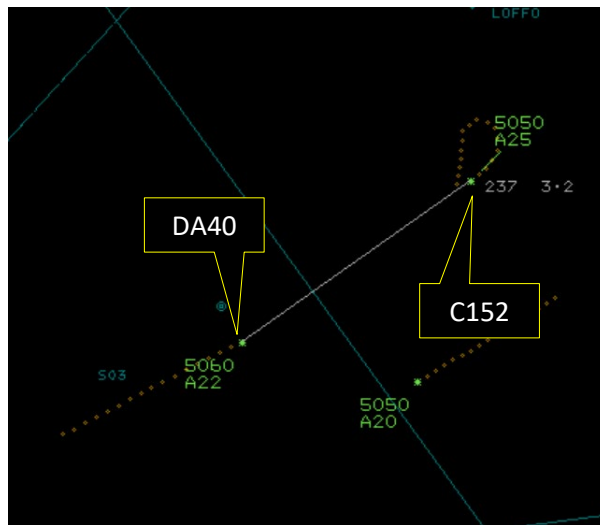
An analysis of the NATS radar was undertaken and both aircraft were identified using Mode S data. The DA40 was seen maintaining an east-northeasterly heading from 0904 toward CPA at 2200ft. At 0905 the C152 turned right into a clockwise orbit east-northeast of the CPA, exiting at 0905:58 towards the DA40 (Figure 1). At 0906:34 the C152 started a gradual descent from 2500ft.

Figure 1- Time 0905:58 C152 exiting the right turn.

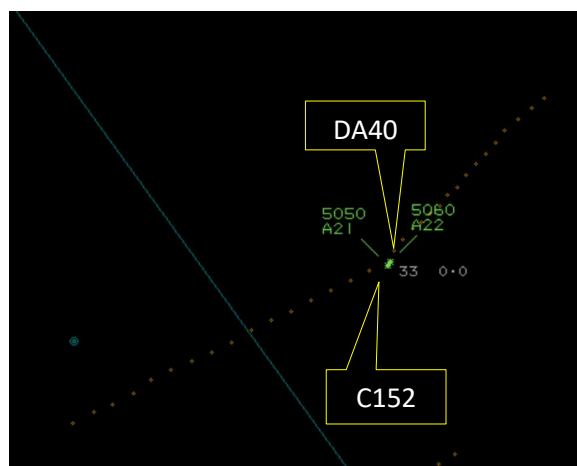
The Airprox was visible, with the CPA occurring at 0906:54 with 0.0NM horizontal and 100ft vertical separation indicated as the aircraft crossed (Figure 2). However, due to potential radar inaccuracies the horizontal distance is recorded above as less than 0.1NM.

Figure 2 – Time 0906:54 CPA indicates 0NM and 100ft separation.
