AIRPROX REPORT No 2024147

Date: 30 Jun 2024 Time: 1106Z Position: 5116N 00209W Location: 3NM SSW Keevil

PART A: SUMMARY OF INFORMATION REPORTED TO UKAB

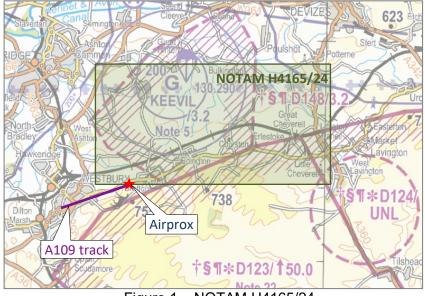
Figure 1 – NOTAM H4165/24

A NOTAM for a military exercise in the area shown in Figure 1 was active at the time of the Airprox.

Members gave further consideration to NOTAM H4165/24. Given that (after CPA) the pilot of the A109 had routed through this area where 'multiple aircraft' had been conducting 'high energy manoeuvres', some members suggested that the pilot of the A109 had not been aware of NOTAM H4165/24 and, as such, may not have noticed a NOTAM for paragliding activity had one been active.

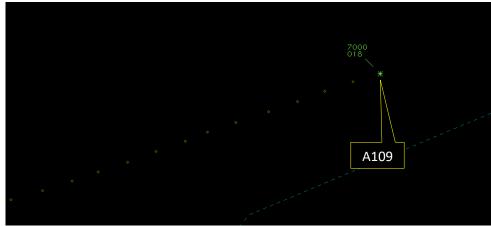
Figure 2 – CPA at 1106:26

An analysis of the NATS radar replay was undertaken and the A109 could be positively identified from Mode S data (Figure 2). The paraglider was not observed on the radar replay.

The paraglider pilot kindly supplied GPS track data for their flight. The diagram was constructed and the separation at CPA determined by combining the different sources.
