AIRPROX REPORT No 2024153

Date: 04 Jul 2024 Time: 0935Z Position: 5112N 00051E Location: 1.3NM SE of Challock Airfield

PART A: SUMMARY OF INFORMATION REPORTED TO UKAB

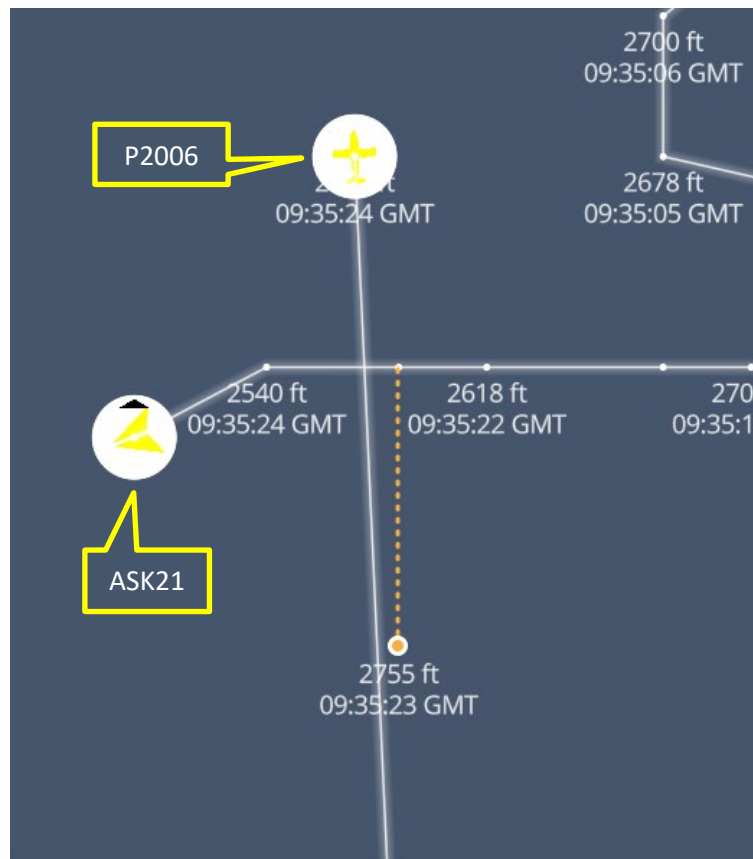
An analysis of the NATS radar replay was undertaken and the P2006, which was positively identified using Mode S data, had been the only high wing twin engine aircraft passing through the position reported by the ASK21 pilot. There were multiple primary targets seen, and nothing identified as the ASK21. Both aircraft were identified using ADS-B data and it was seen that CPA occurred at 0935:24 as the ASK21 was manoeuvring clockwise through west to northwest and the P2006 travelling approximately north.

Figure 1- Time 0935:23 separation at CPA 140ft vertically and <0.1NM
