AIRPROX REPORT No 2024160

Date: 13 Jul 2024 Time: 1009Z Position: 5250N 00245W Location: Sleep Airfield

PART A: SUMMARY OF INFORMATION REPORTED TO UKAB

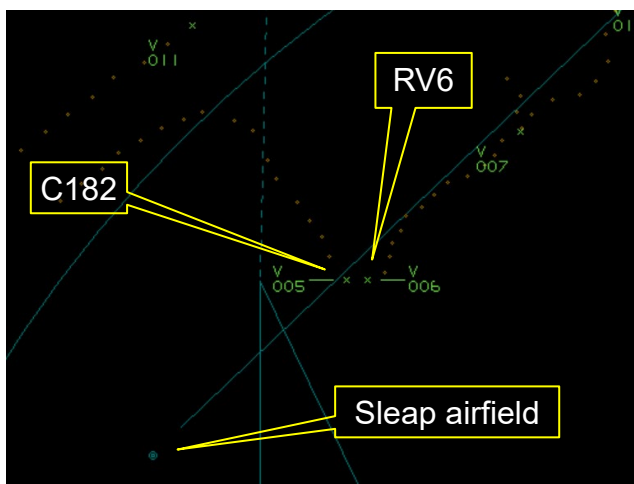
Figure 2: 1008:31 - 100ft V/0.1NM H

Figures 2 and 3 above show the closure geometry ahead of CPA with the closest radar-derived separation not reducing below 0.1NM. Figure 4 captures the point after the C182 pilot has initiated avoiding action and at which CPA is recorded – 0ft V/<0.1NM H. Figure 5 shows the ADS-B trace of the C182 and RV6, with other traffic in the circuit; this picture is approximately 19sec ahead of CPA and is the last point at which the RV6 track is updated on this system.

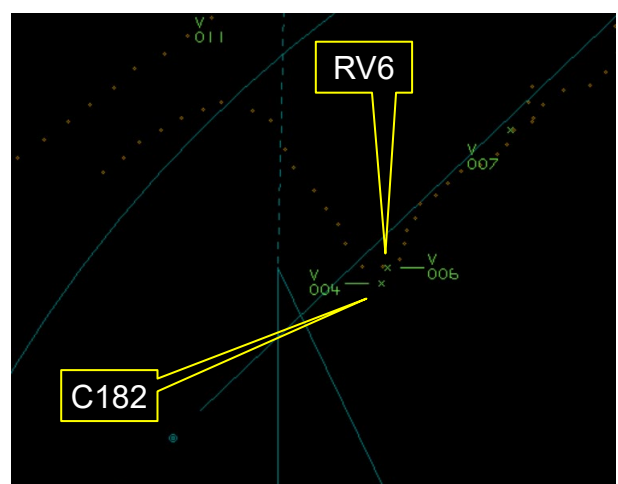
Figure 3: 1008:35 – 200ft V/0.1NM H

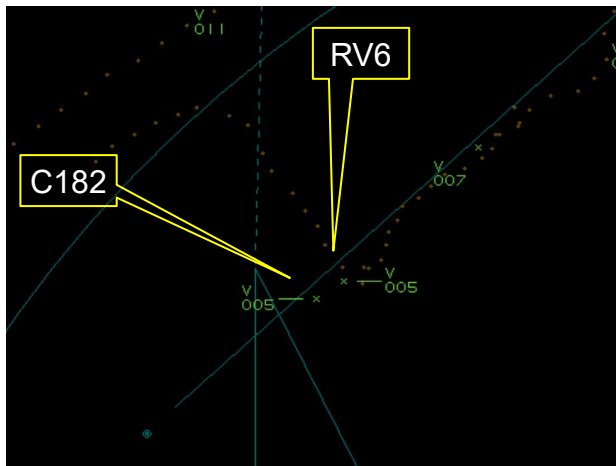
Figure 4: CPA - 1008:39 – 0ft V/0.1NM H

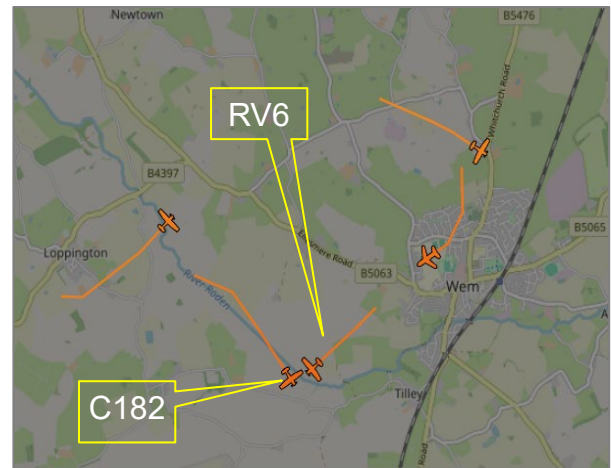
Figure 5: ADS-B Exchange screenshot at CPA minus 10sec - 1008:20. The RV6 track ceased to update after this time.
