AIRPROX REPORT No 2024169

Date: 19 Jul 2024 Time: ~1137Z Position: 5101N 00211W Location: Compton Abbas

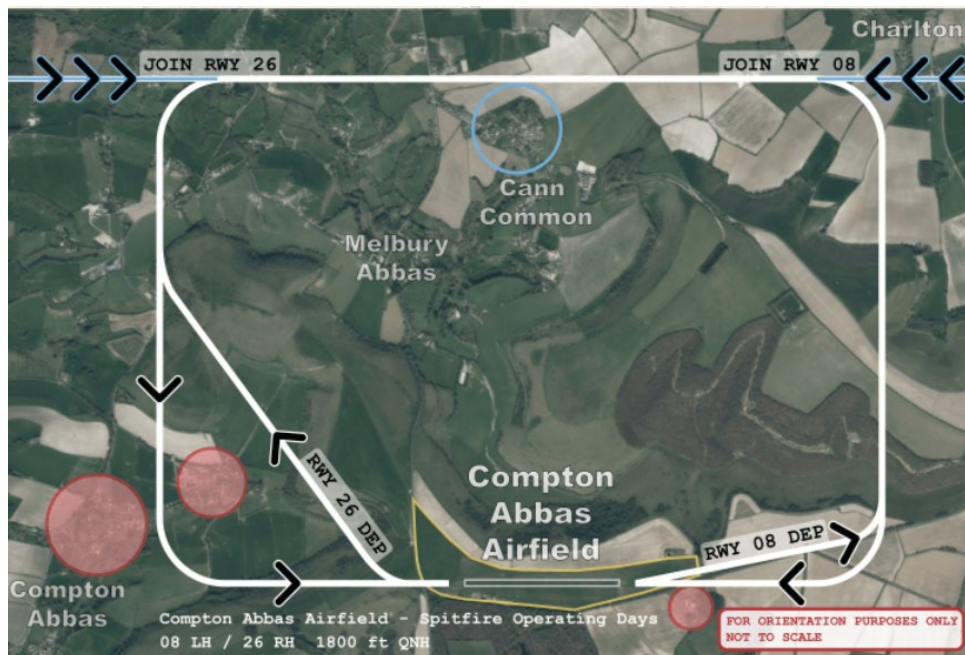
Figure 1 – circuit join on Spitfire operating days.

During NOTAM d days of Spitfire Operations, the standard overhead join and deadside will not be in use. A downwind join must be used instead. This is to ensure these areas are kept sterile exclusively for the Spitfire.

Please plan your airfield arrival to join on 'extended downwind', at the circuit altitude of 1800' QNH, as shown by blue arrows in the diagram above.

The downwind leg is flown as usual, please keep the aircraft to the North of 'Cann Common', marked with a blue circle on the diagram

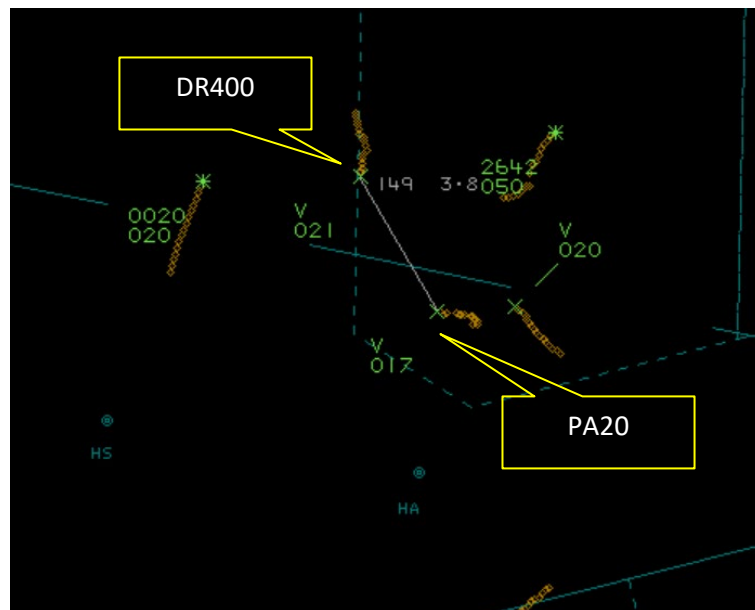
Figure 2 - 1132:53

At Figure 2, the two aircraft were 3.8NM apart and they continued to close until 1133:40 (Figure 3), when the PA20 faded from the radar replay. The DR400 also faded from the radar replay (probably as they both descended below radar coverage) at 1134:05.

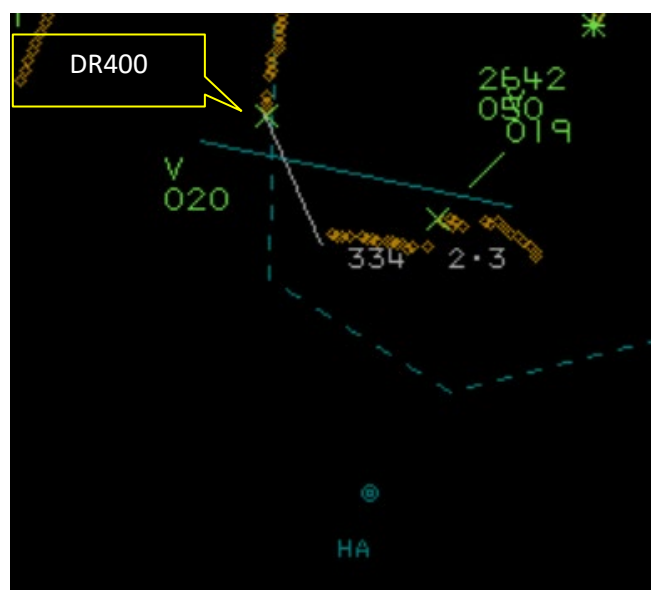
Figure 3 - 1133:40

Although the positioning of the PA20 could be determined from their GPS track, other ADS-B data platforms were assessed and there was no corresponding data for the DR400; therefore the exact separation could not be ascertained.
