AIRPROX REPORT No 2024171

Date: 18 Jul 2024 Time: 1423Z Position: 5216N 00006E Location: Impington, Cambs.

PART A: SUMMARY OF INFORMATION REPORTED TO UKAB

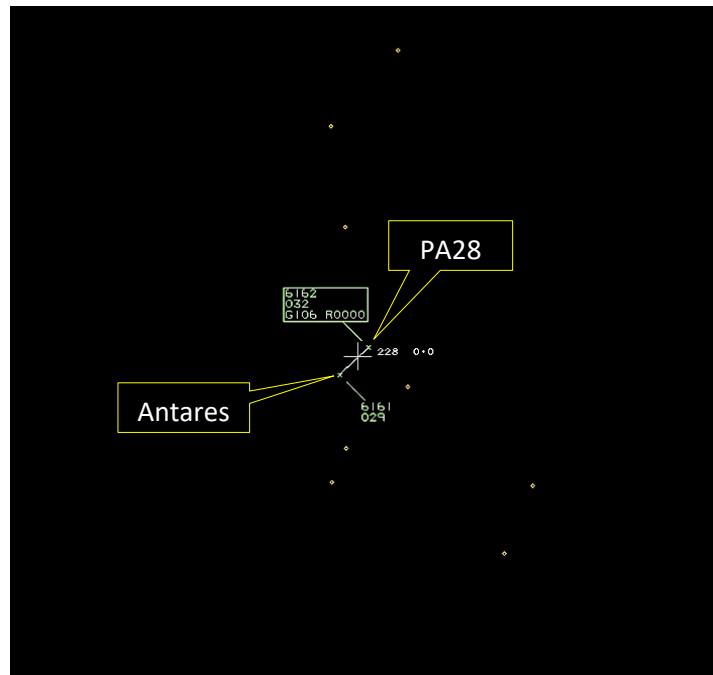
An analysis of the NATS radar replay was undertaken and both aircraft could be seen throughout using Mode S data. The Antares had been circling anti-clockwise, climbing, and moving slightly northwards, reaching 2900ft on 1013hPa. The PA28 was in a descent tracking approximately southwards and indicating 3200ft on 1013hPa.

Figure 1- CPA 1423:28 0NM and 300ft indicated separation

The point of CPA was 1423:28 with a separation of 300ft vertically and less than 0.1NM horizontally.
