**AIRPROX REPORT No 2024175**

Date: 24 Jul 2024 Time: 1533Z Position: 5407N 00320W Location: 3NM W Walney

**PART A: SUMMARY OF INFORMATION REPORTED TO UKAB**

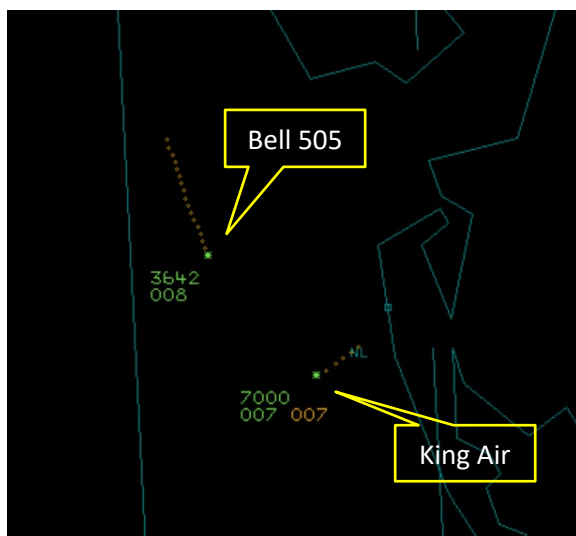
Figure 1 – 1532:39

An analysis of the NATS radar replay was undertaken. Both aircraft could be identified using Mode S data. At Figure 1 the King Air could be seen climbing out from Walney as the Bell 505 transited southbound indicating 800ft (radar QNH 1019hPa). The two aircraft continued to close until CPA at 1533:15, with both aircraft indicating 600ft and 0.3NM horizontal separation. At this point the King Air was 2.9NM from Walney (see Figure 4); Walney’s ATZ has a 2NM radius.

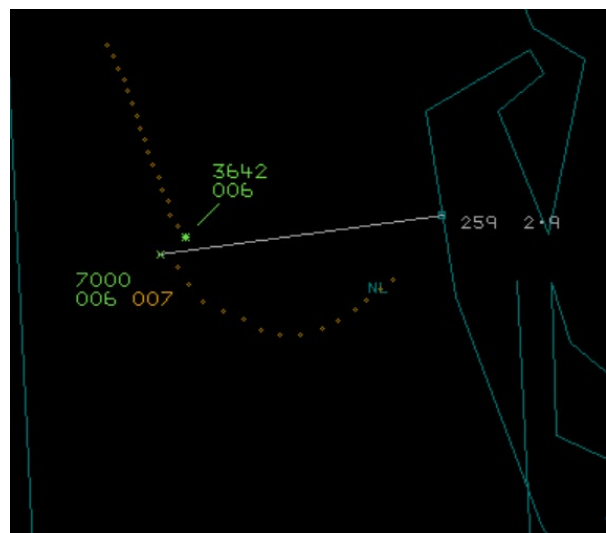
Figure 4 – Aircraft 2.9NM from Walney at CPA
