**AIRPROX REPORT No 2024179**

Date: 31 Jul 2024 Time: 1235Z Position: 5157N 00105W Location: 3NM NE Bicester

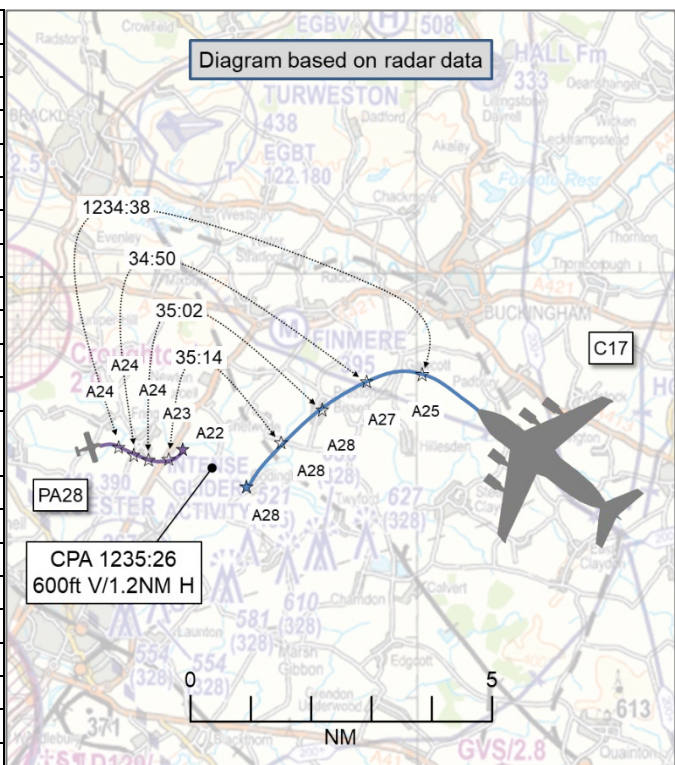
CPA occurred at 1235:26 and was recorded as 1.2NM and 600ft separation.

The CPA between the two aircraft was approximately 1.2NM laterally, Mode C of [PA28 C/S] showed 2200ft and the Mode C of [C17 C/S] showed 2800ft.

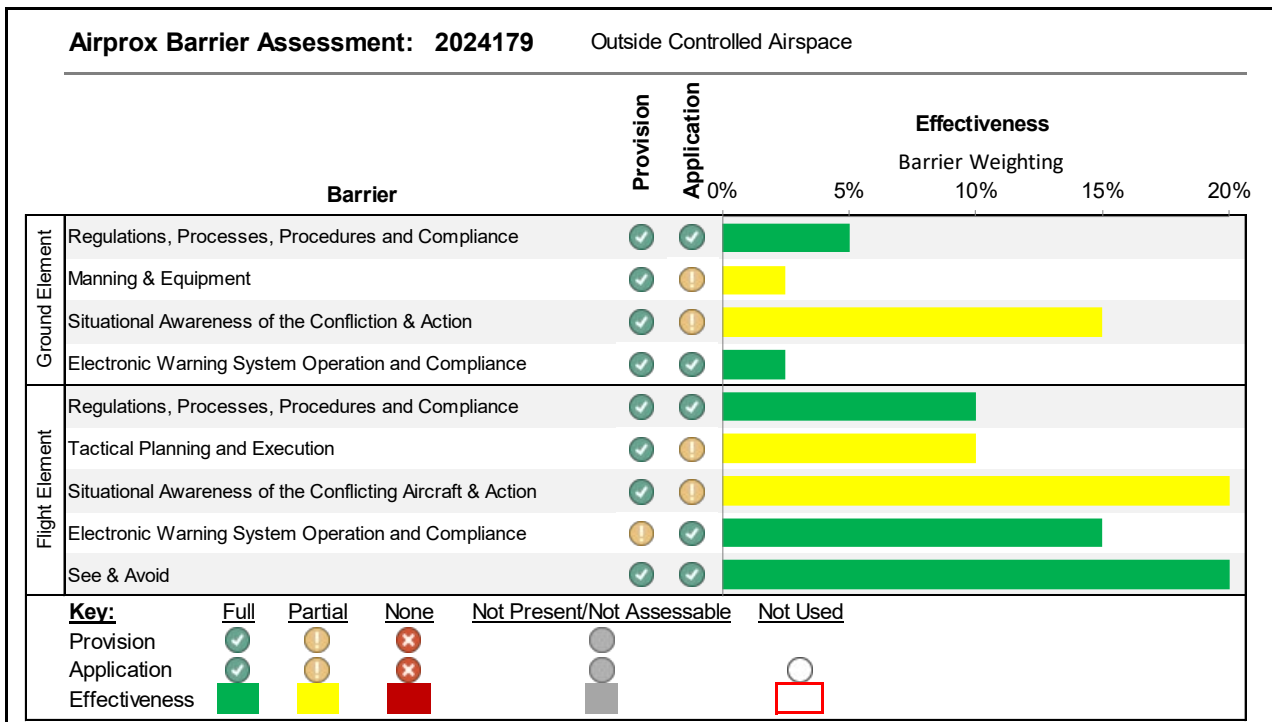
Safety Barrier Assessment<sup>3</sup>

**Manning and Equipment** were assessed as **partially effective** because the Benson trainee controller turned the C17 towards the PA28 and the OJTI did not comment or intervene.

**Situational Awareness of the Confliction and Action** were assessed as **partially effective** because the Benson trainee controller instruction to the C17 pilot to turn left contributed to the Airprox.

**Tactical Planning and Execution** was assessed as **partially effective** because the C17 pilot turned towards the PA28 despite having been given Traffic Information and ‘own navigation’.

**Situational Awareness of the Conflicting Aircraft and Action** were assessed as **partially effective** because the C17 pilot flew close enough to the PA28 to cause themselves concern despite situational awareness from their TCAS display.
