AIRPROX REPORT No 2024180

Date: 01 Aug 2024 Time: 1350Z Position: 5107N 00104E Location: Pent Farm

PART A: SUMMARY OF INFORMATION REPORTED TO UKAB

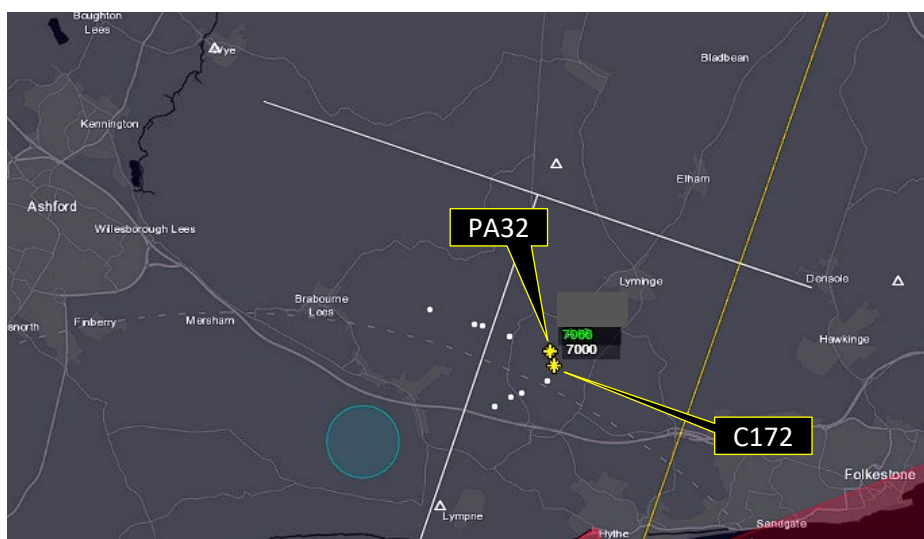
Figure 1 – Screenshot taken at 1349:20 from the unofficial and unapproved FID (which is inaccessible from Lydd Tower)

The investigation took place and found that no action could have reasonably been taken by the ATCO on duty. The reporting pilot was not in communication with Lydd at the time of the incident, so could not have been warned of traffic in the vicinity. Pent Farm is known to the Unit, as are several other strips in the area. It is marked on the charts at 9.9NM from Lydd.

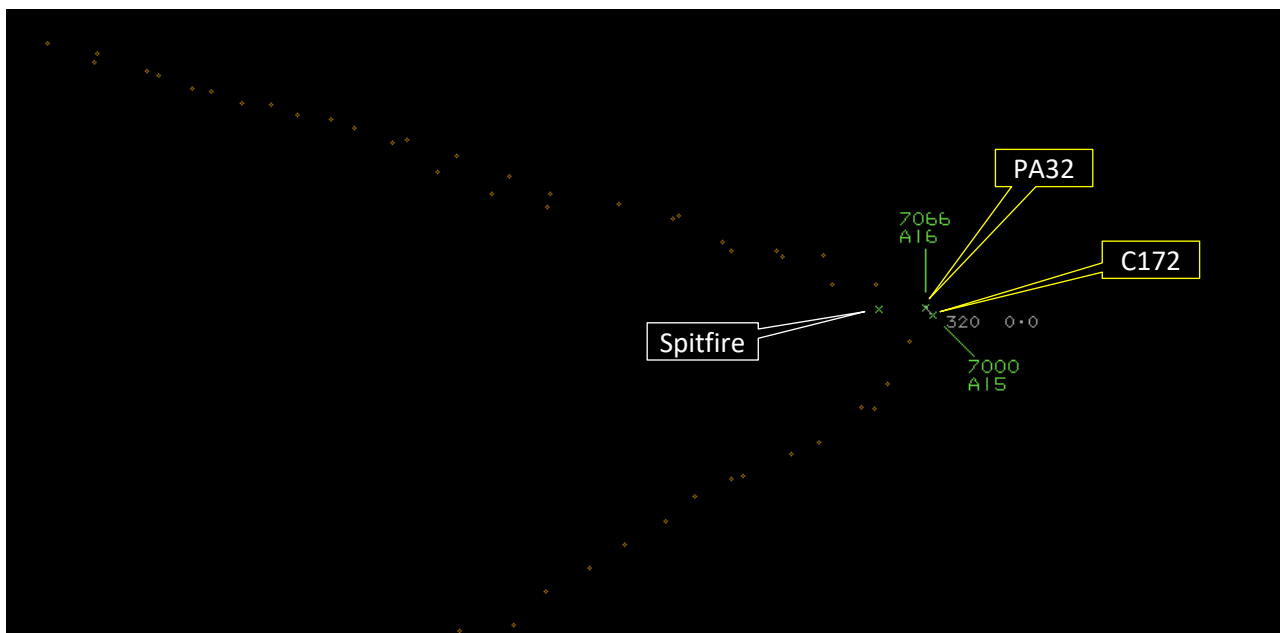
An analysis of the NATS radar replay was undertaken. Both aircraft could be positively identified from Mode S data (Figure 2). The diagram was constructed and the CPA determined from the radar data.

Figure 2 – CPA at 1349:34

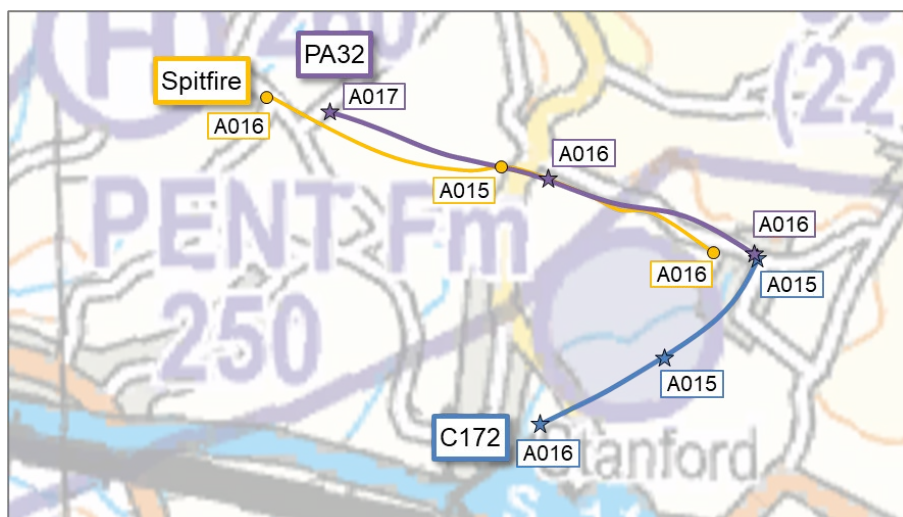
Figure 3 – The tracks and relative positions of the Spitfire, PA32 and C172
