AIRPROX REPORT No 2024181

Date: 02 Aug 2024 Time: 1543Z Position: 5210N 00102W Location: IVO Grimscote

PART A: SUMMARY OF INFORMATION REPORTED TO UKAB

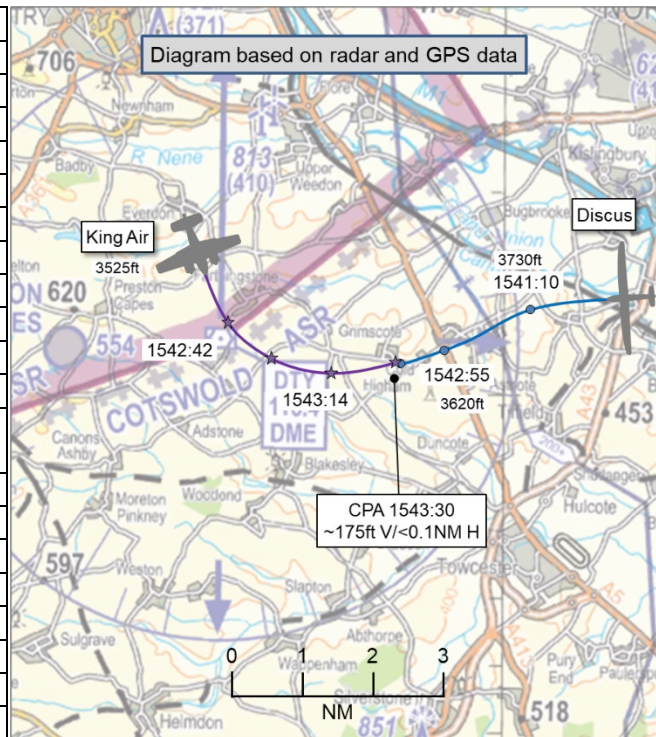
Recorded	Aircraft 1	Aircraft 2
Aircraft	Discus	King Air
Operator	Civ Gld	Civ Comm
Airspace	London FIR	London FIR
Class	G	G
Rules	VFR	VFR
Service	None	Basic
Provider	N/A	Cranfield
Altitude/FL	3350ft	3525ft
Transponder	Not fitted	A, C, S
Reported		
Colours	White	White
Lighting	None	Nav, strobes, recognition
Conditions	VMC	VMC
Visibility	>10km	>10km
Altitude/FL	3500ft	3500ft
Altimeter	QNH	QNH (1011hPa)
Heading	~260°	090°
Speed	50kt	180kt
ACAS/TAS	PowerFLARM	SkyEcho
Alert	None	None
Separation at CPA		
Reported	30ft V/0NM H	Not seen
Recorded	~175ft V/<0.1NM H

The King Air was tracked throughout using Mode S radar whereas the Discus appeared intermittently on that system and only as a primary contact. Both aircraft were tracked via the CAAs Airspace Analyser Tool and the picture at page 1 is drawn together using both radar and GPS data sources. Reference to the 'ghost' aircraft at figure 2 was clarified by the crew of the King Air as the operator's SOPs requiring a safety pilot on board for the type of training flight [in this case]. One of their pilots in the back of the King Air had carried an iPad and had been using an [electronic conspicuity equipment]. Although unaware at the time, they now believed this to have been registered to a different aircraft, hence the 'ghost' return.

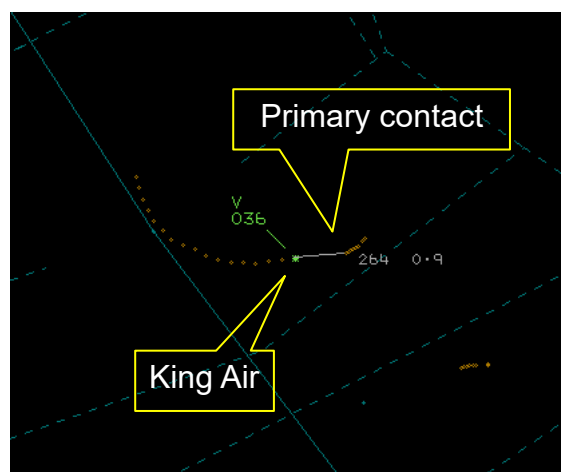
Figure 1: At CPA (1543:30): The King Air had been at 3550ft and the last point at which an aircraft (which cannot be confirmed as the Discus) had shown as a primary radar contact (1543:06). Following the radar replay through for a further minute (1544:26), the primary contact did not reappear.

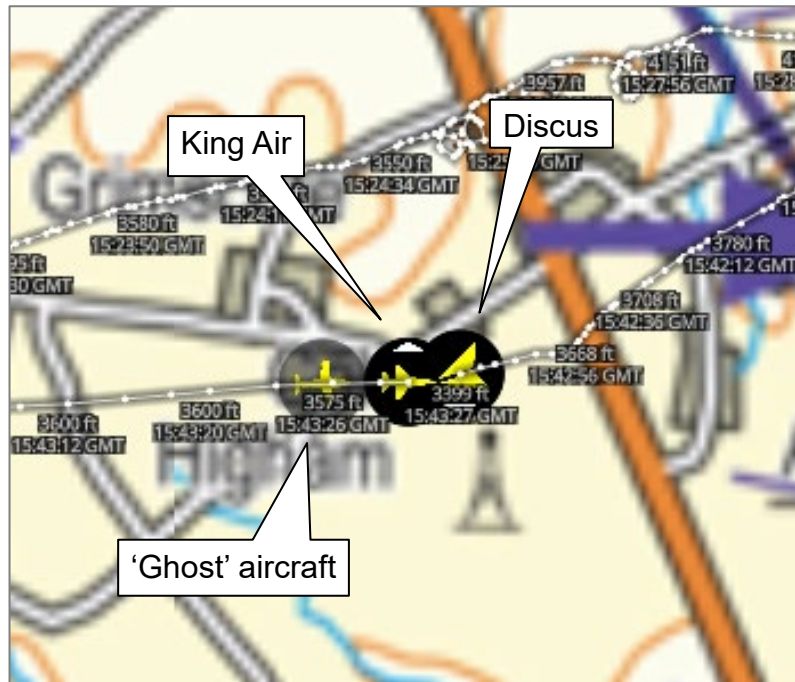
Figure 2: (Taken from the CAA's Airspace Analyser Tool) The Discus is timed at 1543:27 and passing 3350ft descending rapidly. The King Air is timed at 1543:30 and passing 3575ft climbing.
