AIRPROX REPORT No 2024201

Date: 11 Aug 2024 Time: 1413Z Position: 5143N 00113W Location: IVO Oxford

PART A: SUMMARY OF INFORMATION REPORTED TO UKAB

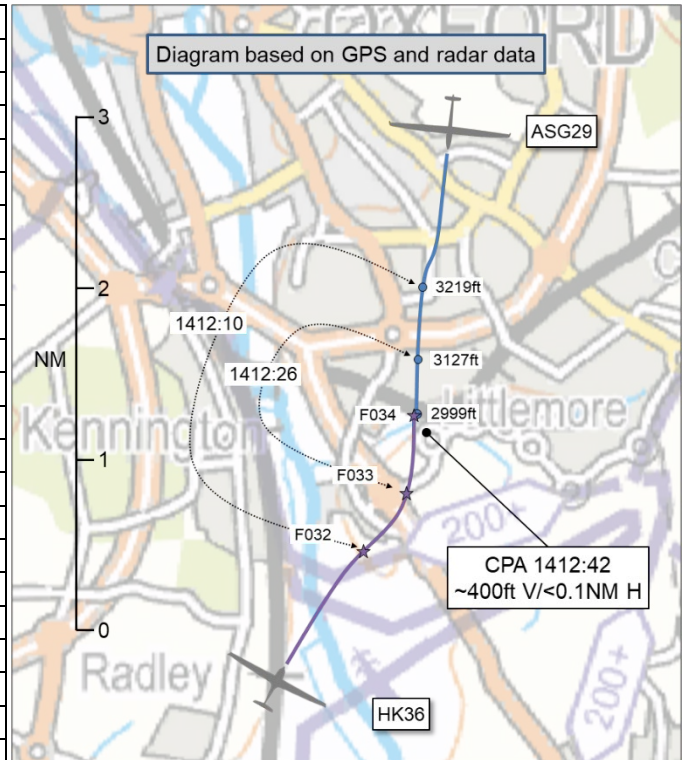
THE ASG29 PILOT reports that, just south of Oxford [city], they were working out a route home (via the cumulus clouds) and something drew their eyes directly forward. They realised it was a fast-moving light-aircraft and they dived to avoid it. There were a lot of grey/white clouds around and assume that, with its relatively small head-on profile, they didn't pick it up with their usual lookout. Their [EC device] didn't pick it up and, they assume, the other plane didn't have a [similar EC device] fitted. Once they saw it, they dived underneath (there was no time to turn). They should have spotted it earlier but, despite scanning all of the next clouds on their track, they hadn't picked it up until quite late.

[The pilot of the ASG29 opined that] it would have been a direct head-on collision. They were flying straight and level (as much as a glider can) and assessing options for their next climb. The aeroplane appeared very quickly in front of them. They may have been just below the nose [of the powered aircraft] so maybe the [other pilot] didn't see them as they were out of sight.

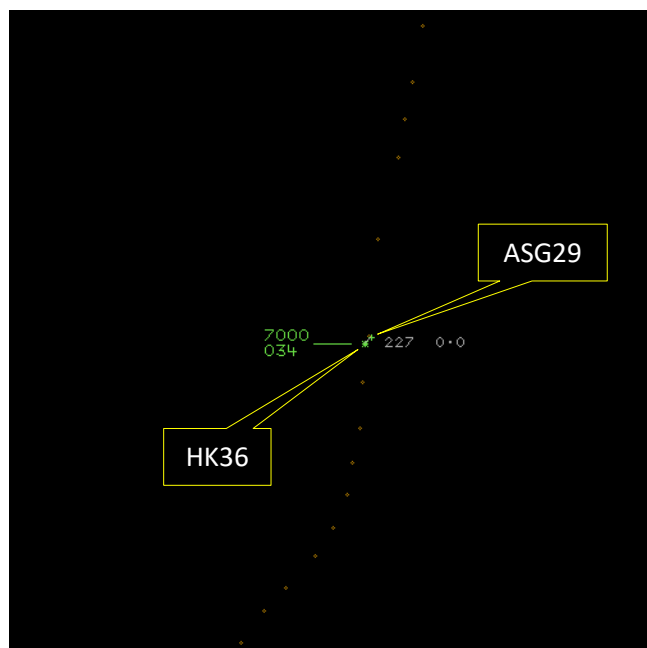
Figure 1 – CPA at 1412:42

An analysis of the NATS radar replay was undertaken and the HK36 could be positively identified from Mode S data (Figure 1).

The pilot of the ASG29 kindly supplied GPS track data for their flight. The ASG29 was identified by reference to the track data and their narrative report. The diagram was constructed and the separation at CPA determined by combining the various data sources.
