AIRPROX REPORT No 2024205

Date: 12 Aug 2024 Time: 1201Z Position: 5113N 00109W Location: 9NM W Odiham

PART A: SUMMARY OF INFORMATION REPORTED TO UKAB

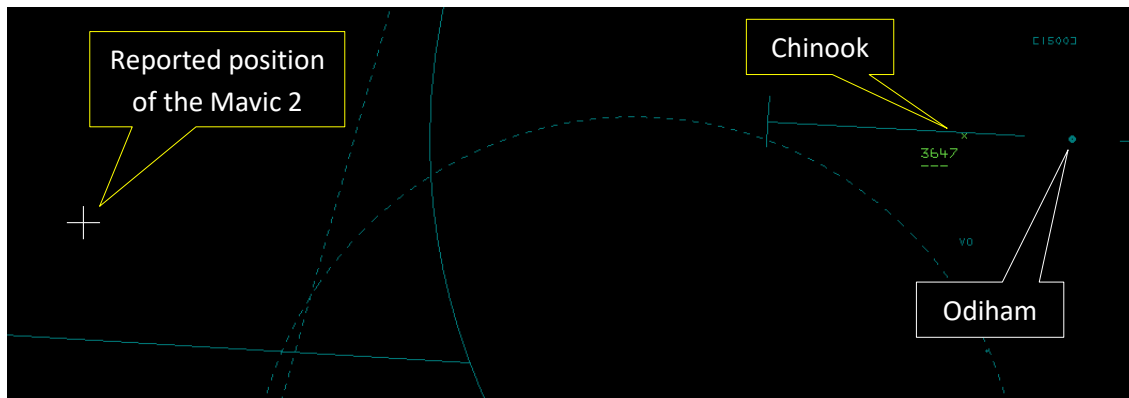
An analysis of the NATS radar replay was undertaken and the Chinook could be positively identified from Mode S data (Figure 1). The Mavic 2 was not observed on radar. The pilot of the Mavic 2 provided an annotated picture showing the track of the Chinook traversing the Airprox location from the north-east to south-west, and the direction of their avoiding action to the south-east.

Figure 1 – The Chinook first appeared on the NATS radar at 1157:17

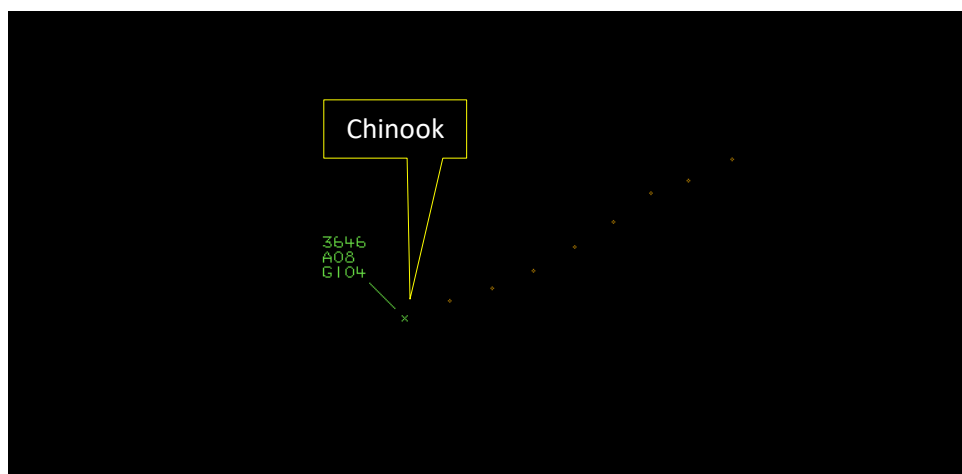
The diagram for this Airprox report was constructed from the radar data. The position of the Mavic 2 has been shown as the reported position. The pilot of the Mavic 2 had reported their height as 10m AGL. The elevation of the terrain at the reported position of the Mavic 2 is 534ft AMSL. Therefore, the separation between the Mavic 2 and the Chinook was estimated to have been around 233ft but this could not be verified. The horizontal separation between the Chinook and the reported position of the Mavic 2 was less than 20m but the actual separation could not be verified.

Figure 2 – CPA at 1201:18. The groundspeed of the Chinook was 104kt.
