AIRPROX REPORT No 2024206

Date: 13 Aug 2024 Time: 1436Z Position: 5110N 00144W Location: MoD Boscombe Down

PART A: SUMMARY OF INFORMATION REPORTED TO UKAB

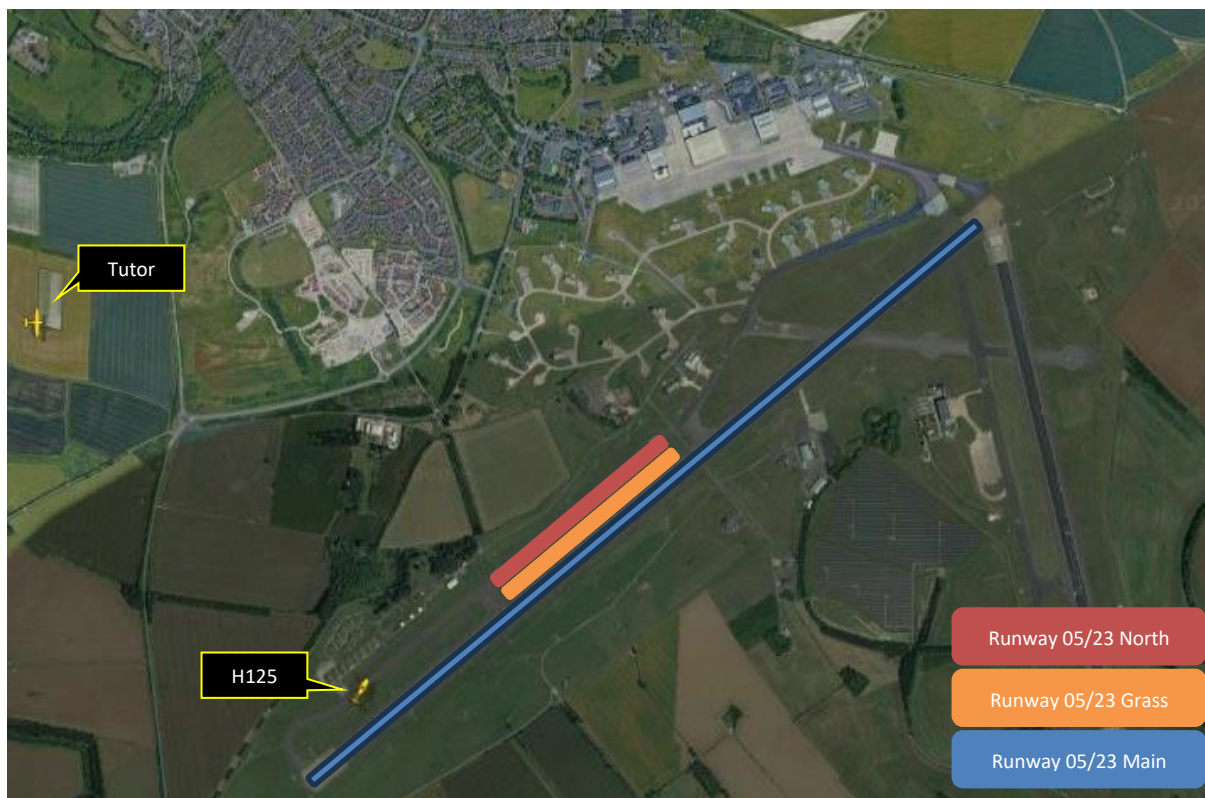
Figure 1. Estimated relative positions of the H125 and Tutor following the H125's departure.

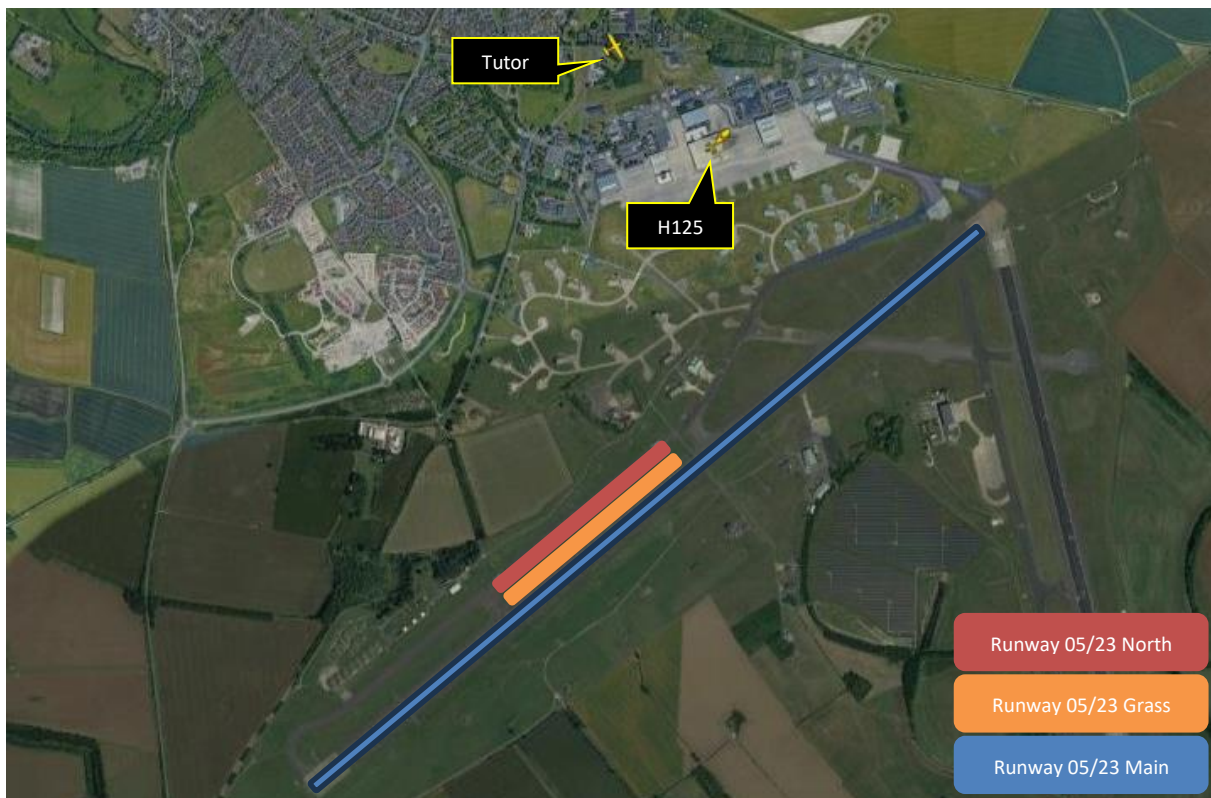
At 1435:23, the H125 [pilot] reported “downwind 23 grass”, the Boscombe Down Aerodrome controller attempted to acknowledge the position report through passing the surface wind, however, incorrectly transmitted on the Boscombe Down Ground frequency. As the H125 [pilot] was only providing a position report there was no requirement for them to receive an acknowledgment, equally the lack of response did not affect any traffic sequencing actions.

Figure 2. Estimated relative positions of the H125 and Tutor whilst both downwind.
