AIRPROX REPORT No 2024214

Date: 17 Aug 2024 Time: ~1030Z Position: 5058N 00211W Location: Compton Abbas

PART A: SUMMARY OF INFORMATION REPORTED TO UKAB

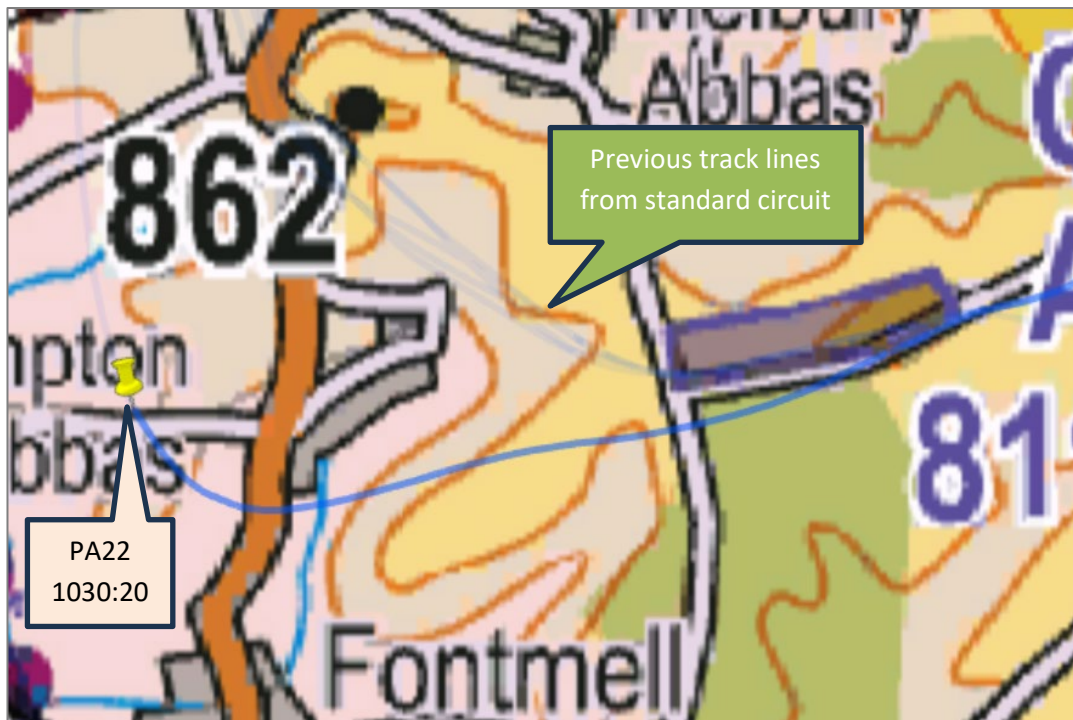
The PA22's navigation log displayed their third circuit and subsequent go-around as described by the pilot, including the extended direct heading before turning onto a right-hand crosswind after CPA (Figure 2).

Figure 2 – Time 1030:20 position of the PA22 after CPA

Based on the reports from both pilots, the Thruster turned left after departure. As the PA22 pilot had not taken their right turn prior to CPA, the Airprox is assessed to have occurred between the end of RW26 and Compton Abbas village at approximately 1029:48. The separation at CPA could not be determined.
