**AIRPROX REPORT No 2024215**

Date: 16 Aug 2024 Time: ~1607Z Position: 5332N 00023W Location: IVO Humberside Airport

**PART A: SUMMARY OF INFORMATION REPORTED TO UKAB**

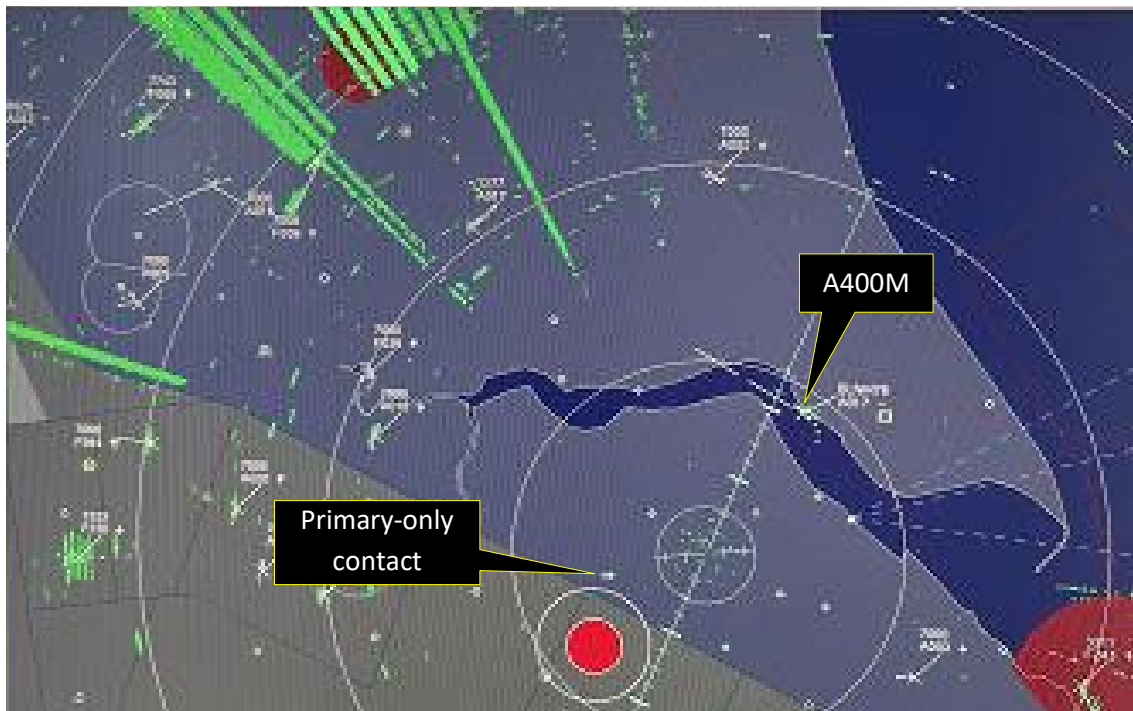
The situational display showed a large number of primary radar returns, particularly in the north-west sector of the display. There was a small, barely distinguishable return 3 miles west of Brigg at the start of the recording, slowly moving east. That return did not produce a defined trail so may have been dismissed as spurious, its movement was only noticeable if it was watched. When the situational display was moved, the return disappeared. There was also a lot of [radar interference] around 1549:50 which obscured some of the picture (Figure 1).

Figure 1 – The traffic situation at 1549:50

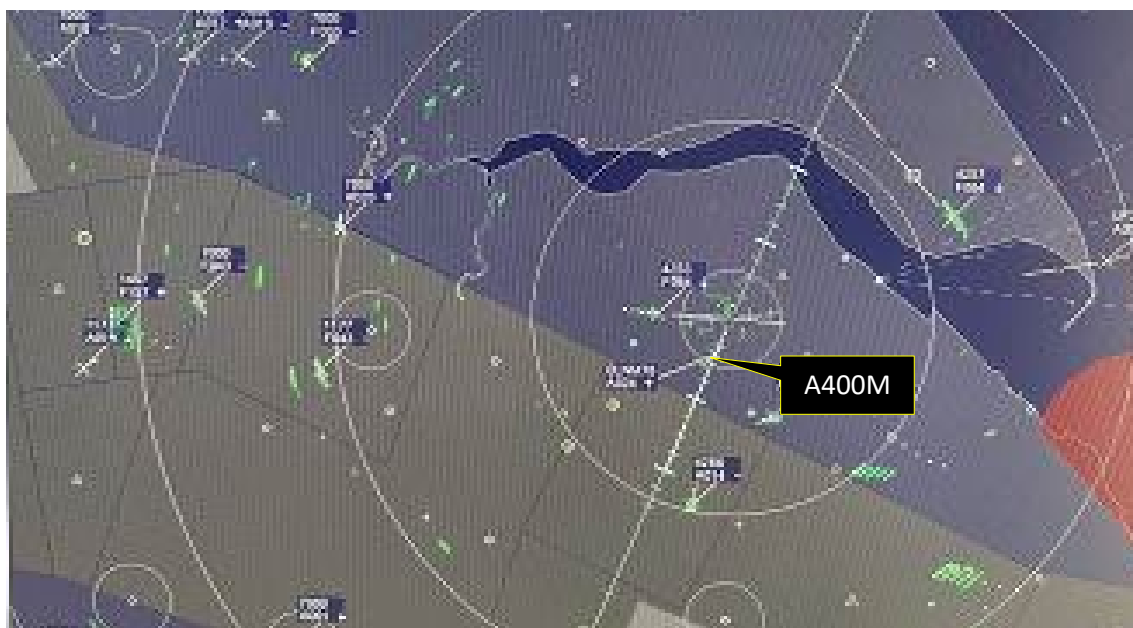
At 1606, [the A400M] was climbing-out passing 2400ft as it passed the ATZ boundary and the suspect primary-only return was just outside the ATZ boundary.

Figure 2 – The traffic situation at 1606

The [paramotor] was not seen on the situational display, consequently [the pilot of the A400M] could not be advised of the [paramotor]. The controller was working in a high workload environment and did not ask the pilot of the A400M about the details of the [paramotor], such as altitude/colour/direction of flight to pass on to other aircraft. The [paramotor] pilot should have advised ATC of their flight if they were non-radio.

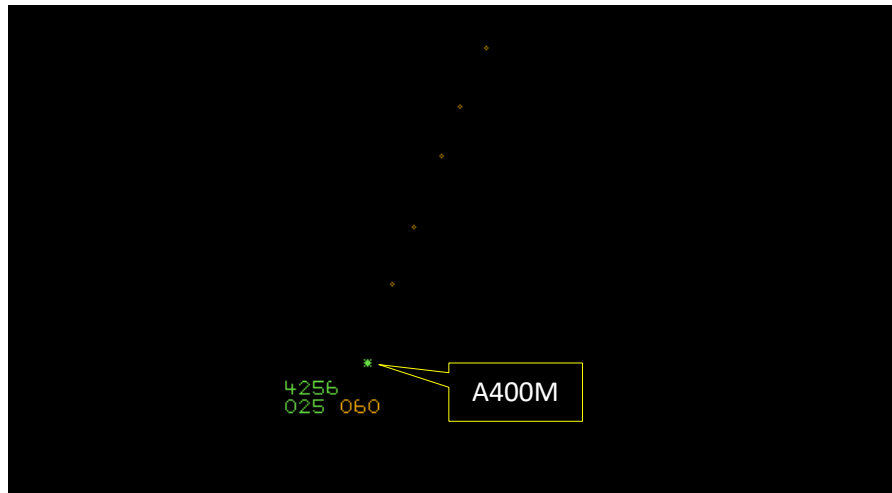
An analysis of the NATS radar replay was undertaken. The A400M could be identified from Mode S data (Figure 3). The paramotor was not observed. The diagram was constructed from the radar data and the position of the paramotor has been shown as reported by the pilot of the A400M. The separation at CPA could not be determined.

Figure 3 – 1606:46 (assessed as the approximate time of CPA)
