AIRPROX REPORT No 2024226

Date: 29 Aug 2024 Time: 1057Z Position: 5154N 00208W Location: 1NM E of Gloucester Airport

PART A: SUMMARY OF INFORMATION REPORTED TO UKAB

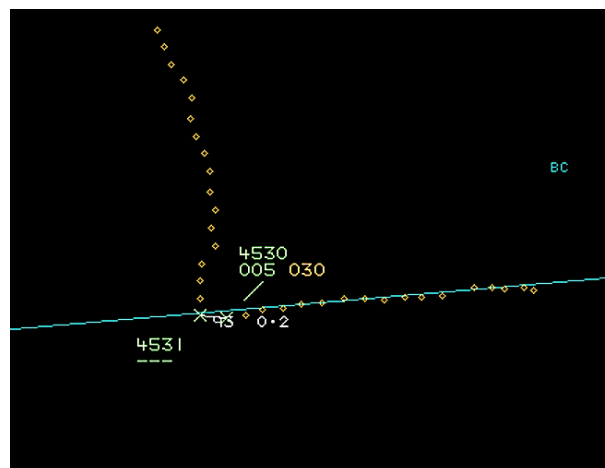
An analysis of the NATS radar replay was undertaken and both aircraft were positively identified using Mode S data. CPA was at 1056:34 with 0.2NM horizontal and less than 100ft separation (Figure 2).

Figure 2: 1056:34 separation 0.2NM and less than 100ft.

After CPA the Decathlon and DA42 diverged as the Decathlon began to climb away.
